July 1, 2015

00406-01910 Version 3

Safety Recall: Front Passenger's Airbag Inflator May Produce Excessive Pressure After Long-Term Exposure To High Absolute Humidity

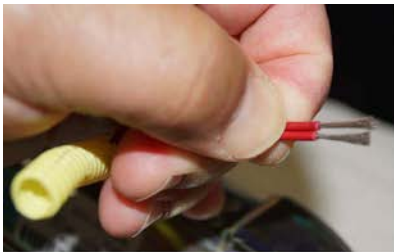
- Strip away about 1 inch of the wire insulation, then twist the wires together.

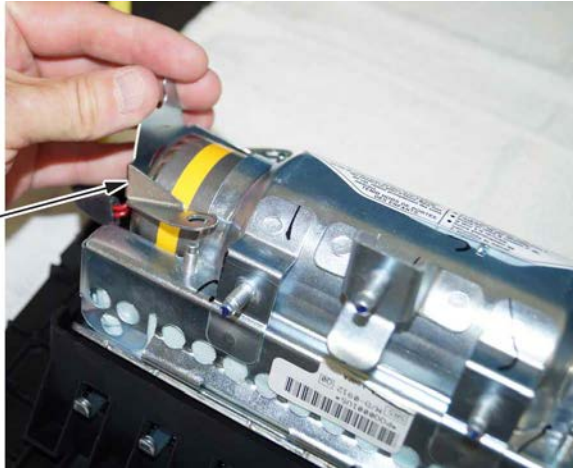
INFLATOR BRACKET

11. Remove the inflator bracket.

NOTE: You can only remove one of the brackets, as the other is welded to the airbag housing.

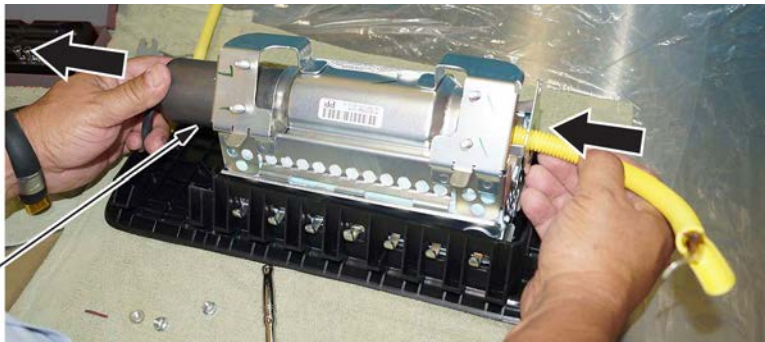
12. Remove the inflator by pushing it out.

INFLATOR
Do not reuse.

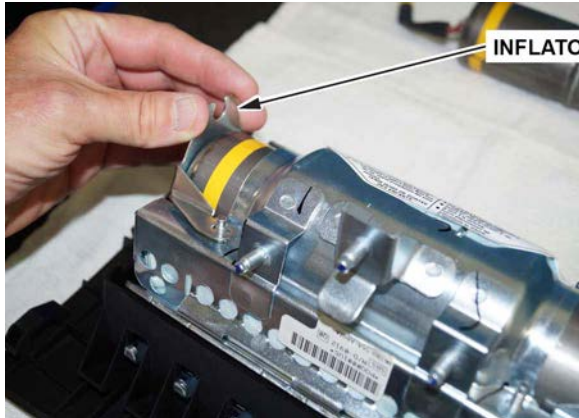
- Reinstall the inflator bracket. There should be no space or gap between the bracket and inflator.

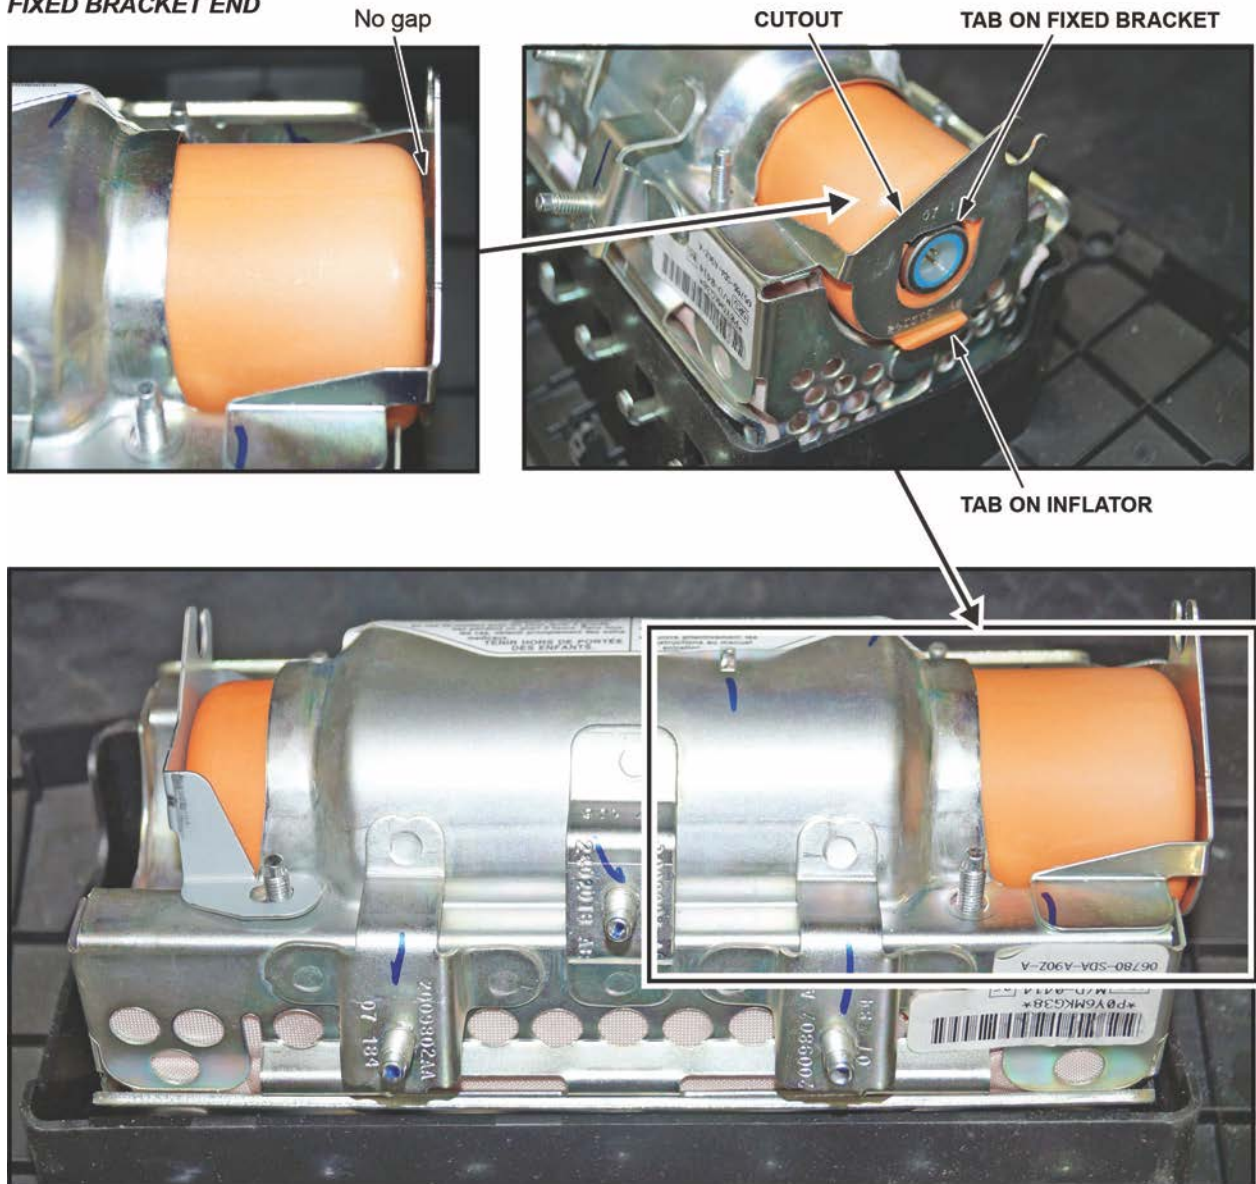
FIXED BRACKET END

- Slide the inflator in until the plastic cutout and the small flat spot align with the tab on the bracket. There should be no space or gap between the inflator and bracket.

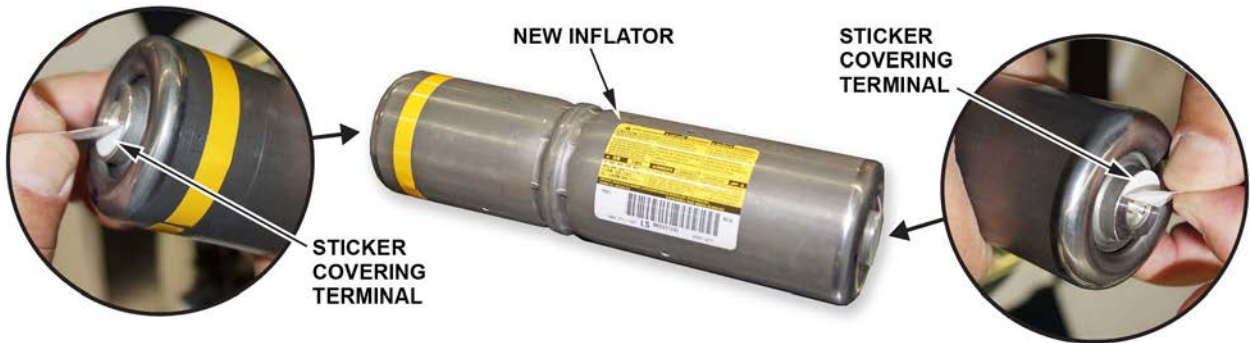
15. Remove the stickers covering the terminals on both sides of the new inflator.

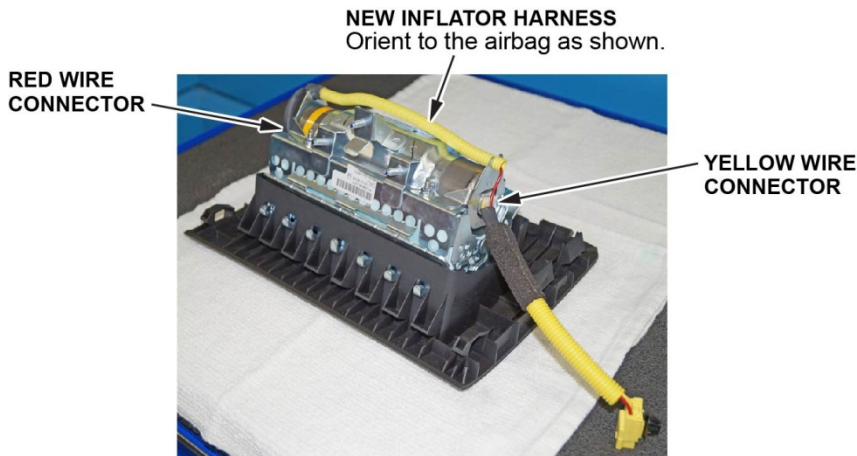
- Make sure the airbag and harness are aligned as shown.

NOTE: Make sure you have the orientation correct as shown below. If you connect the harness incorrectly, the harness cannot be removed, and you will not be able to reinstall the airbag because the harness will be too short.
