00407-01886 Version 6

Safety Recall: Front Passenger's Airbag Inflator May Produce Excessive Pressure After Long-Term Exposure To High Absolute Humidity

Supersedes 14-070, dated June 16, 2015; see Revision Summary

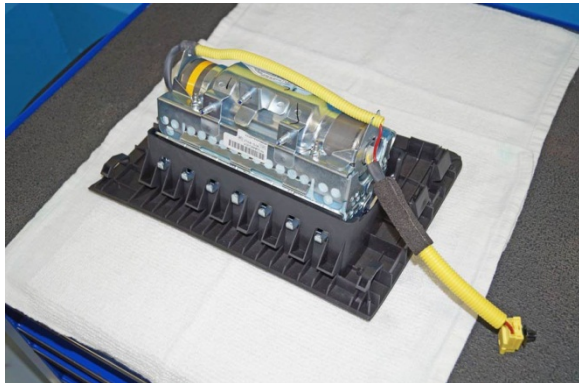
3. Remove the front passenger's airbag by referring to the applicable electronic service manual.
 4. Place the airbag, face-down, on a clean shop towel.

- The orientation of the airbag is critical because if the inflator is installed incorrectly, the harness will be too short when you reinstall the airbag.
- The brackets between the various models are similar but may differ from the example shown.

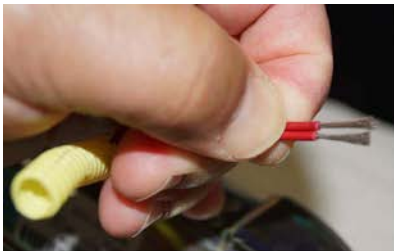
- Strip away about 1 inch of the wire insulation, then twist the wires together.

- Tape the twisted ends with electrical tape.

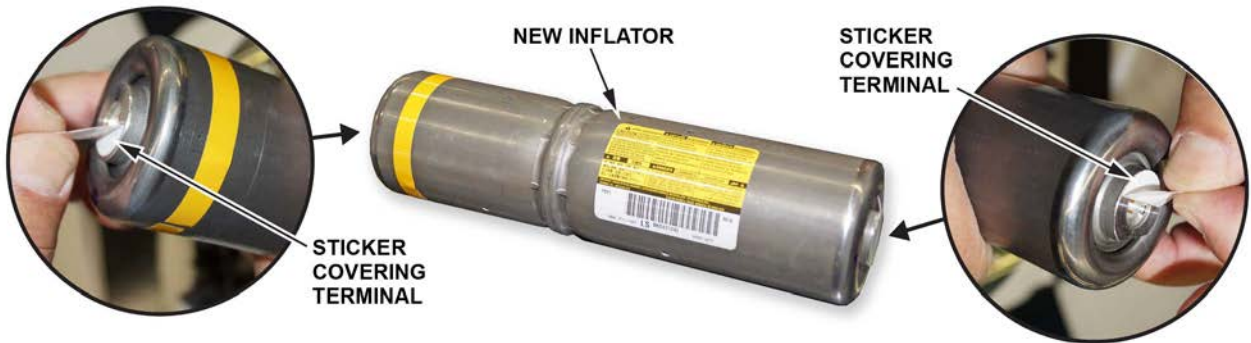
15. Remove the stickers covering the terminals on both sides of the new inflator.
