Service Bulletin

14-070

Safety Recall: Front Passenger's Airbag Inflator May Produce Excessive Pressure After Long-Term Exposure To High Absolute Humidity

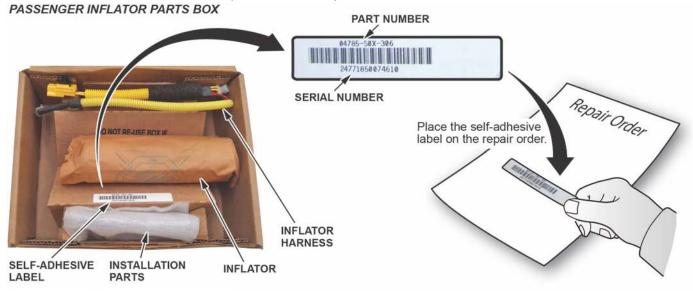
- 1. Peel the label located inside the inflator box from its backing and attach it to the RO. For the warranty claim to be paid, the **replacement inflator part number that you received** must be on the warranty claim and your warranty clerk must enter the serial number in the Diagnostic Trouble Codes field.

- The replacement part number is printed on the top part of the label and the serial number is printed on the bottom. Make sure you attach the label to the RO and give it to the warranty clerk.
- There may also be a colored sticker located in the kit, ignore it because it is not used.
- Not all inflator kits have a label included. In those cases, write the serial number and part number from the side
 of the inflator box on the RO. The part number always starts with 047.

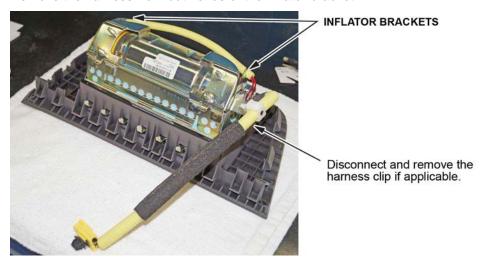
5. Remove the harness from both ends of the inflator bracket.

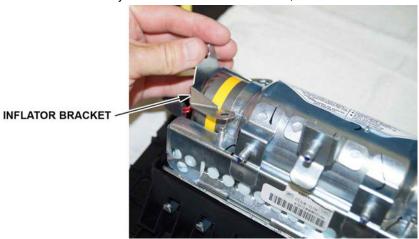
9. Remove the inflator bracket.

NOTE: You can only remove one of the brackets, as the other is welded to the airbag housing.

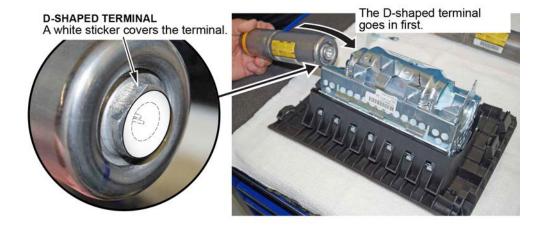
• One connector looks like a "D" whereas the other connector is a circle. Make sure you insert the "D" shaped terminal into the airbag first.

NOTE: There is a yellow band marking on the circle side.

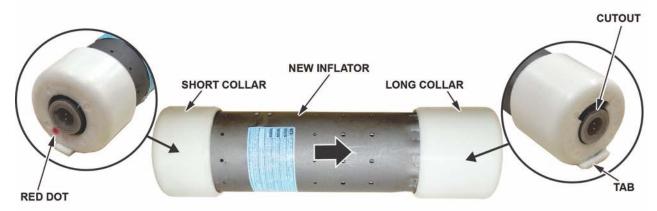
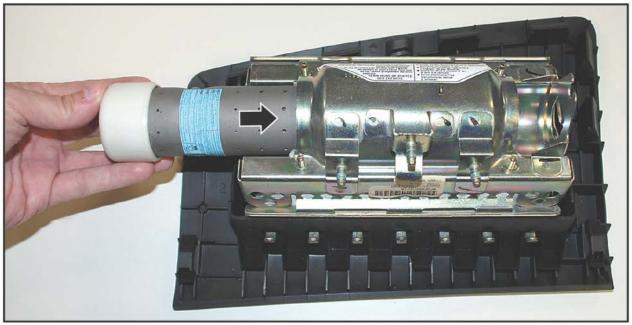
• One side of the inflator has a longer collar, a longer tab, a plastic cutout, and a small flat spot on the connector. The other side of the inflator has a shorter collar, a shorter tab, and a red dot. Make sure you insert the end with the longer collar into the airbag first.

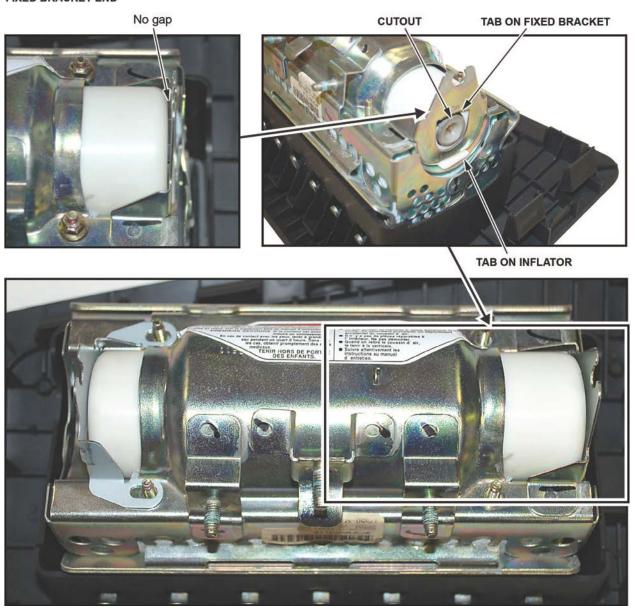
FIXED BRACKET END

Slide the inflator in until the plastic cutout and the small flat spot align with the tab on the bracket. There should be no space or gap between the inflator and bracket.

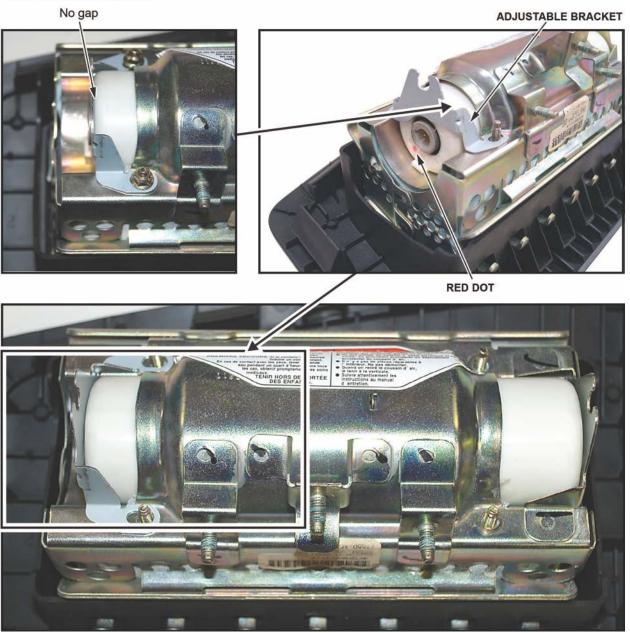
ADJUSTABLE BRACKET END

• Install the bracket included in the kit onto the airbag module. There should be a red dot visible on the end of the plastic connector. There should be no space or gap between the inflator and bracket.

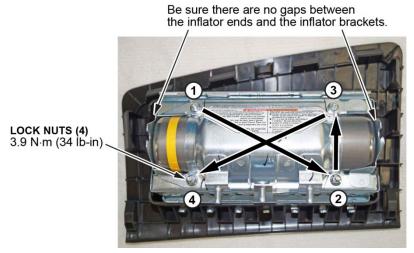
12. Install the new 5 mm locknuts and torque them in sequence to 3.9 Nom (34 lb-in).

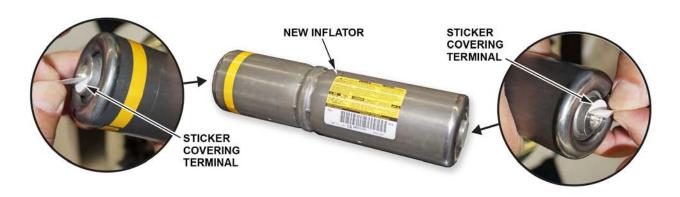
13. Remove the stickers covering the terminals on both sides of the new inflator.

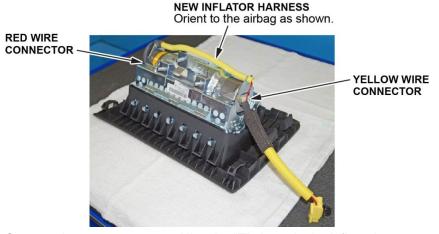
- 14. Install the new inflator harness.
 - Make sure the airbag and harness are aligned as shown.

- Make sure you have the orientation correct as shown below. If you connect the harness incorrectly, the harness cannot be removed, and you will not be able to reinstall the airbag because the harness will be too short.
- On the replacement inflators with plastic collars, connect the red wire connector to the connector with the red dot.
- On the replacement inflators without plastic collars, connect the red wire connector to the connector nearest the yellow band.

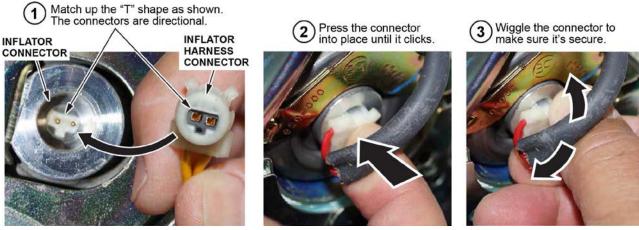
• Connect the two connectors. Align the "T" shape in the inflator harness connector with the T-shaped inflator connector, then press the connector into place.

After you hear each connector click, wiggle it to make sure it is secure.
 NOTE: If the connector is not properly aligned, it will come out.

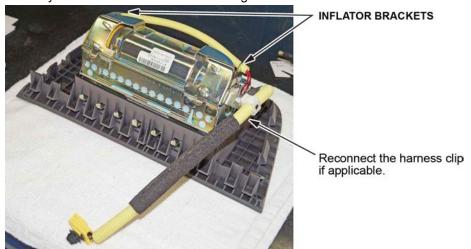
- 15. Connect the harness to the inflator brackets.
 - Insert the side without the shrink-wrap tubing first. Insert the harness at the third "valley" in the corrugated tube.
 - Insert the side of the harness with the shrink-wrap tubing into the inflator bracket. Make sure the harness is securely inserted and that it does not sag.
