September 16, 2015

00406-01910 Version 4

Safety Recall: Front Passenger's Airbag Inflator May Produce Excessive Pressure After Long-Term Exposure To High Absolute Humidity

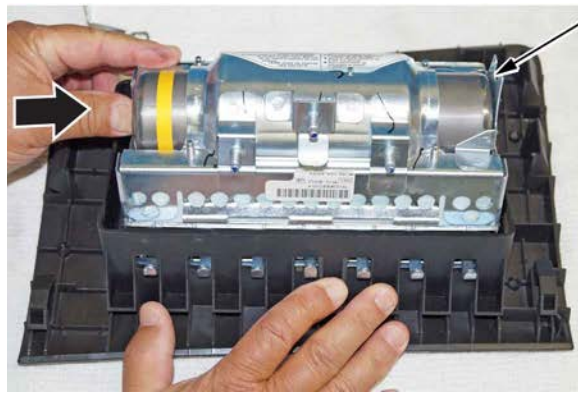
- Slide the inflator in until the “D” aligns with the tab on the inflator bracket. There should be no space or gap between the inflator and bracket.

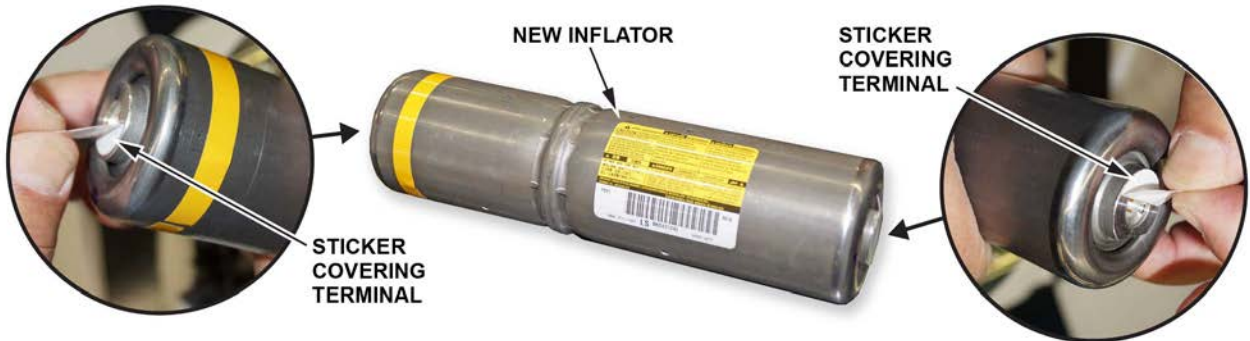
15. Remove the stickers covering the terminals on both sides of the new inflator.
