May 1, 2015

00406-01910 Version 2

## Safety Recall: Front Passenger's Airbag Inflator May Produce Excessive Pressure After Long-Term Exposure To High Absolute Humidity

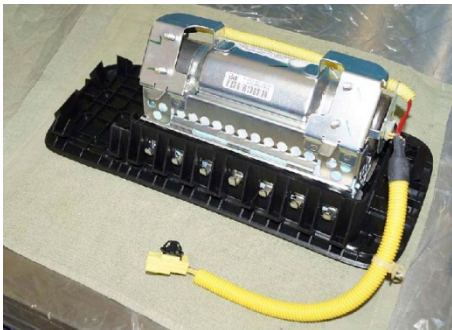
2. Remove the front passenger's airbag.
3. Place the airbag face-down on a clean shop towel as shown.

- The orientation of the airbag is critical because if the inflator is installed incorrectly, the harness will be too short when you reinstall the airbag.
- The brackets between the various models are similar but may differ from the example shown.

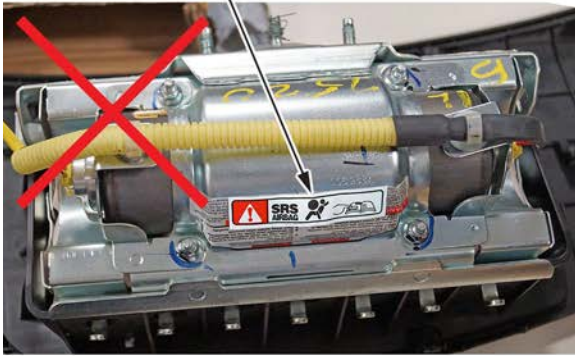
NON-STANDARD SAFETY LABEL

- If there is nothing unusual about the airbag or the inflator, go to step 5.
- If there are any unusual markings, like an incorrect label or a model year written in marker, the airbag and inflator may not be the correct airbag and/or inflator for the vehicle or it may be a counterfeit part. For more information about counterfeit airbags, you can refer to [safercar.gov](http://safercar.gov), enter keywords **MANAGING COUNTERFEIT**, and select **Recommended Dealer Guidance for Managing Counterfeit Air Bags** from the list. **If you suspect that the airbag or inflator is counterfeit, do not continue this procedure.** Contact your DPSM for assistance.

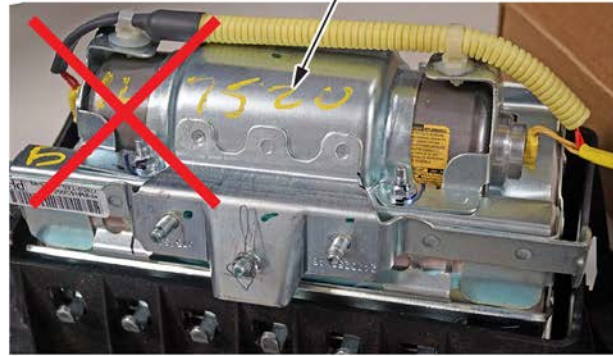
GREASE PENCIL OR PAINT MARKINGS

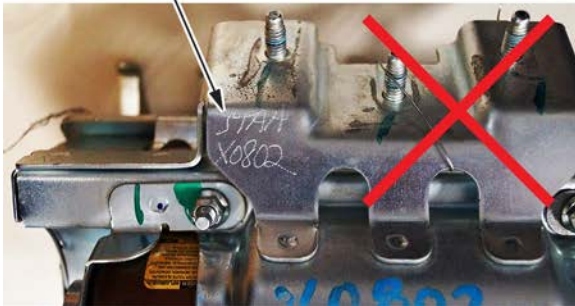
HAND ENGRAVING

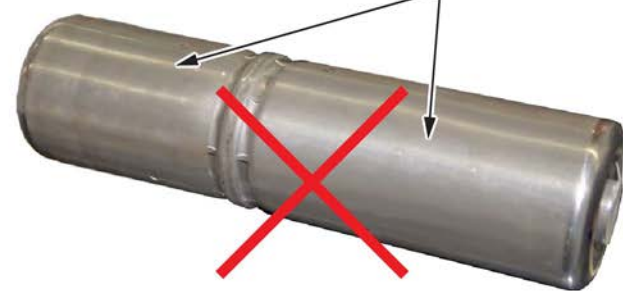
NO LABELS ON INFLATOR

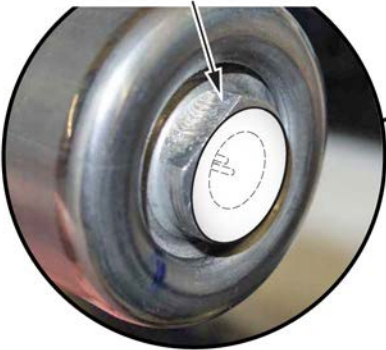
- One connector looks like a "D" whereas the other connector is a circle. Make sure you insert the "D" shaped terminal into the airbag first.

NOTE: There is a yellow band marking on the circle side.

D-SHAPED TERMINAL  
A white sticker covers the terminal.

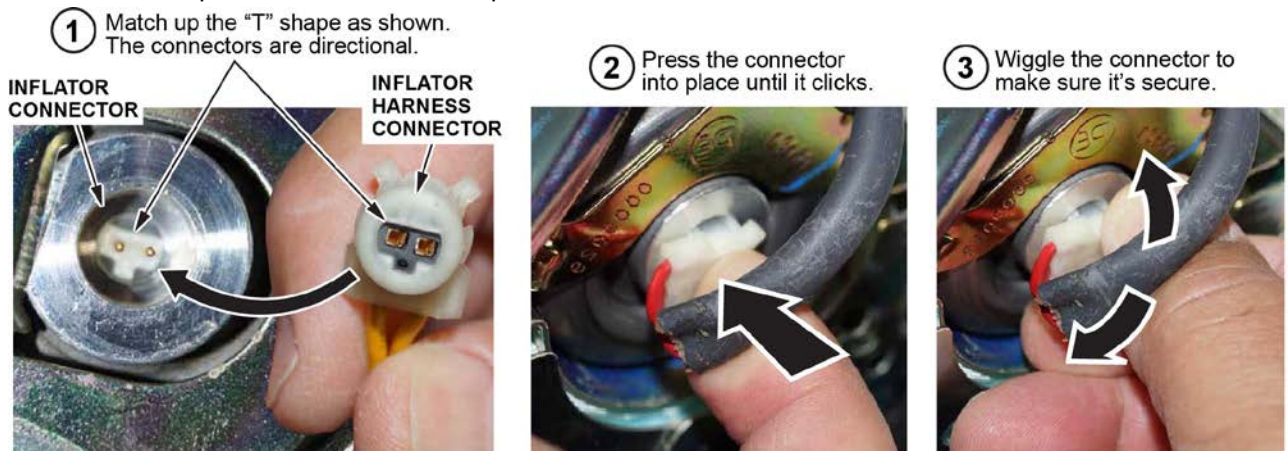
- Connect the two connectors. Align the "T" shape in the inflator harness connector with the T-shaped inflator connector, then press the connector into place.

- After you hear each connector click, wiggle it to make sure it is secure.
- NOTE: If the connector is not properly aligned, it will come out.
