00407-01886 Version 9

## Safety Recall: Front Passenger's Airbag Inflator May Produce Excessive Pressure After Long-Term Exposure To High Absolute Humidity

Supersedes 14-070, dated December 19, 2015 to revise the information highlighted in **yellow**

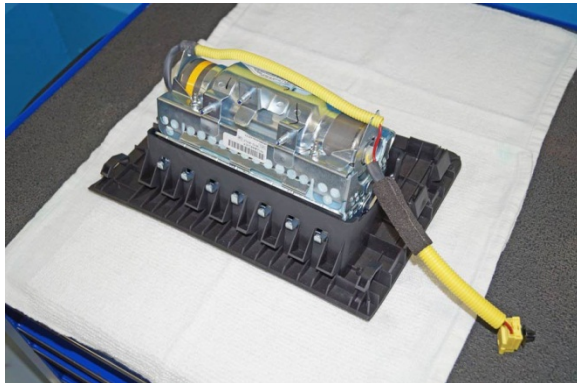
- The orientation of the airbag is critical because if the inflator is installed incorrectly, the harness will be too short when you reinstall the airbag.
- The brackets between the various models are similar but may differ from the example shown.

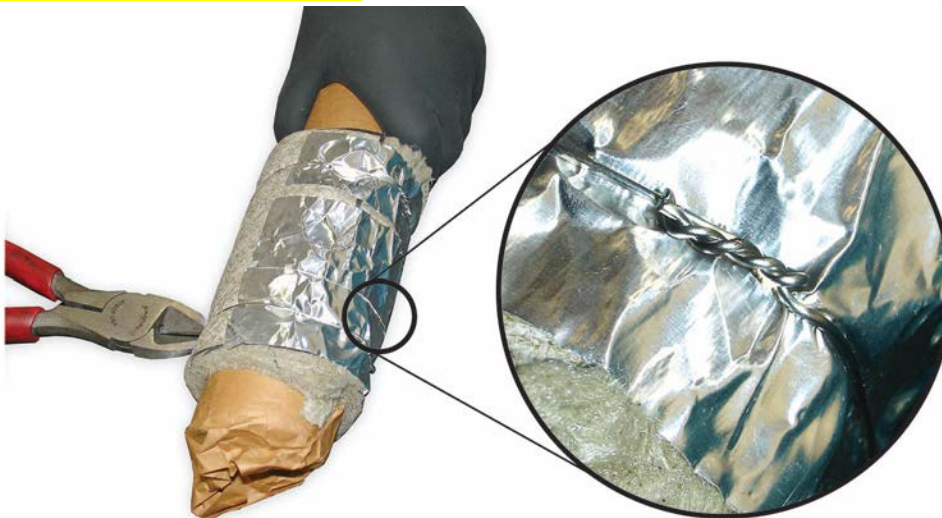
- Wear disposable gloves and protective glasses. The insulation is not toxic or dangerous, but some people may be sensitive to the insulation.
- Dispose of the insulation and wrapping paper to avoid getting the insulation dust/fibers on you or the airbag assembly.
- Do not reuse the insulation or wrapping paper. You do not need to wrap the inflator being removed from the vehicle when it is returned.
- Cut the wires off from the opposite side from where they are tied (twisted) together.

NOTE: Do not cut the insulation.

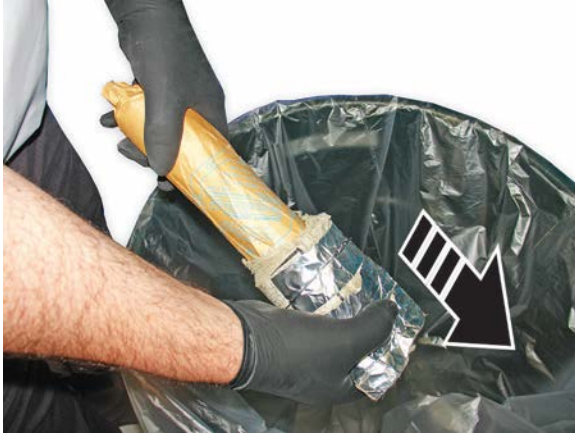
- Hold the paper wrapping the inflator with one hand and slide the insulation off into the trash.

NOTE: The insulation is securely wrapped around the inflator. You may have to use some force to slide the insulation off. Do not cut the insulation and be careful that you do not move the white or orange plastic ends.

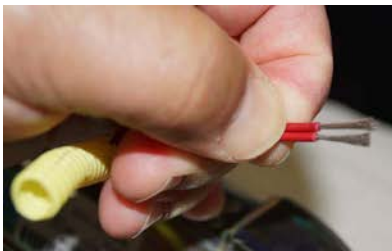
- Strip away about 1 inch of the wire insulation, then twist the wires together.

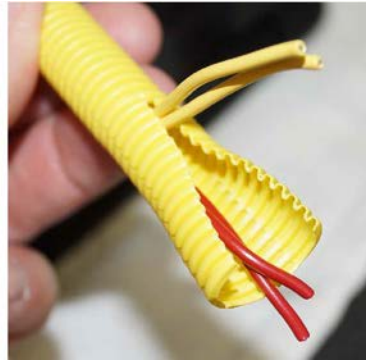
- Cut about 2 inches of the corrugated tube, then pull out the yellow wires.

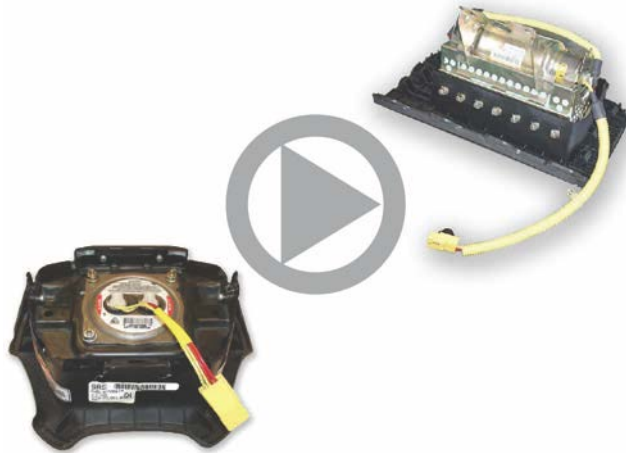
Click on the image below for a short video about the different variations of the driver's and front passenger's replacement inflators involved with the recalls related to inflators. While both the driver's and front passenger's inflators are shown in the video, this is informational only. Replace inflators only as directed by the iN VIN status inquiry.

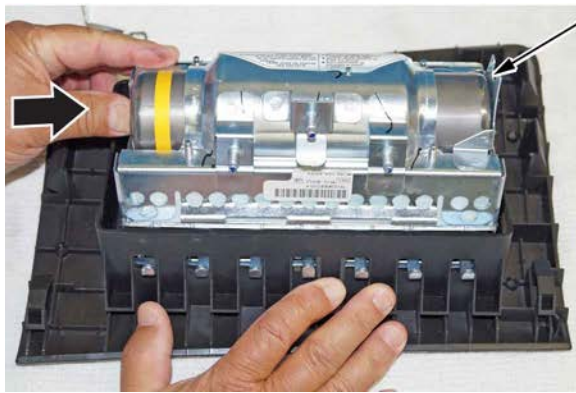
- Slide the inflator in until the “D” aligns with the tab on the inflator bracket. There should be no space or gap between the inflator and bracket.

No gap.

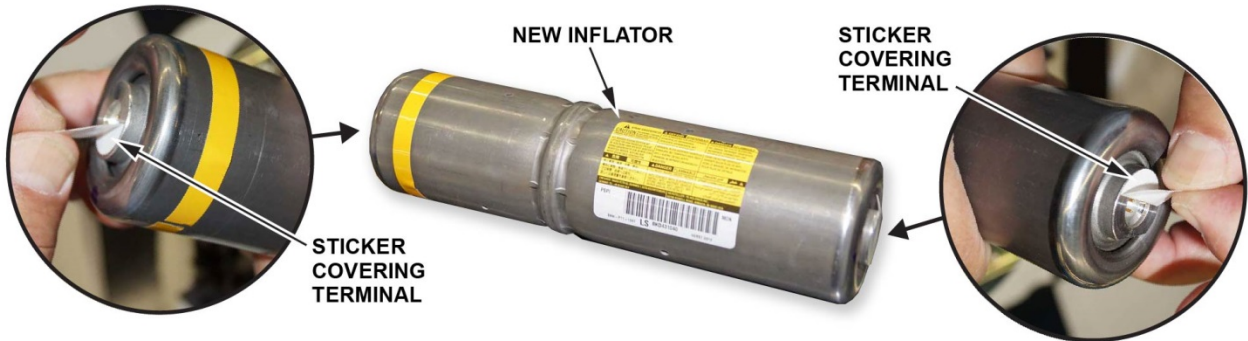
16. Remove the stickers covering the terminals on both sides of the new inflator.
