**September 16, 2015**

00407-01886 Version 7

## **Safety Recall: Front Passenger's Airbag Inflator May Produce Excessive Pressure After Long-Term Exposure To High Absolute Humidity**

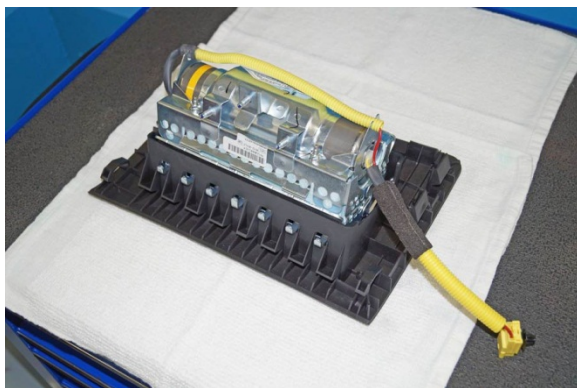
- The orientation of the airbag is critical because if the inflator is installed incorrectly, the harness will be too short when you reinstall the airbag.
- The brackets between the various models are similar but may differ from the example shown.

3. Remove the front passenger's airbag by referring to the applicable electronic service manual.
  4. Place the airbag, face-down, on a clean shop towel.

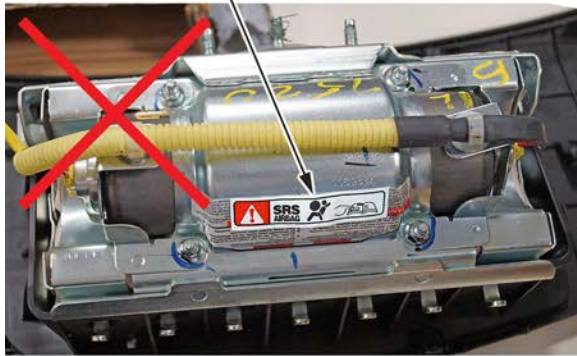
NON-STANDARD SAFETY LABEL

- If there is nothing unusual about the airbag or the inflator, go to step 6.
- If there are any unusual markings, like an incorrect label or a model year written in marker, the airbag and inflator may not be the correct airbag and/or inflator for the vehicle or it may be a counterfeit part. For more information about counterfeit airbags, you can refer to [safercar.gov](http://safercar.gov), enter keywords **MANAGING COUNTERFEIT**, and select **Recommended Dealer Guidance for Managing Counterfeit Air Bags** from the list. **If you suspect that the airbag or inflator is counterfeit, do not continue this procedure.** Contact your DPSM for assistance.

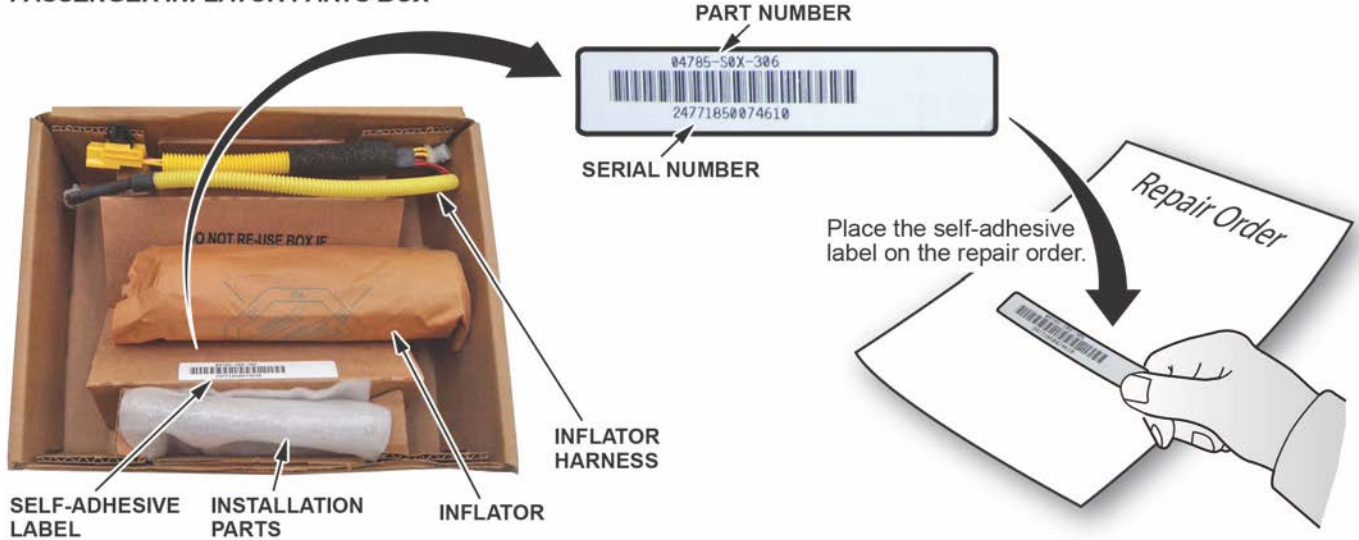
**PASSENGER INFLATOR PARTS BOX**

- The replacement part number is printed on the top part of the label and the serial number is printed on the bottom. **Make sure you attach the label to the RO and give it to the warranty clerk.**
- There may also be a colored sticker located in the kit, ignore it because it is not used.
- Not all inflator kits have a label included. In those cases, write the serial number and part number from the side of the inflator box on the RO. The part number always starts with 047.

6. Peel the label located inside the inflator box from its backing and attach it to the RO. For the warranty claim to be paid, the **replacement inflator part number that you received** must be included in the warranty claim.

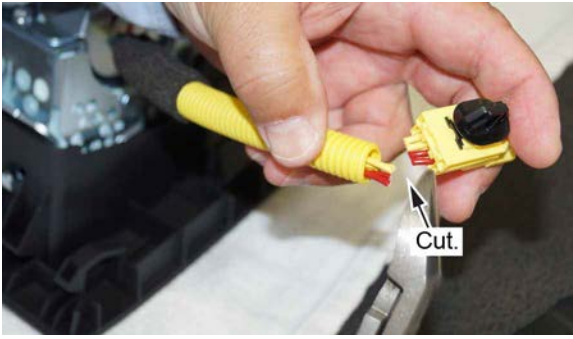
You must cut and short the wires as indicated to prevent accidental deployment.

- Cut all four wires to remove the connector.

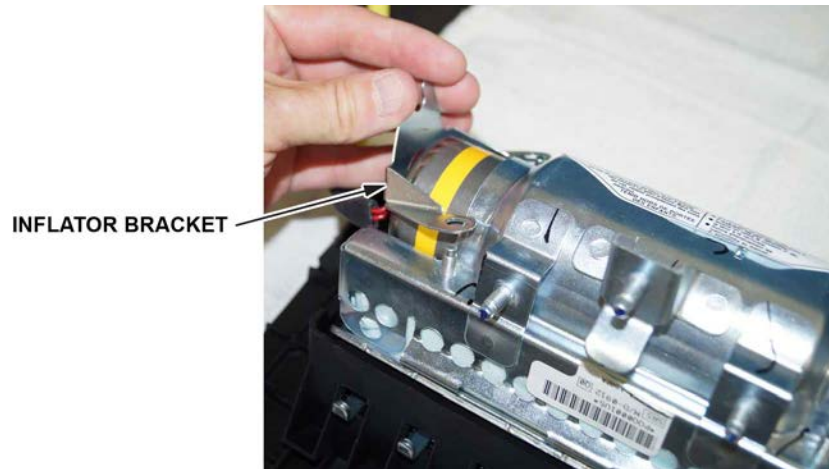
NOTE: You can only remove one of the brackets, as the other is welded to the airbag housing.

11. Remove the inflator bracket.

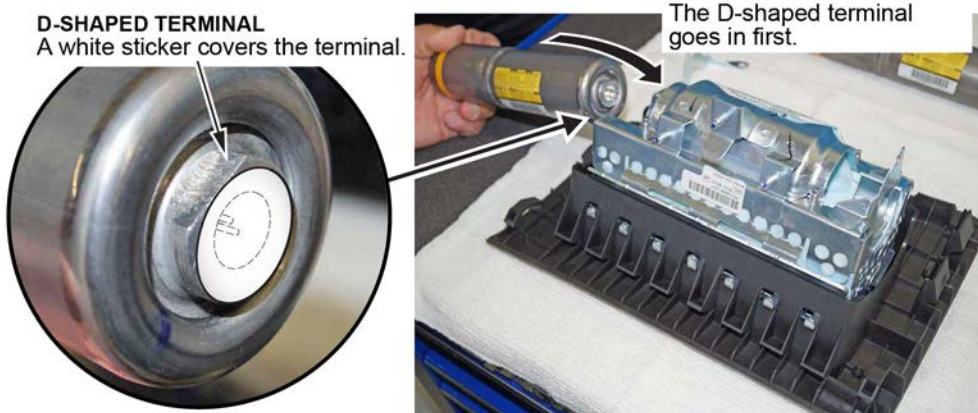
- One connector looks like a “D” whereas the other connector is a circle. Make sure you insert the “D” shaped terminal into the airbag first.

NOTE: There is a yellow band marking on the circle side.

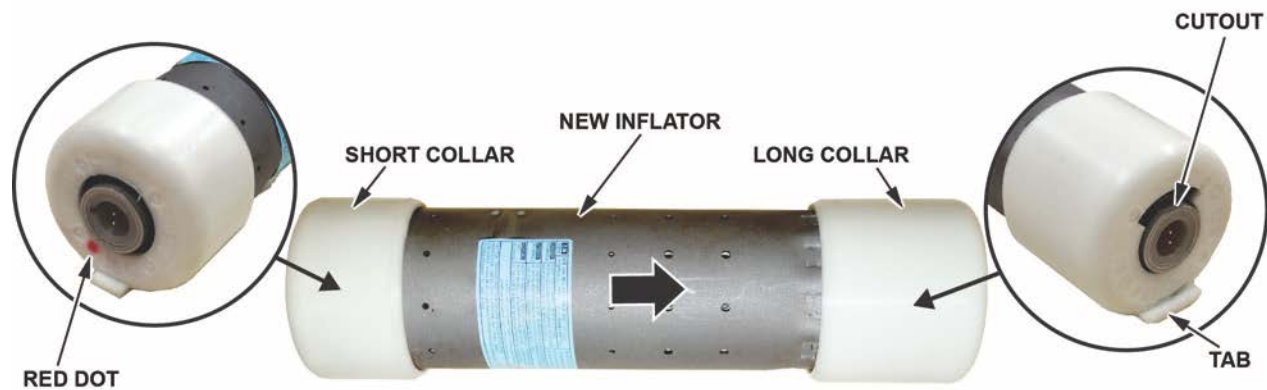
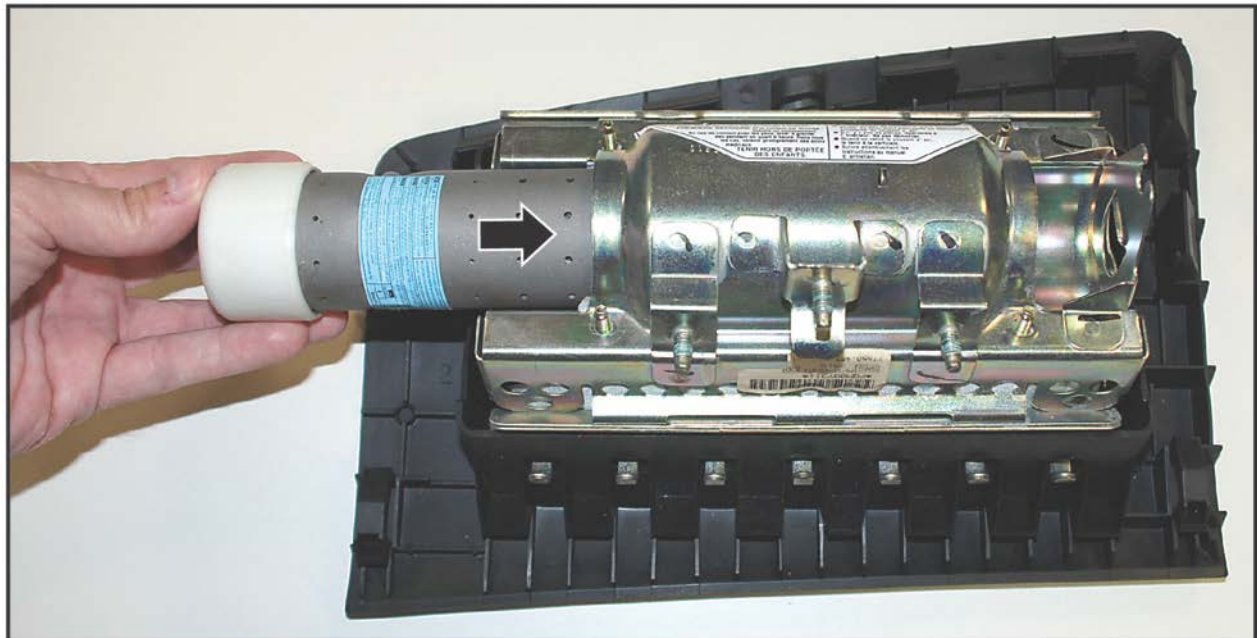
- One side of the inflator has a longer collar, a longer tab, a plastic cutout, and a small flat spot on the connector. The other side of the inflator has a shorter collar, a shorter tab, and a red dot. Make sure you insert the end with the longer collar into the airbag first.

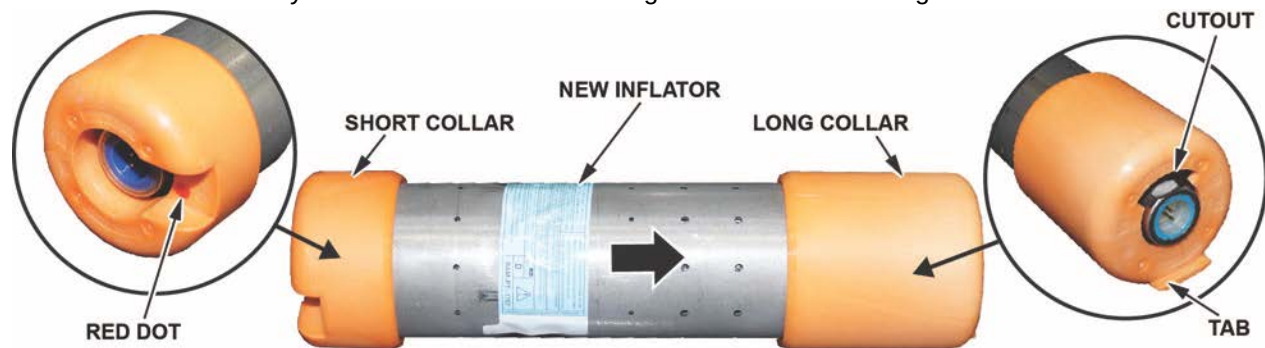
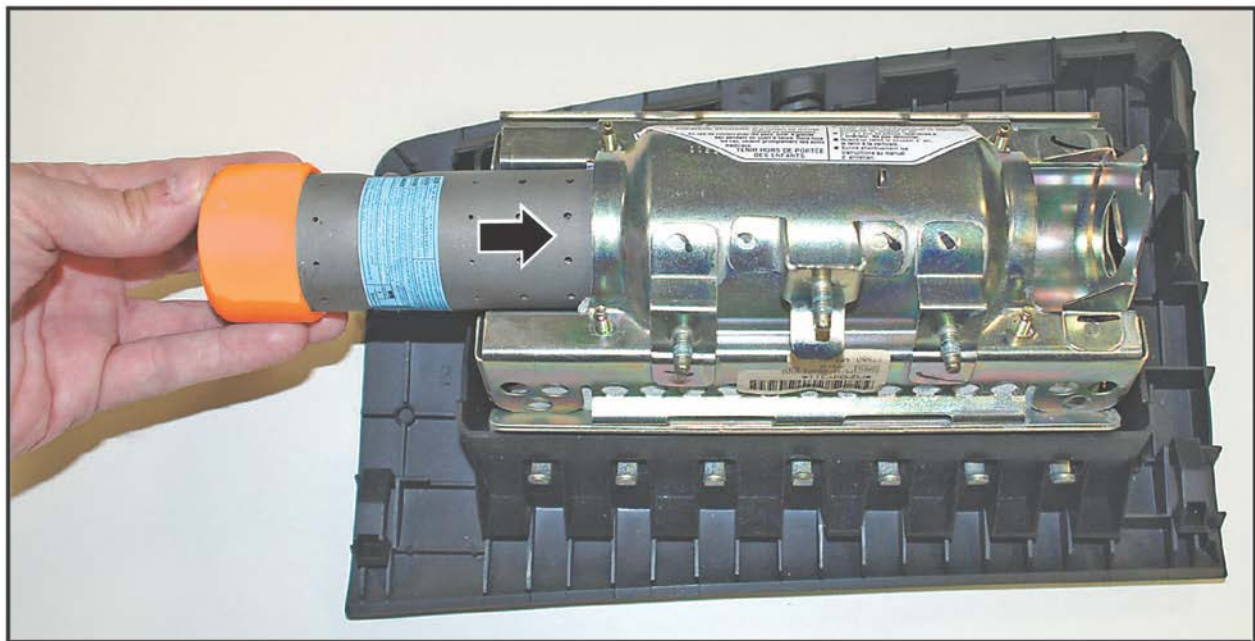
- The collars on this inflator are orange, not white. One side of the inflator has a longer collar, a tab, a plastic cutout, and a small flat spot on the connector. The other side of the inflator has a shorter collar, no tab, and a red dot. Make sure you insert the end with the longer collar into the airbag first.

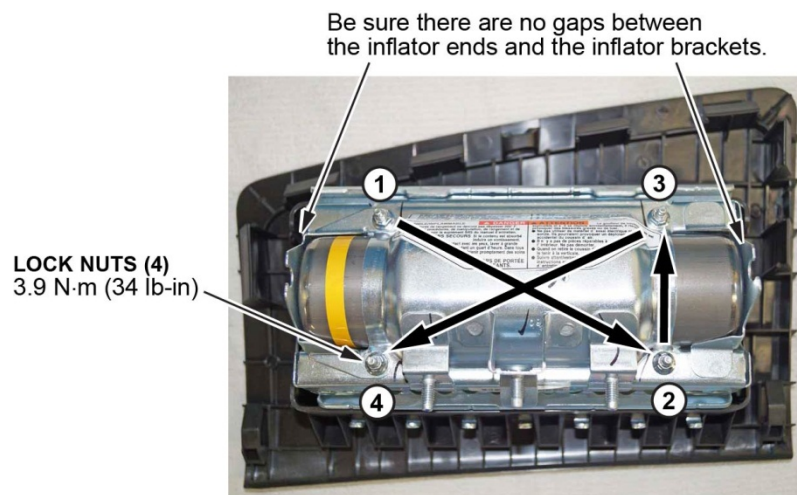
14. Install the new 5 mm locknuts and torque them in sequence to **3.9 N•m (34 lb-in)**.

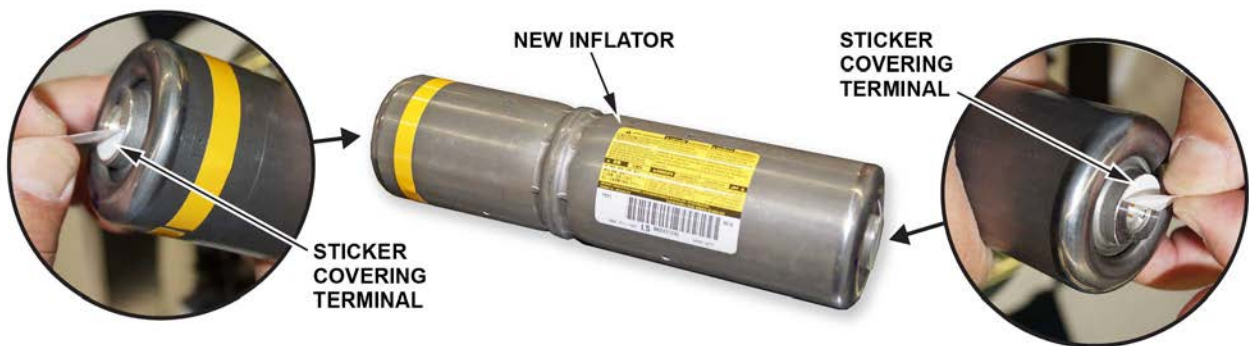
15. Remove the stickers covering the terminals on both sides of the new inflator.

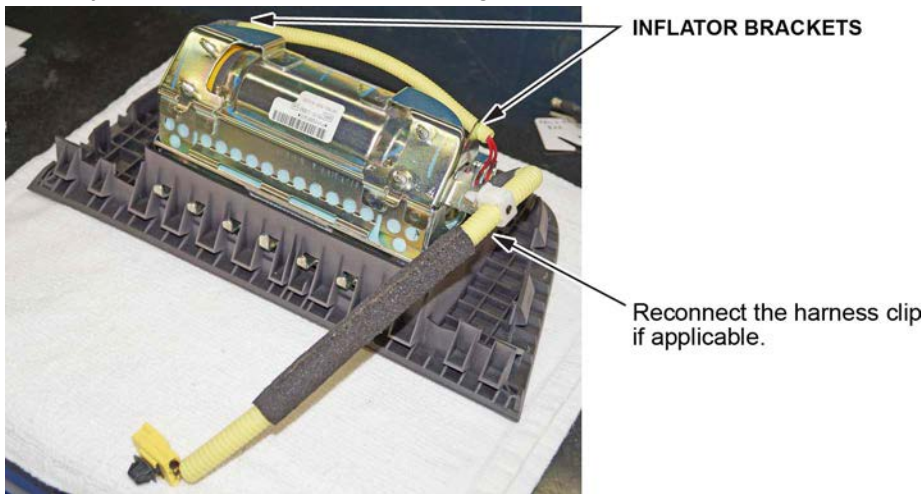
- Insert the side without the shrink-wrap tubing first. Insert the harness at the third “valley” in the corrugated tube.
- Insert the side of the harness with the shrink-wrap tubing into the inflator bracket. Make sure the harness is securely inserted and that it does not sag.
