CAMPAIGN IS ONLY APPLICABLE IN GUAM AND SAIPAN

**TECHNICAL INSTRUCTIONS
FOR
SAFETY RECALL E06
FRONT SUSPENSION LOWER BALL JOINT BOOT LEAK
CERTAIN 2011 - 2013 MODEL YEAR CAMRY**

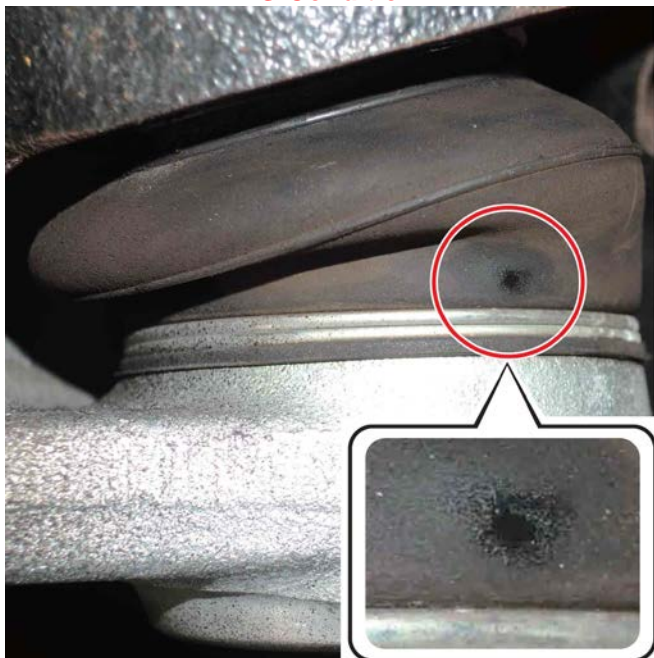
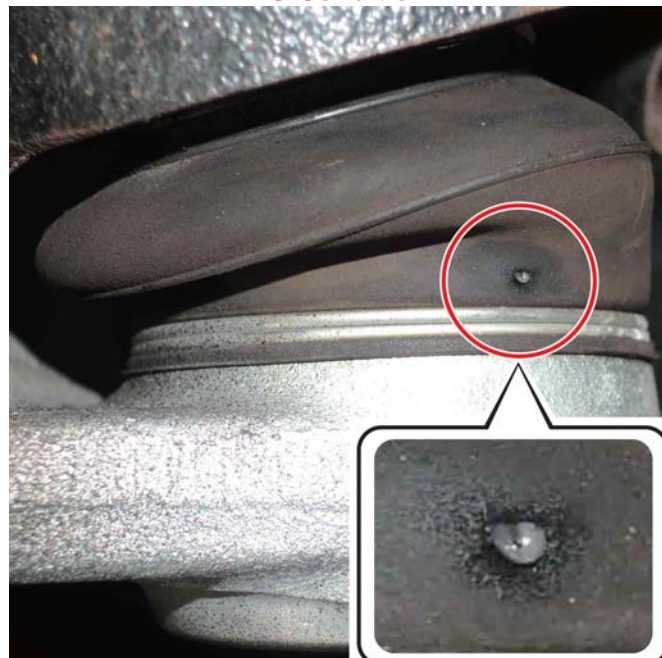
NG Condition

2. INSPECT THE BALL JOINT BOOTS FOR GREASE OOZING OR LEAKAGE

- a) Turn the wheels left and right to gain access for the ball joint boot inspection.
- b) Inspect the locations identified for grease oozing or leakage on the left and right ball joint.

NG: Proceed to section VI for ball joint assembly replacement.

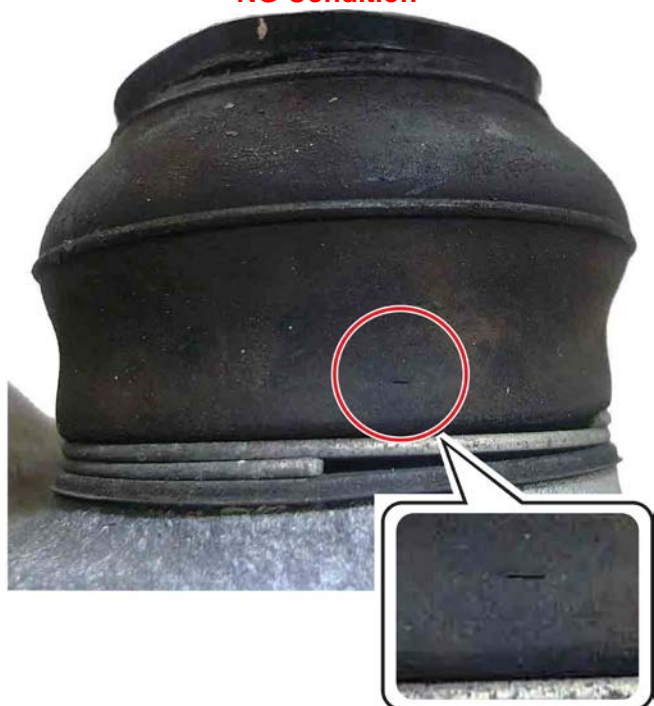
NG Condition

3. INSPECT THE BALL JOINT BOOTS FOR CRACKS OR TEARS

- a) Remove the dirt from the boot using a shop cloth.
- b) Carefully inspect the boot inspection point below for cracking.

NG: Proceed to section VI for ball joint assembly replacement.
