BULLETIN

BULLETIN NUMBER:
CB15-N-001

INOPERATIVE BRAKE LAMPS – 14V-735

- 2012-2014MY Isuzu Stripped Chassis (Reach Van) Vehicles Produced Between July 2011 and August 2014

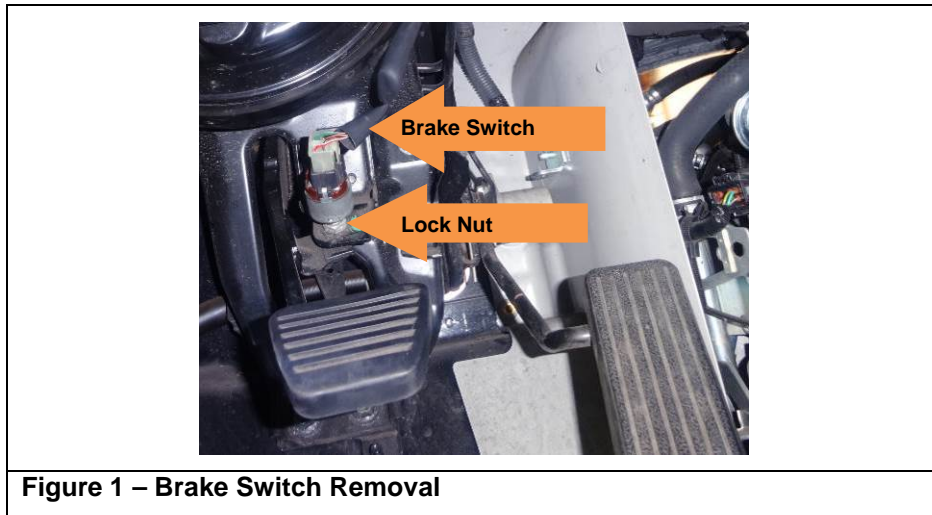
1. Disconnect the brake lamp switch connector.

2. Using a 14mm wrench, loosen the lock nut for the brake lamp switch and remove the switch (See Figure 1).
3. Check the brake lamp switch for a bent condition and/or corrosion damage.
 - a. If the brake lamp switch is bent or the plunger does not operate smoothly, replace it. If the brake lamp switch functions properly or is not bent, it does not need to be replaced.
 - b. Then check both the brake lamp switch and the harness connector for corrosion damage. If there is wiring or connector housing damage, corrosion inside either terminal or an abnormal accumulation of dirt or dust inside the connector, replace the brake lamp switch and the harness connector. See the following “Connector Replacement” procedure in this bulletin for more information.

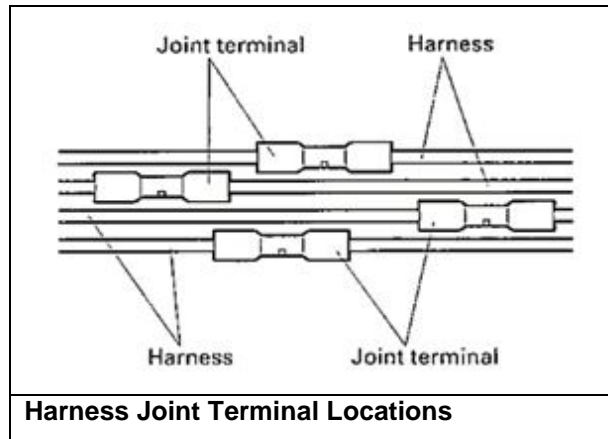
Note: The four (4) new harness joint terminals must be staggered as shown below.

2. Strip the harness sheathing to the determined length.
 3. Push the twisted end of the harness into the joint.
NOTE: Make sure existing wire harness colors match the new replacement wire harness colors.

4. Crimp the joint terminal.
 5. Push the twisted end of the harness into the joint terminal until it touches the center stop.
 6. Crimp the joint terminal.

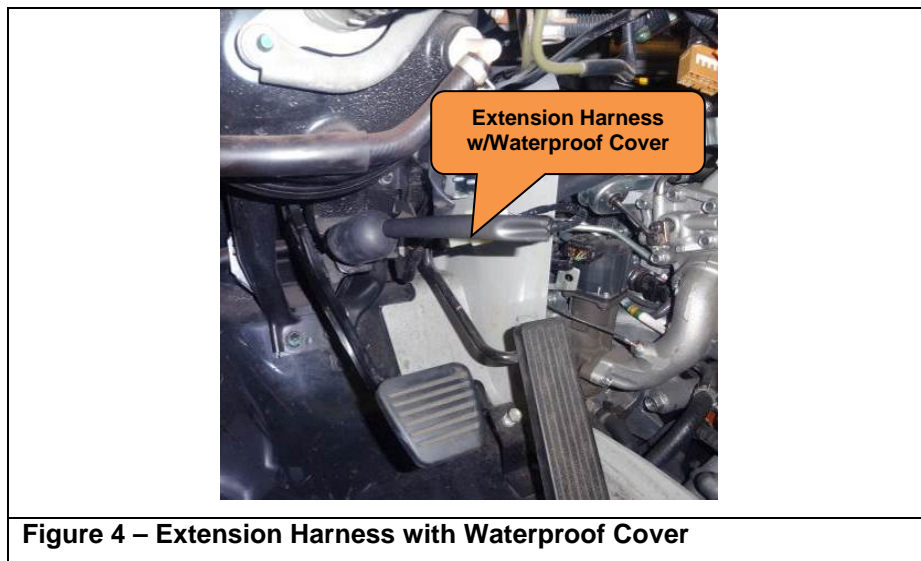
- Plug the new extension harness into the brake lamp switch. Make sure the waterproof cover completely covers the connection at the brake lamp switch (See Figure 4).

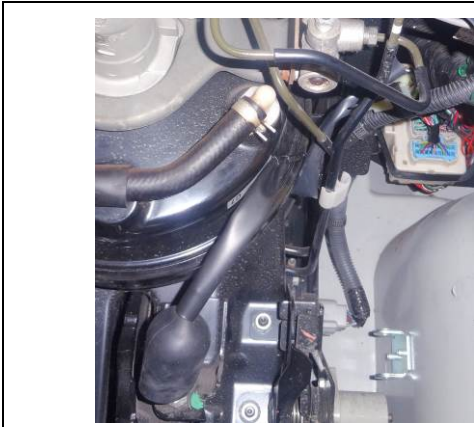
7. Secure the extension harness to the Accelerator Pedal Position (APP) Sensor / Brake Stop Lamp Harness using the provided band clip (See Figures 5 and 6).

Figure 5 – Extension Harness, Installed and Secured with Band Clip

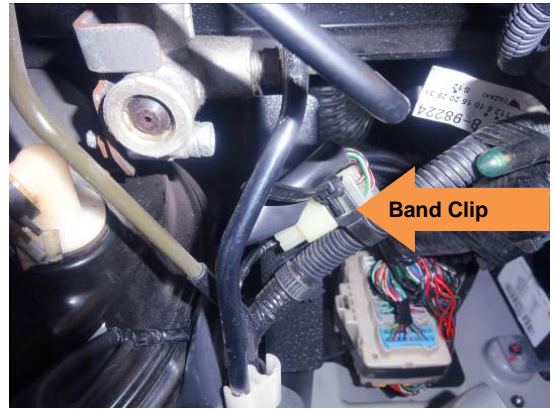
Figure 6 – Band Clip Secured to APP Sensor / Brake Stop Lamp Harness

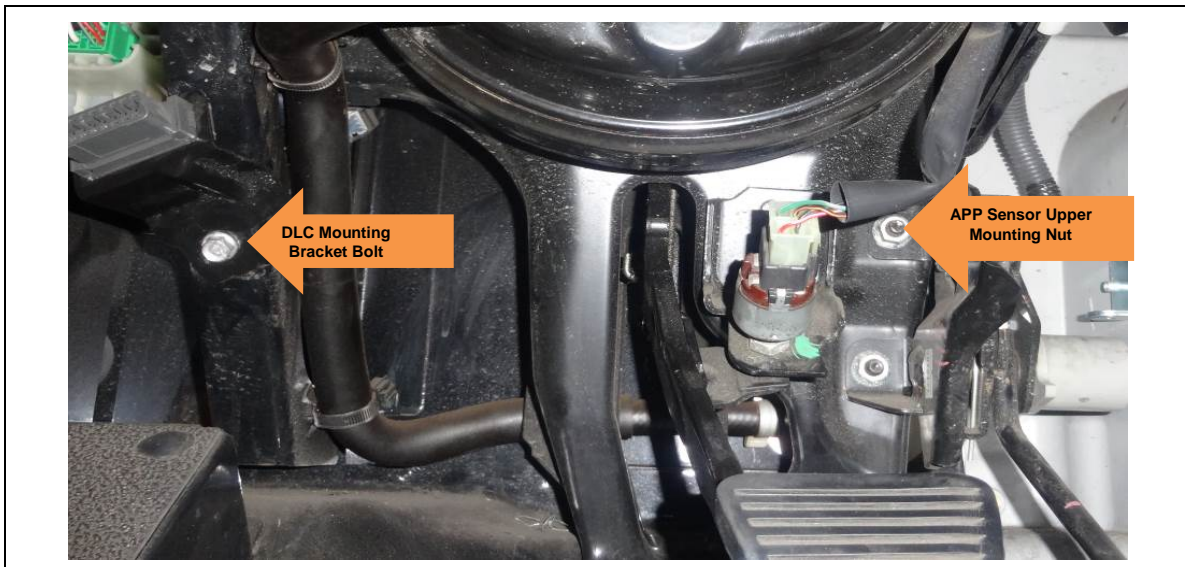
1. Remove the Diagnostic Link Connector (DLC) mounting bracket bolt (See Figure 7).
2. Remove the APP sensor upper mounting nut (See Figure 7).

Figure 7 – DLC Connector Mounting Bracket Bolt and APP Sensor Upper Mounting Nut

4. Torque the DLC mounting bolt to 3.5 lb ft (4.8 Nm).
5. Torque the APP sensor upper mounting nut to 3.5 lb ft (4.8 Nm).
6. Apply the campaign label.

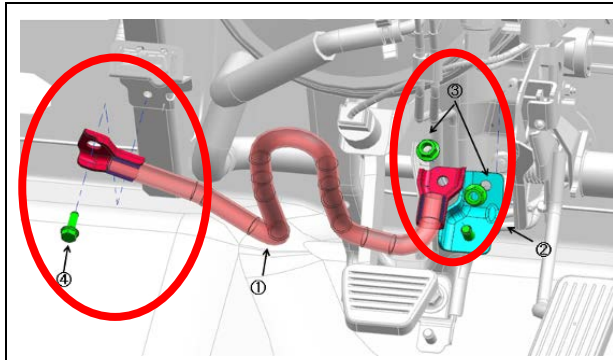
3. Install the brake lamp switch protector (See Figure 8 for 2012MY or Figure 9 for 2013-2014MY).

Figure 8 - 2012MY Bracket Installation Torque Locations (No. 3 and 4)

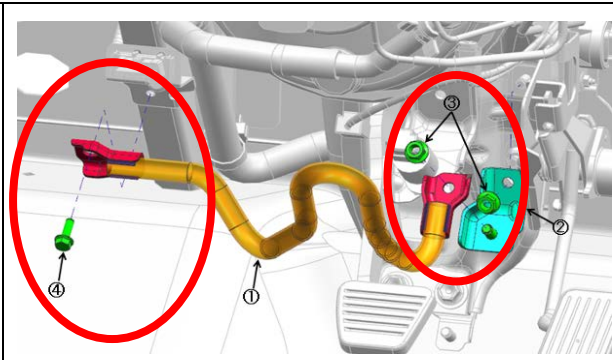
Figure 9 - 2013-2014MY Bracket Installation Torque Locations (No. 3 and 4)
