**TECHNICAL INSTRUCTIONS**  
**FOR**  
**SAFETY RECALL E07**  
**SECOND ROW ASSIST GRIP**  
**CERTAIN 2015 MODEL YEAR SIENNA**

The subject vehicles are equipped with left and right side second row overhead assist grips mounted to the roof rails. In the event of a collision that results in deployment of a curtain shield airbag (CSA), an assist grip could detach from the mounting bracket under some conditions. If an assist grip completely detaches, it may contact an occupant, increasing the risk of injury in a crash.

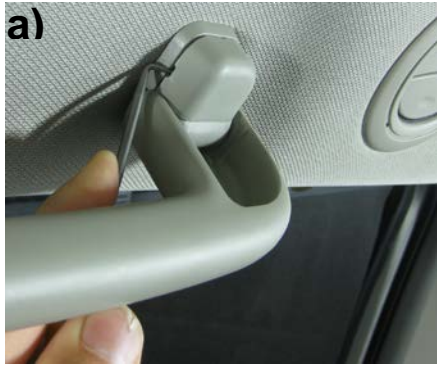
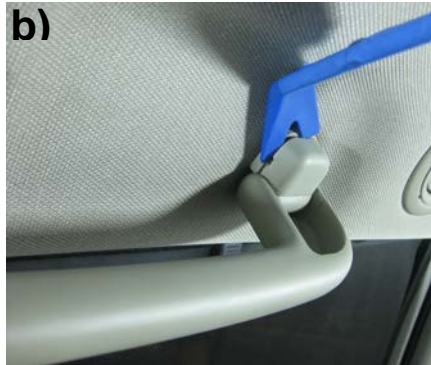
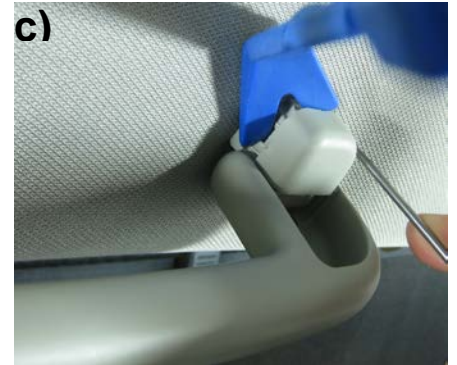
#### 1. REMOVE THE LEFT AND RIGHT SIDE 2<sup>ND</sup> ROW ASSIST GRIP CAPS

- Using a 90 degree pick, disengage the inner claw securing the cap to the assist grip body.
- Place the body molding tool inbetween the cap and assist grip body.
- Using the 90 degree pick disengage the outer cap claw and gently remove the assist grip cap.
- Repeat for the other assist grip caps.

**Note:** The caps on the assist grips are very tight, use caution when trying to remove them to avoid damaging the caps.

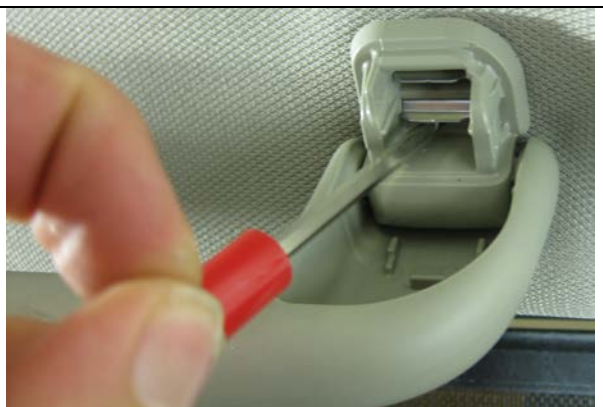
- To release the assist grip sub-assembly gently pry up on the metal clip as shown.
- Remove the assist grip sub-assembly.

**Note:** The metal clips will stay in the body of the vehicle.

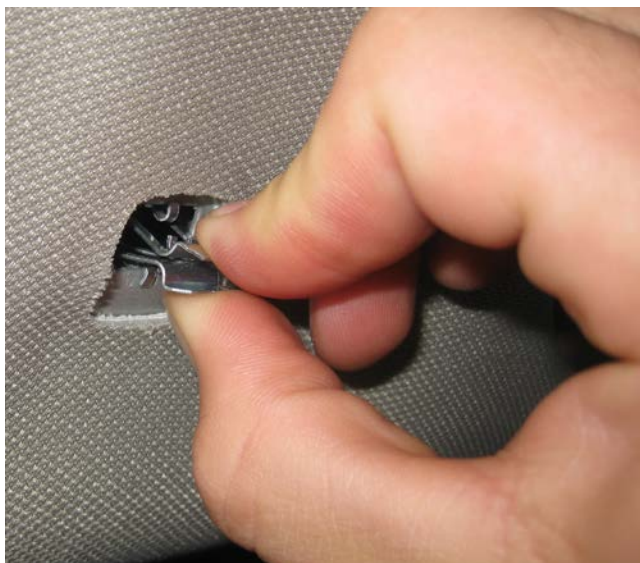
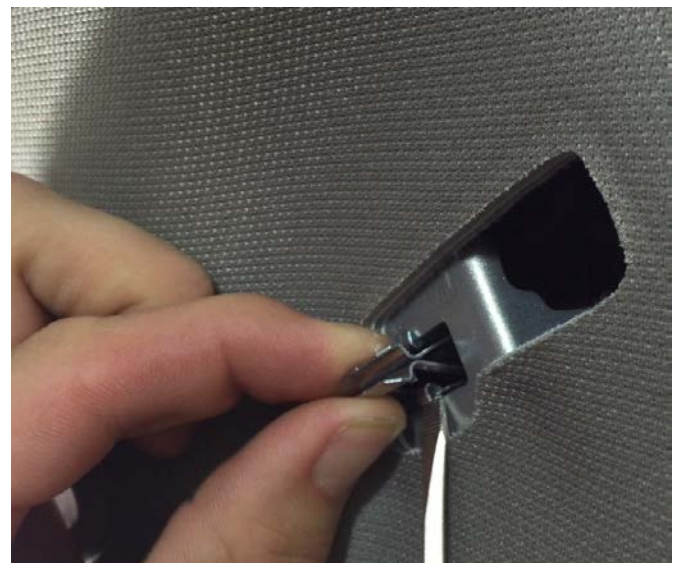
- Remove the metal clips from the vehicle body by pinching them together.

**Note:** In some cases you will be unable to remove the clip by pinching it together, if this occurs use a flat tip screw driver to release the body locking claw.

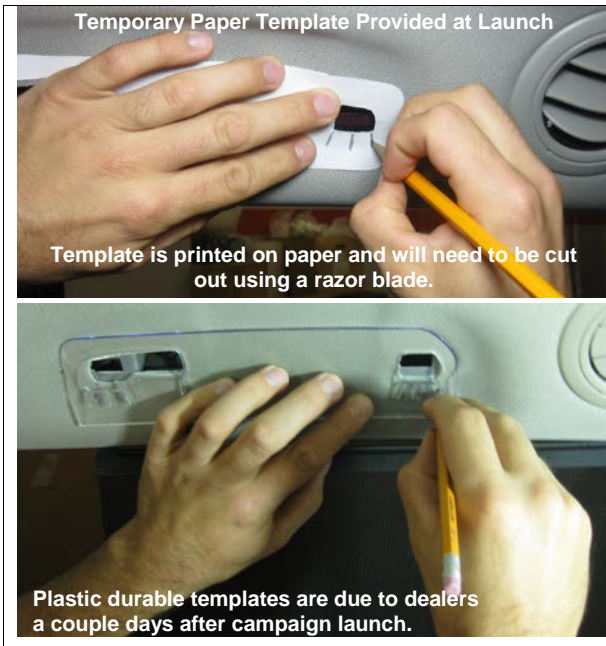
### 1. TRACE THE 7 CSA STRESS RELIEFS

- Align the template that was provided with the assist grip mounting holes in the headliner.

**Note:** The template provided can be used on both the right and left side of the vehicle.

- Using the template trace the reliefs onto both sides of the headliner using a pencil.
- Confirm the traced lines are 11mm long.

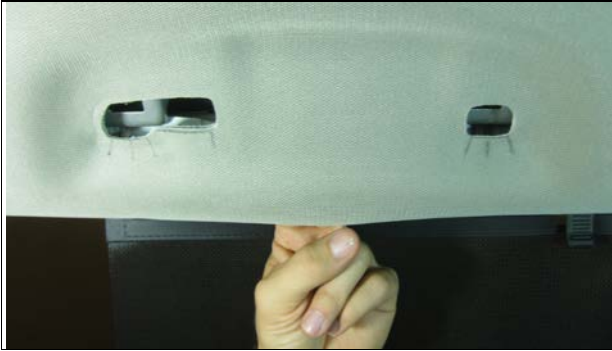
**3. GENTLY ADJUST THE HEADLINER AWAY FROM THE CSA**

**Use caution and be gentle when adjusting the headliner a ½ inch away from the CSA to provide adequate clearance. If the headliner is adjusted too far or too hard it can be damaged.**

- a) Using your fingers reach up between the weather stripping and the headliner as shown.
- b) Gently adjust the headliner ½ inch away from the CSA.
