DOC #	PROCESS NAME	PAGE	REVISION	STATION	BY	DATE
	Weatherizing Unused Electrical Connections	1 OF 1		SER	DBaker	12/17/2014

This Recall notice applies to all 2015 product built from July 1, 2014 to December 12, 2014.

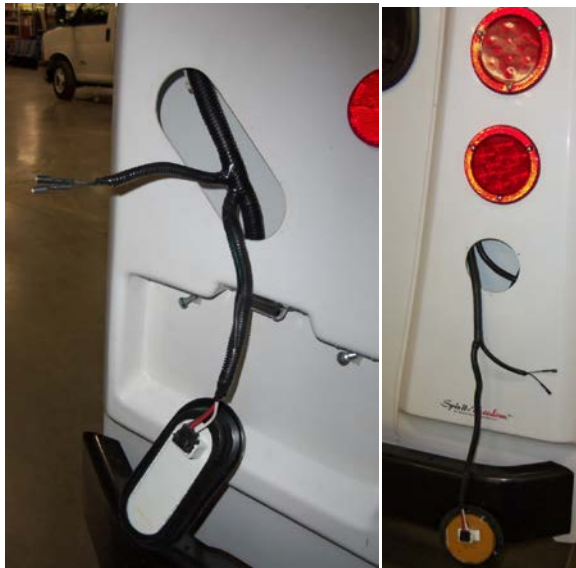
Step 1- Remove bottom light.

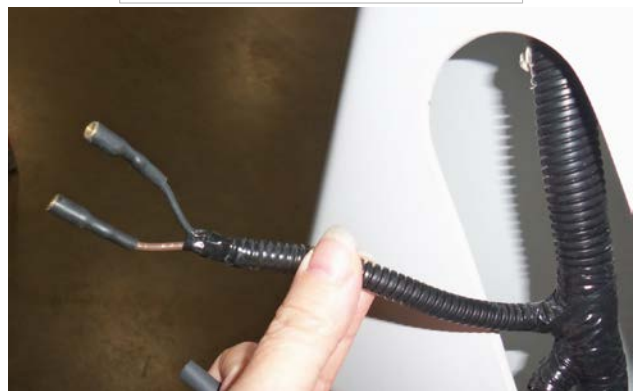
Step 2- Locate the unused side marker light connection.

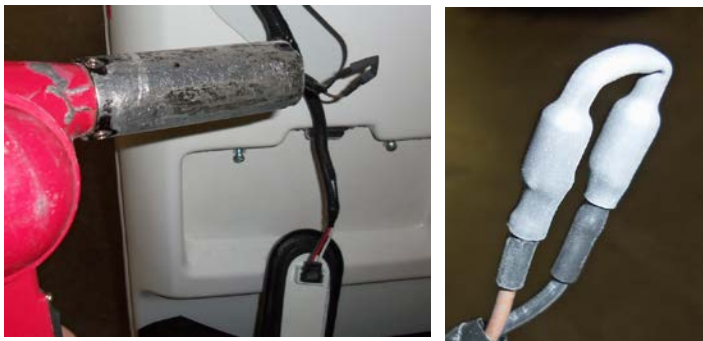
Step 3- Add a 2" piece of shrink wrap over the ends and shrink with heat gun.

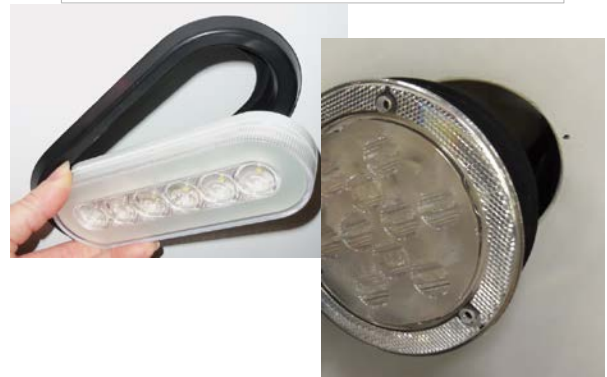
Step 4- Reinstall the light and repeat with other side.
