This bulletin provides the procedure to secure the headliner plates in the 2010-2013MY Soul vehicles equipped with sunroofs, built from January 8, 2009 through October 2, 2013. The headliner plates are part of the energy absorbing structure of the headliner. Under certain circumstances, the plates may detach from the headliner upon deployment of the curtain airbag. To correct this condition, Kia is launching a safety recall campaign to secure the plates by applying the industrial adhesive strips as outlined in this bulletin.

### SUBJECT: HEADLINER PLATES FOR 2010-2013MY SOUL VEHICLES EQUIPPED WITH SUNROOF (SC 112)

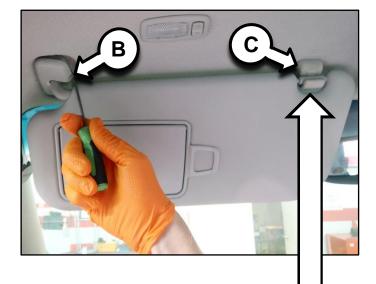
2. Remove the mounting brackets (B & C) for the sun visor.

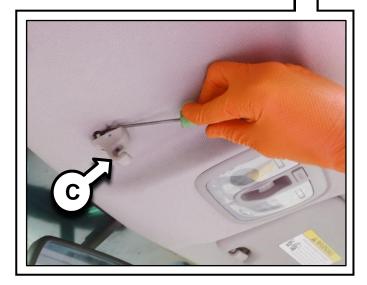
To remove the sun visor hook (C), use a prying tool to apply gentle pressure from the side prior to removing the hook from the headliner.

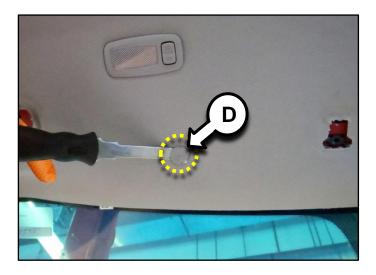
3. Use a prying tool to carefully remove the two clips (D) from the headliner.

If the clips are damaged during removal, replace with the included parts, prior to reinstalling the headliner.

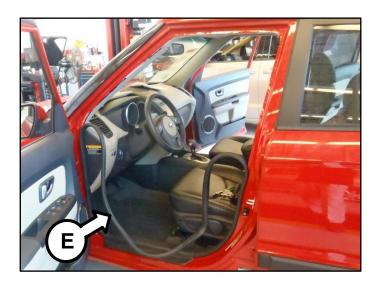
Partially remove the weather stripping (E) from around the front door opening, as shown.

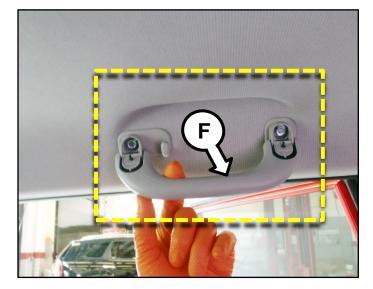
Remove two screws securing the grab handle (F). Make sure to remove all four (4) grab handles.

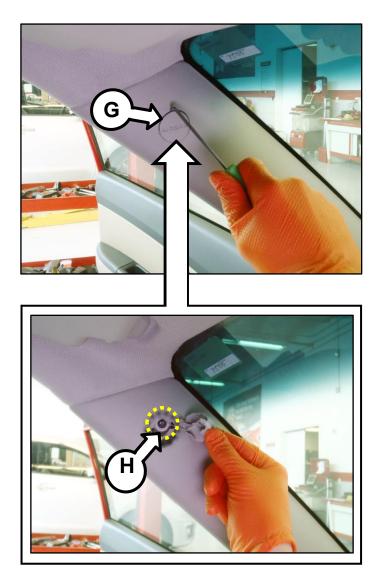
Use a prying tool to gently detach the cover (G) on the A-Pillar trim panel. 6. Then, remove the screw (H) and remove the trim panel.

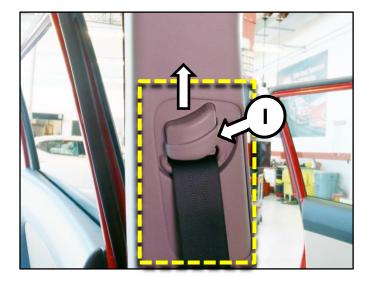
7. Adjust the seat belt height adjuster (I) to the highest position, as shown.

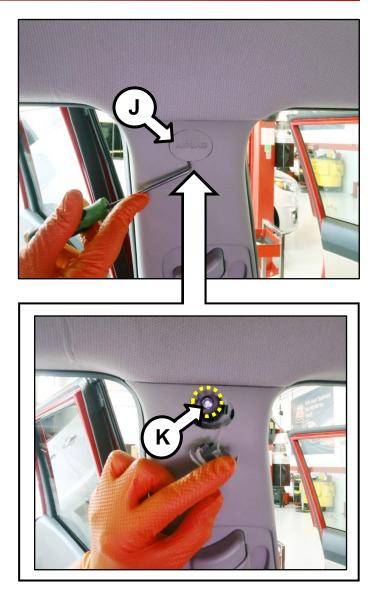
Use a prying tool to gently pry-off the cover from the upper B-Pillar trim panel (J), as shown. Then, remove the bolt (K) securing the upper portion of the trim panel in place.

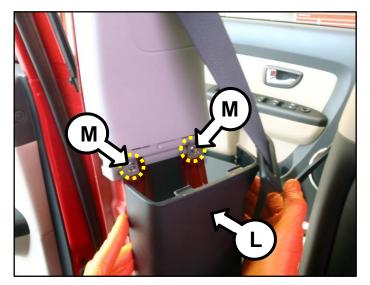
Partially detach the lower B-Pillar trim panel (L) by pulling with both hands. Then, remove two bolts (M) securing the lower end of the upper B-Pillar panel.

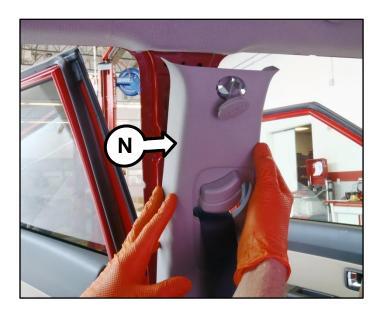
10. Remove the upper B-Pillar panel (N) and allow it to hang by the seat belt.

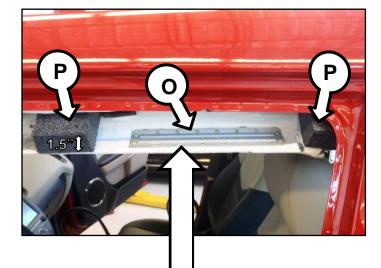
11. Use gentle pressure at all four door openings to partially pull the headliner down until the metal plates (O) are exposed.

To prevent damage to the headliner, use a pair of 1.5" (40mm) tall foam blocks (P) to limit the amount of downward travel and provide working space between the vehicle and the headliner.

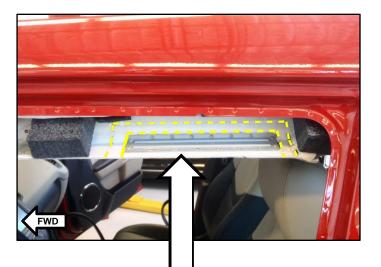
12. Remove the backing and apply the shorter tape pads (10.63" x 2.56") over the metal plates at the front LH/RH door openings.

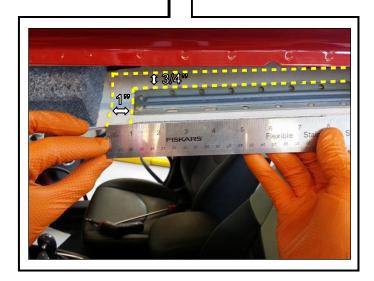
- Allow for approximately 1" of overhang from the side of the metal plate to the edge of the pad and approximately <sup>3</sup>/<sub>4</sub>" from the top of the metal plate to the upper edge of the pad.
- The lower edge of the pad should align with the bottom edge of the headliner without any overlap.

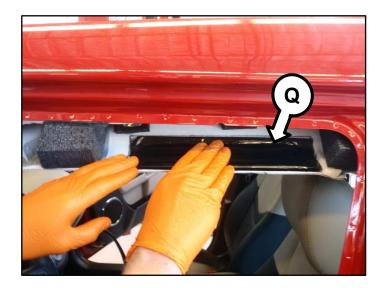
Use your fingers to gently press down over the entire surface of the pad (Q) to ensure proper adhesion.

To prevent damage to the headliner, do NOT exceed the 1.5" (40mm) travel limit when pressing down on the pads and support the headliner from below, as necessary.

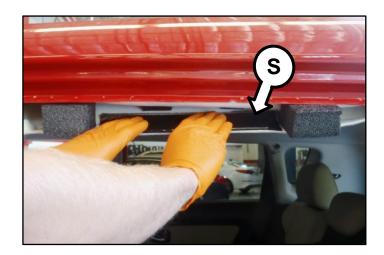
14. Install two 1.5" (40mm) tall foam blocks (R) between the vehicle body and the headliner to limit downward travel of the headliner, as shown.

15. Remove the backing and apply the longer tape pads (11.8" x 2.56") over the metal plates at the rear LH/RH door openings.

- Allow for approximately 1" of overhang from the side of the metal plate to the edge of the pad and approximately <sup>3</sup>/<sub>4</sub>" from the top of the metal plate to the upper edge of the pad.
- The lower edge of the pad should align with the bottom edge of the headliner without any overlap.
- Use your fingers to gently press down over the entire surface of the pad (S) to ensure proper adhesion.
