PRODUCT CAMPAIGN BULLETIN

APPLICABILITY: 2009-2013 Subaru Forester
 2008-2011 Subaru Impreza, WRX, and STI
 2012-2014 Subaru WRX and STI

NUMBER: WQQ-52
DATE: January 2015
NHTSA ID: 14V-830

SUBJECT: Application of Anti-Corrosion Material to the Four-Way (2-2 way) Joint Connector of the Brake Line System

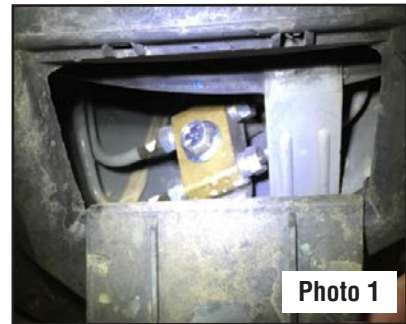
(1-2) Open inspection hole door on fuel tank cover (Photo 1). located on the right-hand side of the vehicle.

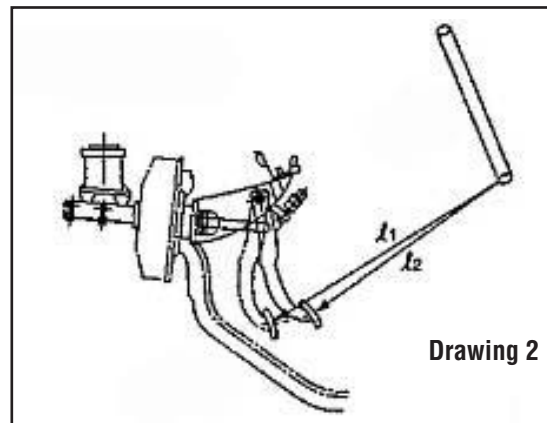
- (2-1) Start the engine and allow it to idle.
- (2-2) Measure dimension “L2” (foot off pedal) as shown in Drawing 2.
- (2-3) Depress the brake pedal until the dimension from steering wheel to brake pedal “L1” becomes 110mm greater than dimension “L2”.
- (2-4) Hold the brake pedal in that position for about 3 seconds.
- (2-5) Shut off the engine.
- (2-6) Raise the vehicle.

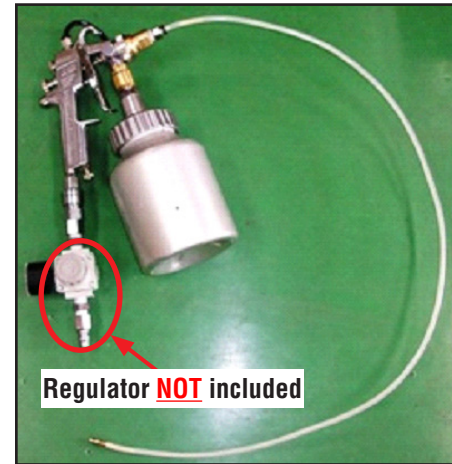
- (1-1) Assemble the spray gun and nozzle according to the spray gun assembly and adjusting instructions outlined above.
- (1-2) Set zero-point of discharge knob and air needle of spray gun.
- (1-3) Fill the tank with anti-rust wax.
- (1-4) Adjust wax amount and air volume by setting the discharge knob, air needle, and compressor air pressure of spray gun.
- (1-5) Test-spray wax to confirm gun operates as intended.

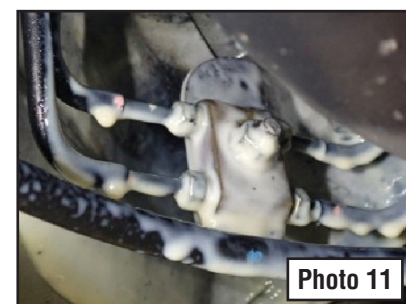
- Spray until the sprayed wax material drips. (Photo 11)
- To insure the proper amount of wax is applied, follow the steps listed above closely.
