**PRODUCT CAMPAIGN BULLETIN**

**APPLICABILITY:** 2009-2013 Subaru Forester  
 2008-2011 Subaru Impreza, WRX, and STI  
 2012-2014 Subaru WRX and STI

**NUMBER:** WQQ-52R  
**DATE:** January 2015  
**REVISED:** July 2017  
**NHTSA ID:** 14V-830

**SUBJECT:** Application of Anti-Corrosion Material to the Four-Way (2-2 way) Joint Connector of the Brake Line System

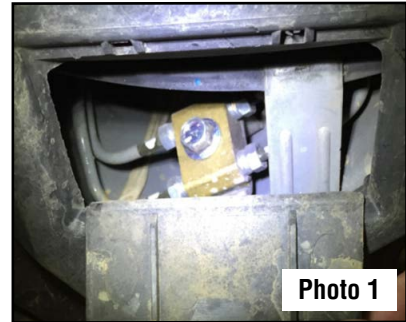
(1-2) Open inspection hole door on fuel tank cover (Photo 1). located on the right-hand side of the vehicle.

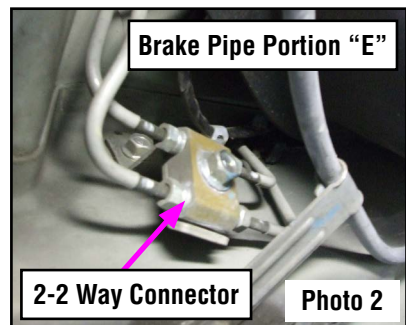
(2-1) Confirm the location of Brake Pipe Portion E at 2-2 Way Connector (Photo 2).

**IMPORTANT:** Even if the 2-2 Way Connector appears to have been previously rust-proofed, the balance of this recall procedure must still be completed in its entirety.

**NOTE:** Removal of the plastic fuel tank protector is not required to perform this recall procedure. The protector was removed to provide a better photographic representation of the areas involved.

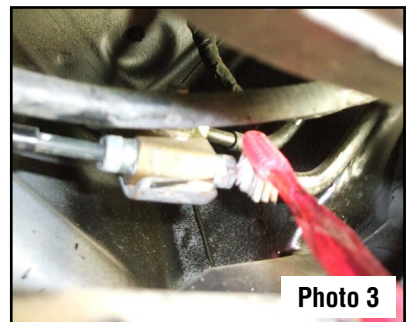
(3-1) Use a tooth brush (plastic bristle) and compressed air to carefully remove dust and dirt (Photo 3).

**IMPORTANT: NEVER** use a metal / wire brush!

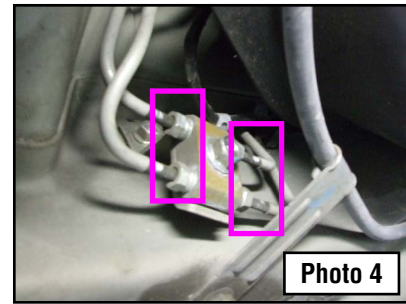
- (4-1) Check for fluid leakage from Brake Pipe Portion E from the areas indicated (Photo 4).

- (5-1) If no brake fluid leakage is verified: Proceed to [Step 2] **BRAKE FLUID LEAKAGE INSPECTION #2 WITH BRAKE PEDAL DEPRESSED.**
- (5-2) If brake fluid leakage is verified: Proceed to [Step 4] **BRAKE PIPING REPLACEMENT.**

**IMPORTANT:** The decision to replace brake piping should strictly be made **ONLY** when brake fluid leakage is verified. Replacement of brake piping due to other reasons including surface rust are not a matter for warranty. Questions related to any out of warranty concerns should be directed to your DPSM.

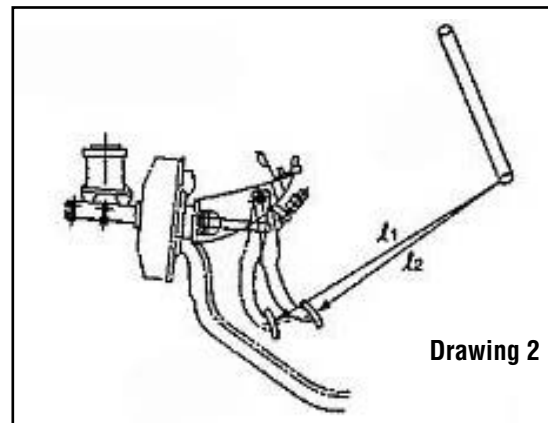
- (2-1) Start the engine and allow it to idle.
- (2-2) Measure dimension “L2” (foot off pedal) as shown in Drawing 2.
- (2-3) Depress the brake pedal until the dimension from steering wheel to brake pedal “L1” becomes 110mm greater than dimension “L2”.
- (2-4) Hold the brake pedal in that position for about 3 seconds.
- (2-5) Shut off the engine.
- (2-6) Raise the vehicle.

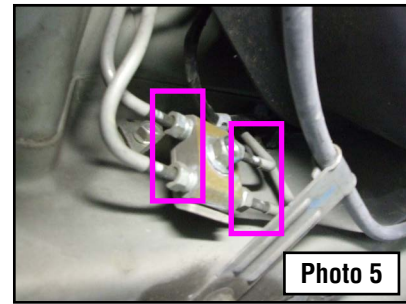
- (3-1) Check for fluid leakage from Brake Pipe Portion E from the areas indicated (Photo 5).

- (4-1) If no brake fluid leakage is verified, Proceed to [Step 3] **APPLICATION of RUST-PROOFING.**
- (4-2) If brake fluid leakage is verified: Proceed to [Step 4] **BRAKE PIPING REPLACEMENT.**

**IMPORTANT:** The decision to replace brake piping should be made **ONLY** when brake fluid leakage is verified. Replacement of brake piping due to other reasons including surface rust is not a matter for warranty. Questions related to any out of warranty concerns should be directed to your DPSM.

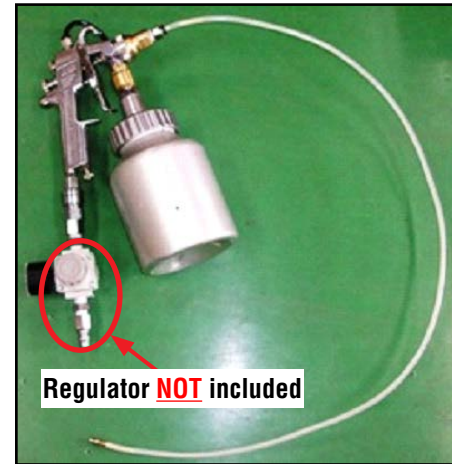
- (1-1) Assemble the spray gun and nozzle according to the spray gun assembly and adjusting instructions outlined above.
- (1-2) Set zero-point of discharge knob and air needle of spray gun.
- (1-3) Fill the tank with anti-rust wax.
- (1-4) Adjust wax amount and air volume by setting the discharge knob, air needle, and compressor air pressure of spray gun.
- (1-5) Test-spray wax to confirm gun operates as intended.

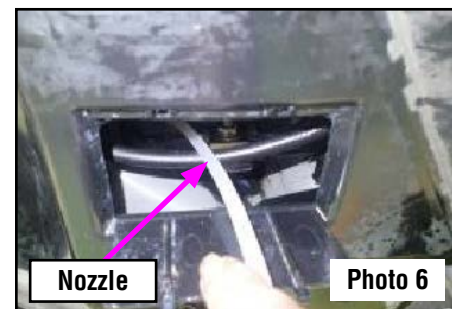
- (2-1) Spraying Brake Pipe Portion E:
  - (2-1-1) Open the inspection hole door in the fuel tank cover and insert the nozzle. (Photo 6)

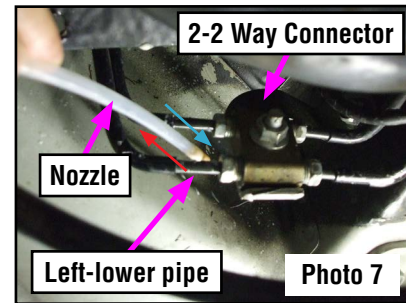
(2-1-2) Insert the nozzle over the left-lower pipe of the 2-2 Way Connector. Remove the nozzle while spraying for 3 seconds or more. (Photo 7)

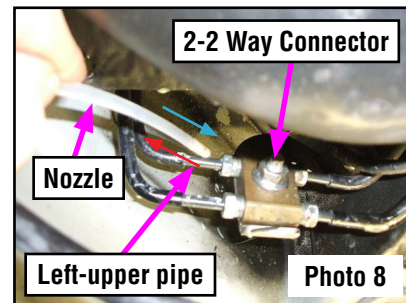
(2-1-3) Insert the nozzle over the left-upper pipe of the 2-2 Way Connector. Remove the nozzle while spraying for 3 seconds or more. (Photo 8)

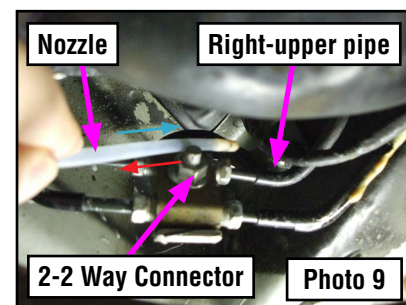
(2-1-4) Insert the nozzle over the right-upper pipe of the 2-2 Way Connector. Remove the nozzle while spraying for 3 seconds or more. (Photo 9)

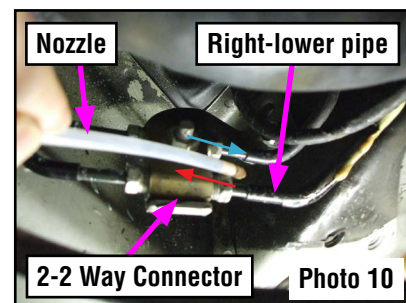
(2-1-5) Insert the nozzle over the right-lower pipe of the 2-2 Way Connector. Remove the nozzle while spraying for 3 seconds or more. (Photo 10)

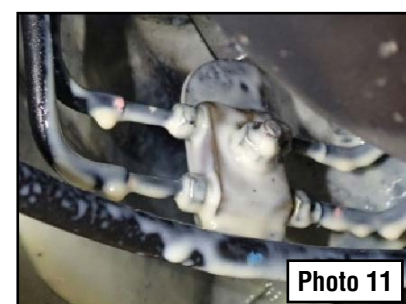
- Spray until the sprayed wax material drips. (Photo 11)
- To insure the proper amount of wax is applied, follow the steps listed above closely.
