2013-15 Nissan Altima Secondary Hood Latch Lubrication Voluntary Safety Recall Campaign

Reference: PC359
Date: March 3, 2015

2013 - 2015 ALTIMA SECONDARY HOOD LATCH LUBRICATION

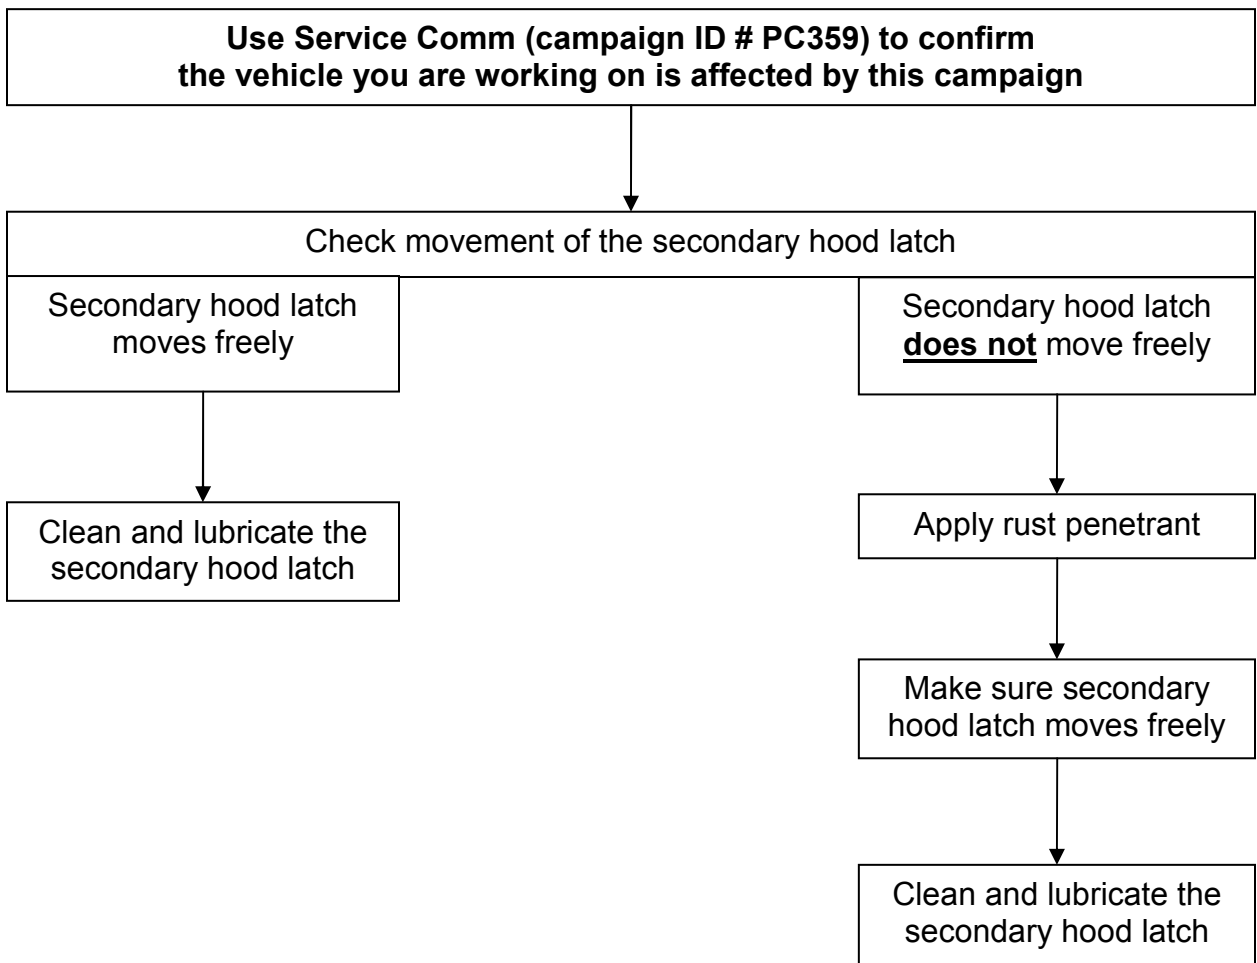
REPAIR OVERVIEW

A. On some of the affected vehicles, if a customer inadvertently actuates the primary hood lock release handle (located on the lower part of the dashboard), the secondary hood latch may not hold the hood closed as designed and the hood may come open while vehicle is in motion.

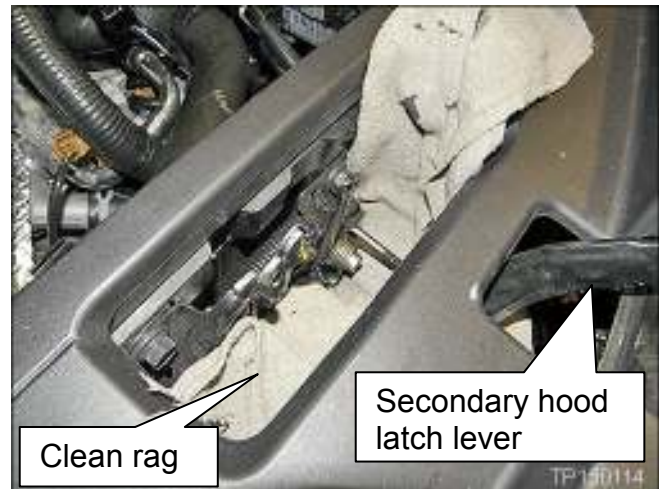
Figure 1

1. Open the engine hood.
2. Place a clean rag under the hood latch assembly as shown in Figure 1.

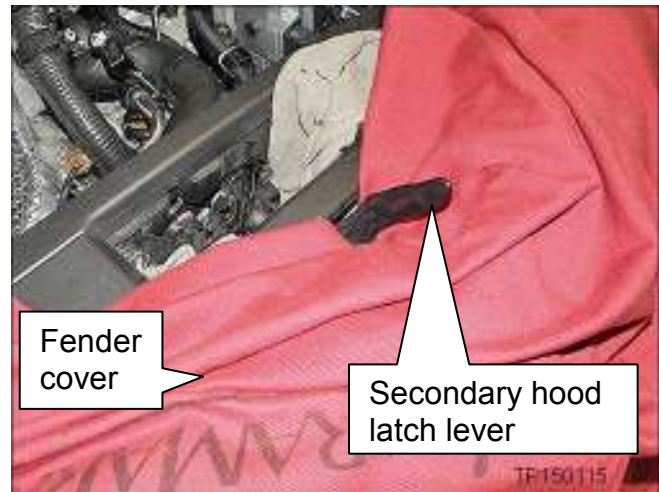
Figure 2

3. Place a clean fender cover to protect the front fascia as shown in Figure 2.
 - Allow the secondary hood latch lever to be above the fender cover as shown.

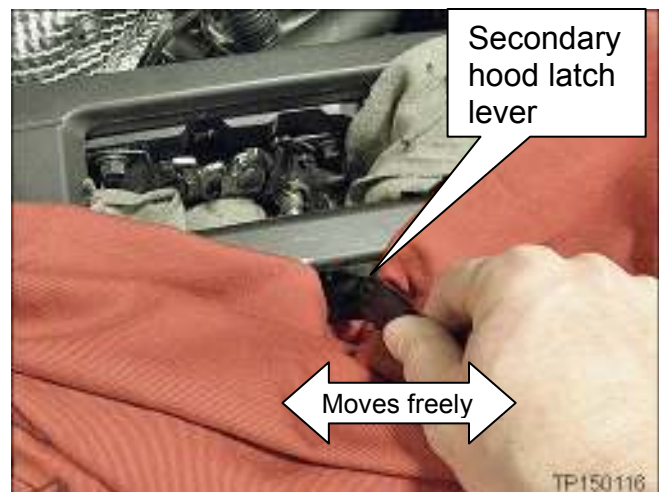
Figure 3

4. Move / cycle the secondary hood latch lever several times.
 - Moves freely – skip to step 7.
 - Does not move freely – go to the next step (step 5).

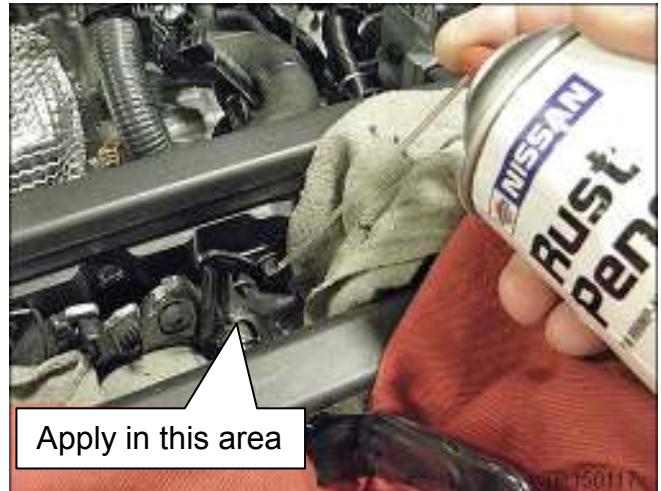
Figure 4

5. **Only if secondary hood latch does not move freely in step 4:**

Apply aerosol rust penetrant to the secondary hood latch.

- Use Nissan Rust Penetrant or equivalent.
- Use a spray extension tube to help direct the application.
- Apply to the pivot pin area and between latch lever and latch body.

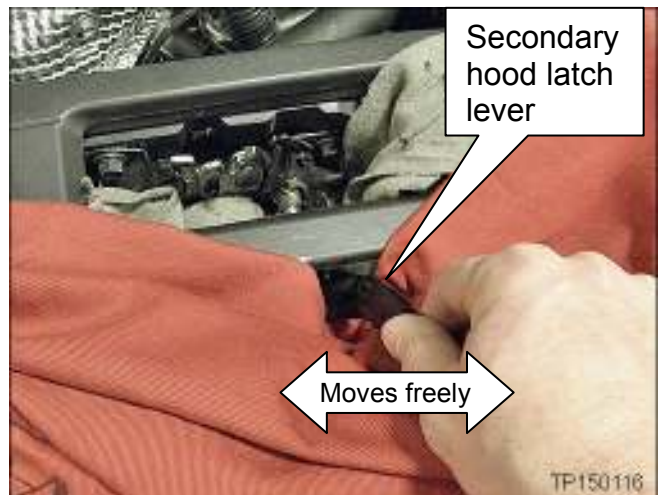
Figure 5

6. Move / cycle the secondary hood latch lever 10-15 times or until it moves freely.

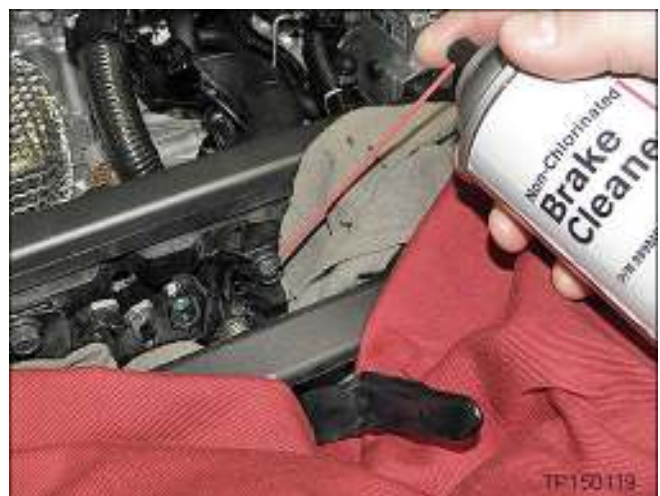
Figure 6

7. Remove / clean previous lubricants and debris from the secondary hood latch.

- Use brake clean or equivalent type cleaner that complies with local regulations.
- Use a spray extension tube to help direct the application.
- Clean the pivot pin area, and clean between latch lever and latch body.

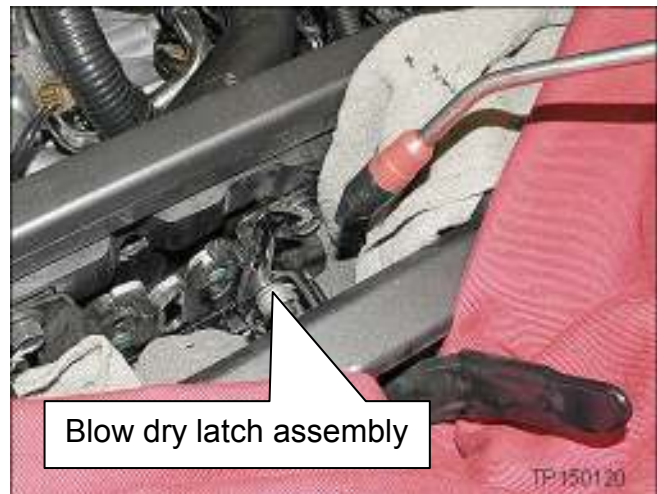
Figure 7

8. Use shop air to blow-dry the latch assembly before proceeding to the next step.

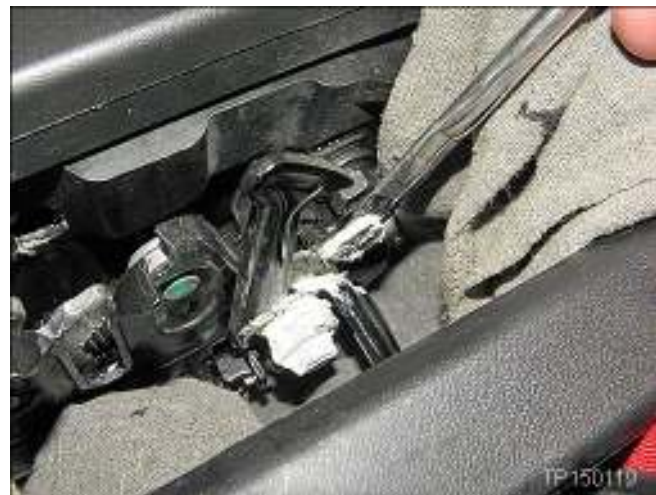
Figure 8

9. Apply non-aerosol white lithium grease to the secondary hood latch.
 - Do not use “spray-on” grease.
 - Apply the grease with a small brush
 - With the brush, work the grease onto the pivot pin area and between latch lever and latch body.
