December 2015
FL679A-D
NHTSA #15V-127
Transport Canada #2015-113
REVISED NOTICE

Subject: Freightliner Cascadia SAM Chassis

Models Affected: Specific Freightliner Cascadia vehicles manufactured March 26, 2007, through September 1, 2010, and equipped with a SAM Chassis.

SAM Chassis/Shield/Drip Loop Inspections and Replacement/Installation

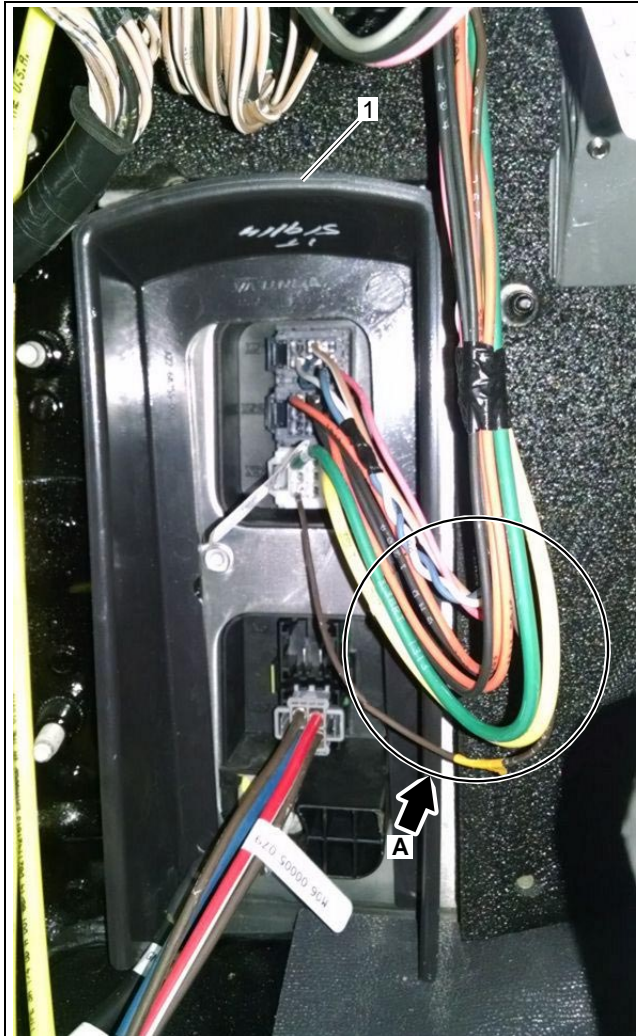
Fig. 1, SAM Chassis with a Drip Shield and a Drip Loop

A. A drip loop prevents water from collecting at the connectors.

- 1. Drip Shield

5. Remove the lower driver's side A-Pillar cover.
6. Inspect the SAM Chassis and verify that a drip shield is installed. See **Fig. 1**. Make sure that the drip shield is in contact with the frontwall at all points. If the drip shield is firmly seated to the frontwall, go to step 9. If there is no drip shield installed or the drip shield is loose or separated at any point from the frontwall, continue with step 7 to replace the drip shield.

7. Disconnect connectors X51 through X55.
8. Remove the liner on the back of the new drip shield from kit 25-FL679-000 to expose the adhesive, then position the drip shield over the SAM Chassis connectors and press securely. Ensure that the drip shield is firmly seated to the frontwall at all points. See **Fig. 1**.

9. Inspect the SAM Chassis harness for a drip loop. See **Fig. 1**. If a drip loop has already been created, go to step 11.
If a drip loop has not been created, continue with step 10.

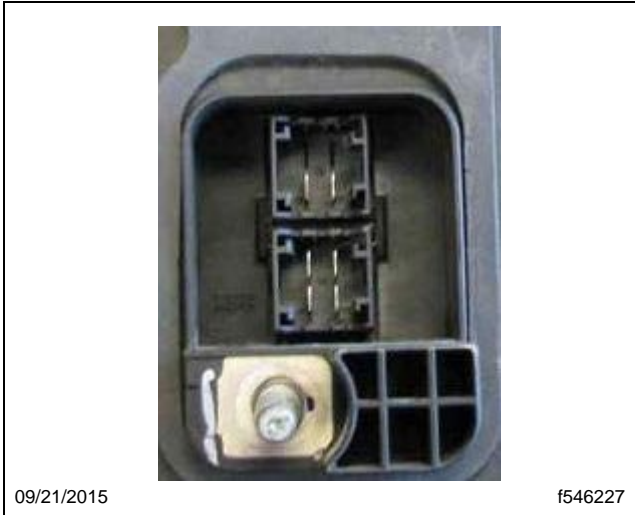
Fig. 3, Clean Terminals with No Corrosion

SAM Chassis Corrosion Quick Reference	
Figure	Description
Fig. 3	Clean connector with no corrosion on the terminals. These terminals are good and do not need to be replaced.
Fig. 4	Green and white corrosion on the connectors. Terminal plating shows no signs of damage. These terminals can be cleaned.
Fig. 5	Dirt and debris on the terminals. These terminals can be cleaned and do not need to be replaced.
Fig. 6	Orange, green, and white corrosion on the terminals. Terminal plating exhibits signs of unrecoverable corrosion. This unit is considered unrecoverable and must be replaced.
Fig. 7	Dielectric grease on the terminals. These terminals can be cleaned and do not need to be replaced.

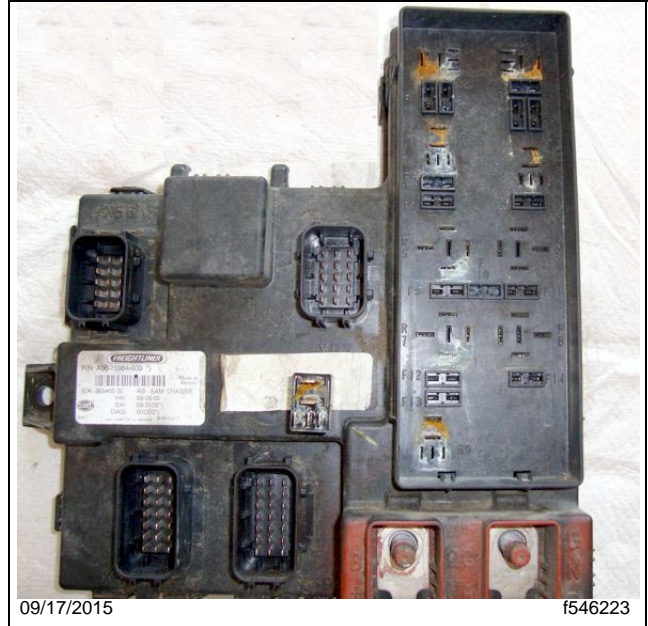
Fig. 8, Condemned SAM Chassis Photo for Warranty

IMPORTANT: If the SAM Chassis needs to be replaced due to unrecoverable levels of corrosion, one or more photos that clearly show the product sticker and the corroded area must be attached to the claim.

- 12.3 If unrecoverable levels of corrosion are found at the SAM Chassis, remove all fuses, relays, and connectors, then take a picture of the SAM Chassis. Make sure that the photo(s) clearly show the product sticker and the corroded area(s) of the SAM Chassis. See **Fig. 8**. This photo must be attached to the claim.
- 12.4 Replace the SAM Chassis. Refer to **Section 54.02, Subject 100** of the *Cascadia Workshop Manual*. Once the SAM Chassis is replaced, continue with step 20.

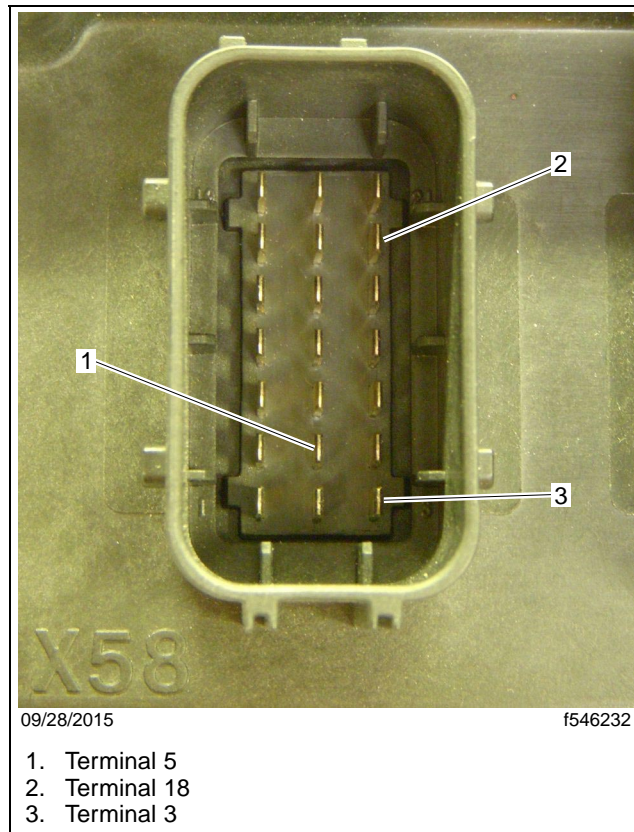
Fig. 9, X58 Terminal Locations for Ohm Tests

14. Perform an ohm test on the SAM Chassis. See **Fig. 9**.

Perform an ohm test on the following three pins:

- **X58-18 to X58-3**; should measure between 50 k Ω to 300 k Ω .
- **X58-18 to X58-5**; should measure between 50 k Ω to 150 k Ω .
- **X58-3 to X58-5**; should measure between 50 k Ω to 150 k Ω .

If the SAM Chassis fails any of the three ohm tests, note the pin and failing measurement (it will be included in the claim story) and replace the SAM Chassis. Refer to **Section 54.02, Subject 100** of the *Cascadia Workshop Manual*, then continue with step 20.
