Forest River, Inc.

IMPORTANT SAFETY NOTICE

Inspection and Installation of Vent

Forest River Campaign Number: 400-03032015-0016

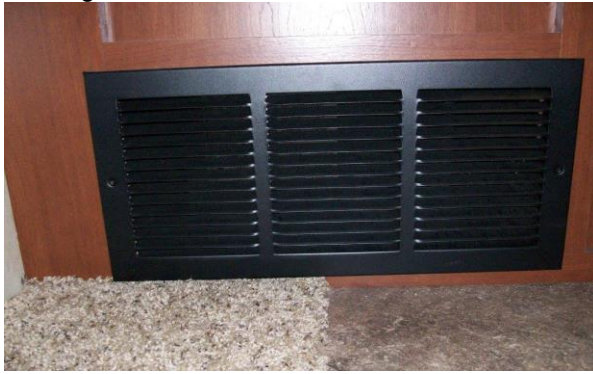
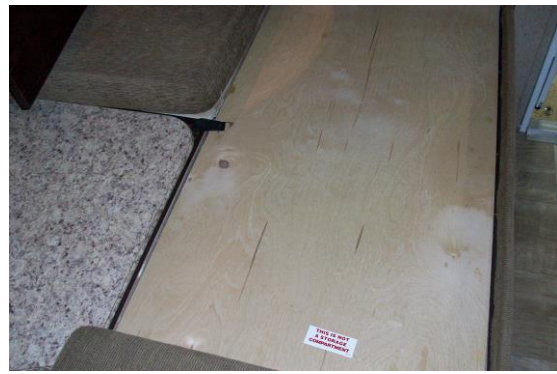
Locate the furnace from the interior of the coach, it will be located behind an access panel similar to this. See Fig 1 and 2 below.

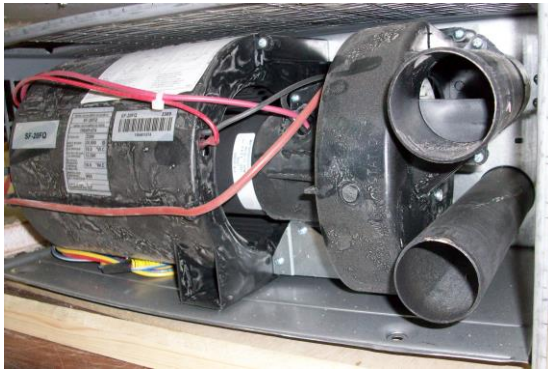
Now remove any Furnace ducting, 12v supply, and gas piping to allow access to the combustion vent tubing at the back of the furnace. See Fig 3 and 4 below.

SF series furnace

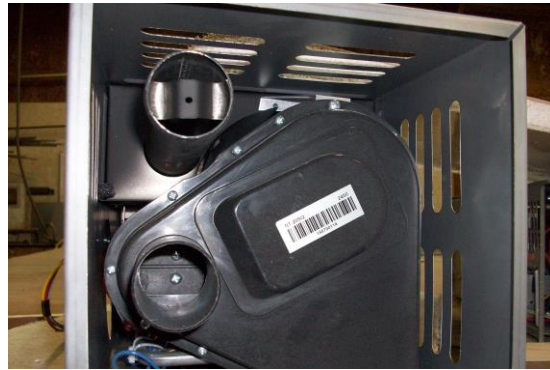
Fig 4

NT series Furnace

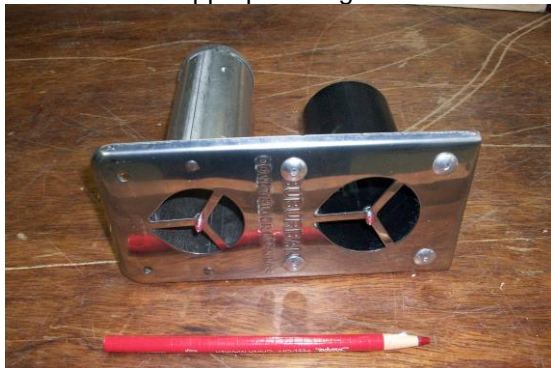
Now install the appropriate Jig onto the duct tubes at the rear of the furnace. See Fig 5 - 8

SF Series hole Jig
PN# SFJ-1

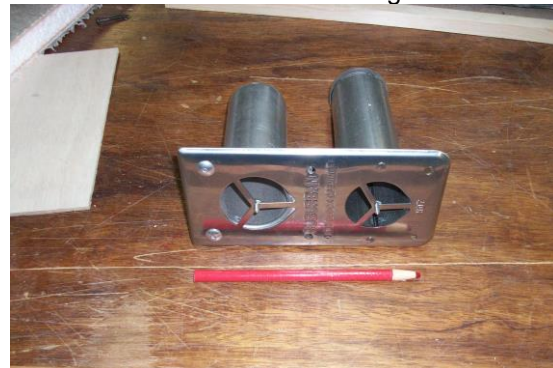
Fig 6

NT Series hole Jig
PN# NTJ-1

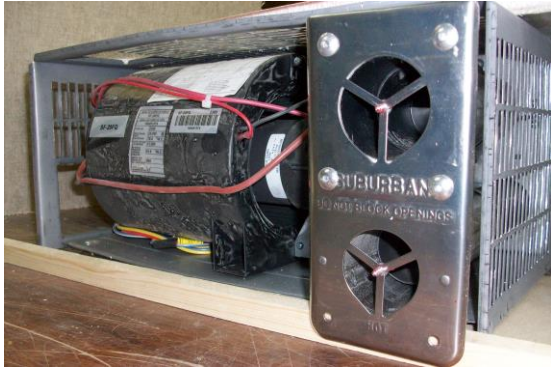
SF Series furnace with jig installed
Fig 7

Use the supplied red grease pencil to color the screw threads at the center of the jig holes, (this will help to clearly mark the drill center location).

Now reposition the furnace as if it were installed, as you slide the furnace toward the outside wall be sure the jig makes enough contact with the outer wall to transfer the red mark.

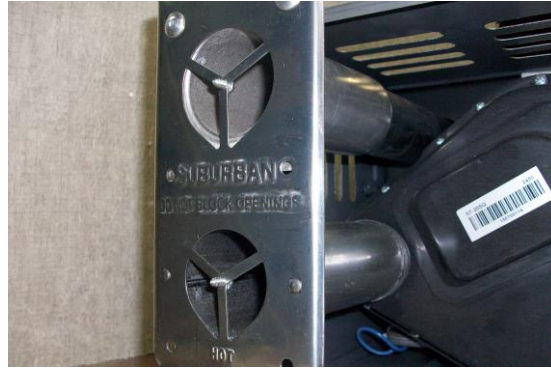
NT Series furnace with jig installed
Fig 8

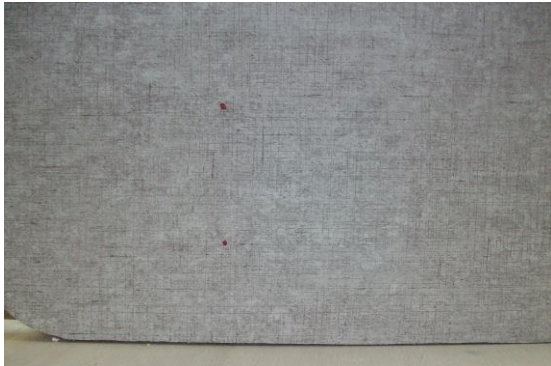
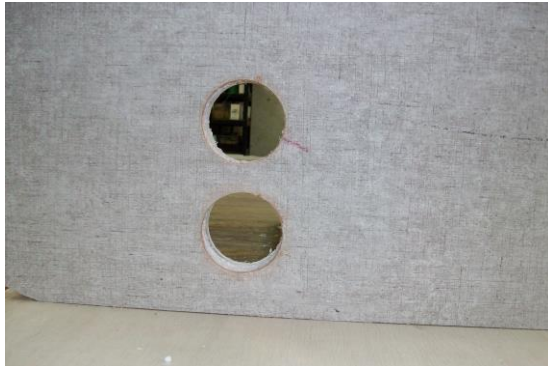
Once again remove the furnace and use the marks you just made with the Jig to drill the two required **2.5in holes**. See Fig 9 and 10

The red marks are the pilot bit locations for the **2.5in hole saw**.

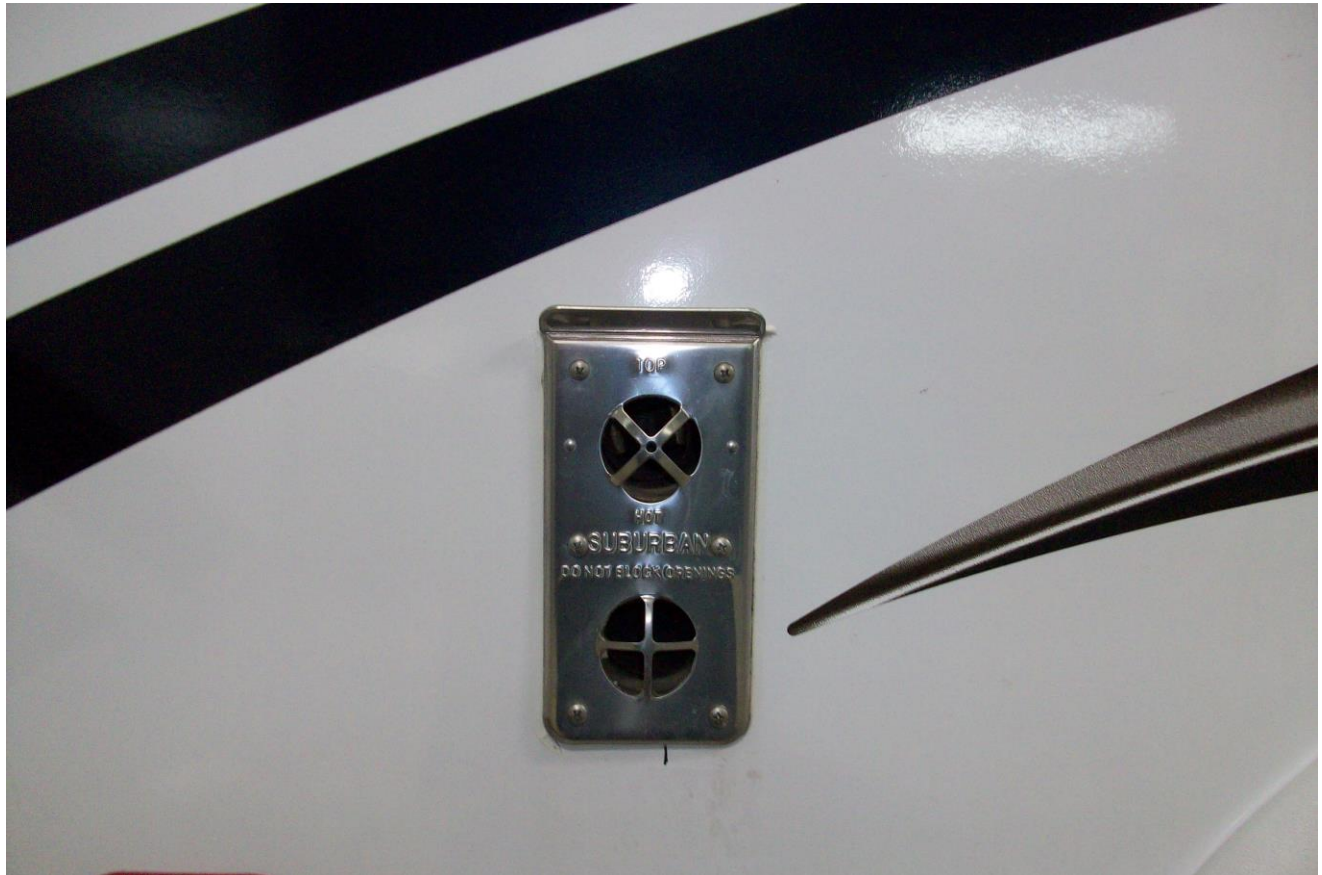
Once the repair if needed, is complete the exterior will look similar to this picture of the exhaust vent installed properly. See Fig 11
