Michael A. Berardi
Director
Service Engineering Operations
Ford Customer Service Division

SUBJECT: **DEMONSTRATION / DELIVERY HOLD - Safety Recall 15S19 - Supplement #1**
Certain 2015 Model Year Mustang Vehicles Equipped with 2.3L Engines
Fuel Tank, Vapor Line, and Parking Brake Cable Heat Shielding

CERTAIN 2015 MODEL YEAR MUSTANG VEHICLES EQUIPPED WITH 2.3L ENGINES — FUEL TANK, VAPOR LINE, AND PARKING BRAKE CABLE HEAT SHIELDING

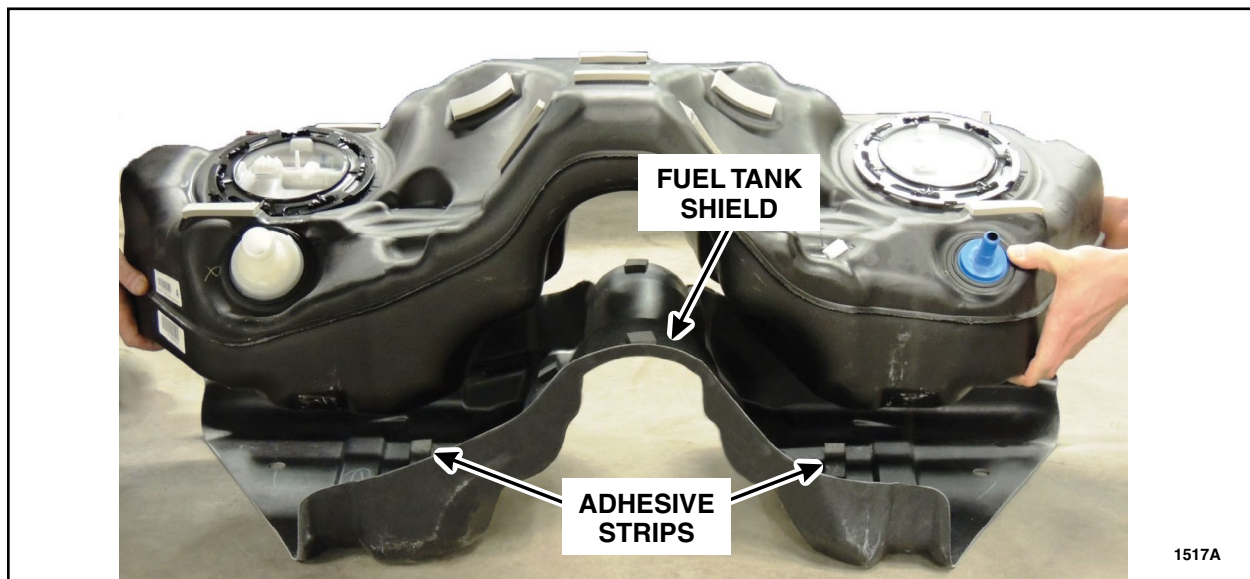
FIGURE 1

1. Remove the fuel tank. Please follow the Workshop Manual (WSM) procedures in Section 310-01.
2. Remove the fuel tank shield by pulling to release the adhesive strips that secure the shield to the tank. See Figure 1.

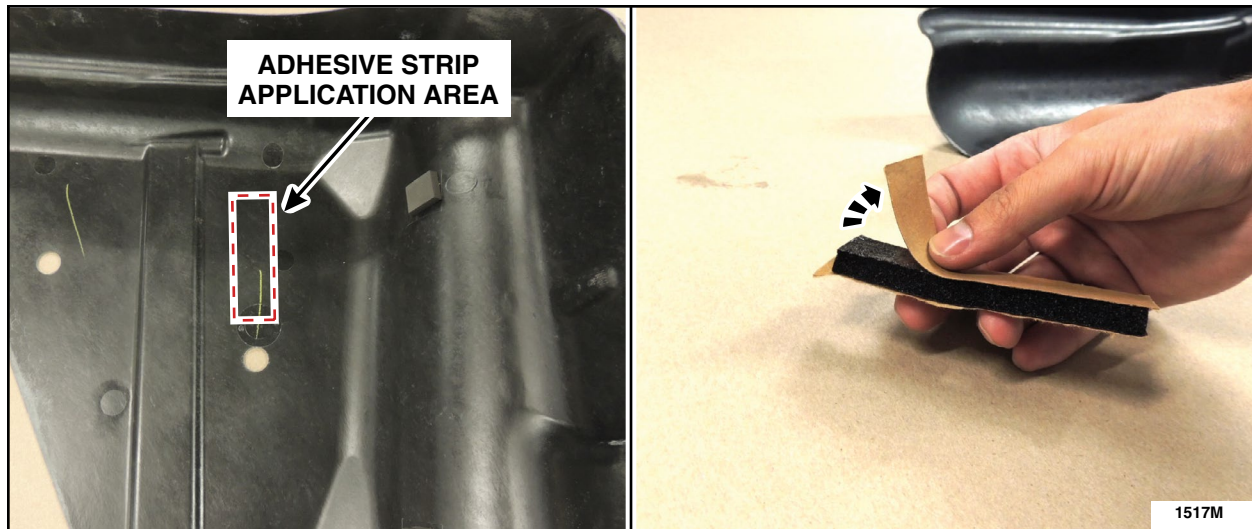
FIGURE 2

4. Locate the adhesive strip application areas on both sides of the new fuel tank shield. Peel off one side of the protective film from each adhesive strip and apply the strips to the new fuel tank shield. See Figure 2.

NOTE: LH side shown, RH similar.

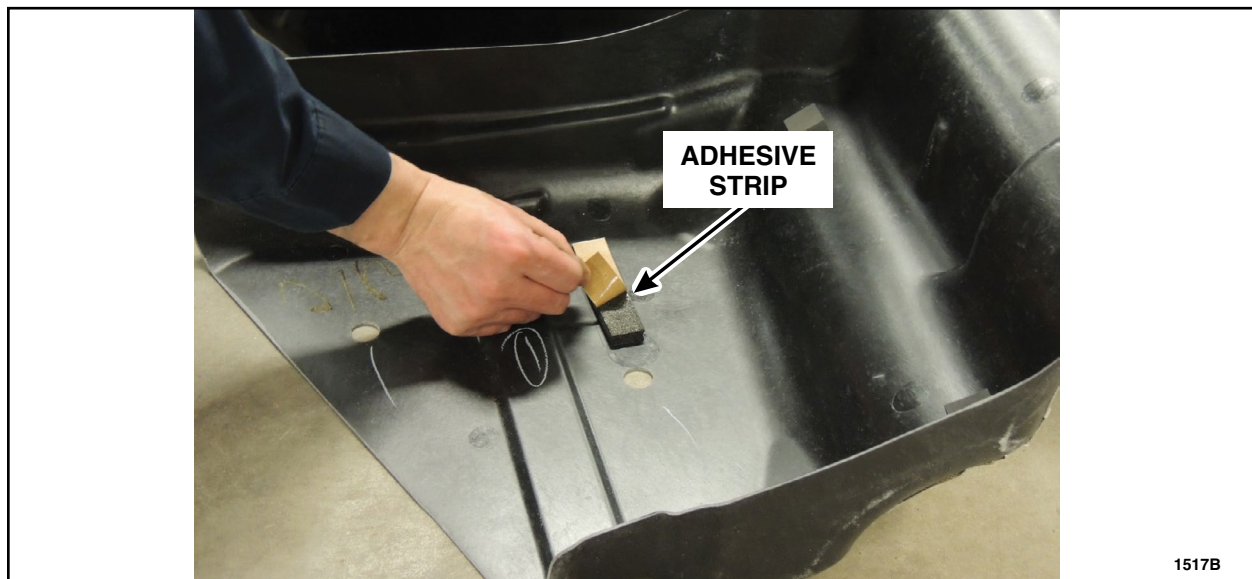
FIGURE 3

5. Remove the protective film from the *new* fuel tank shield adhesive strips and set the fuel tank into the *new* fuel tank shield. See Figure 3.

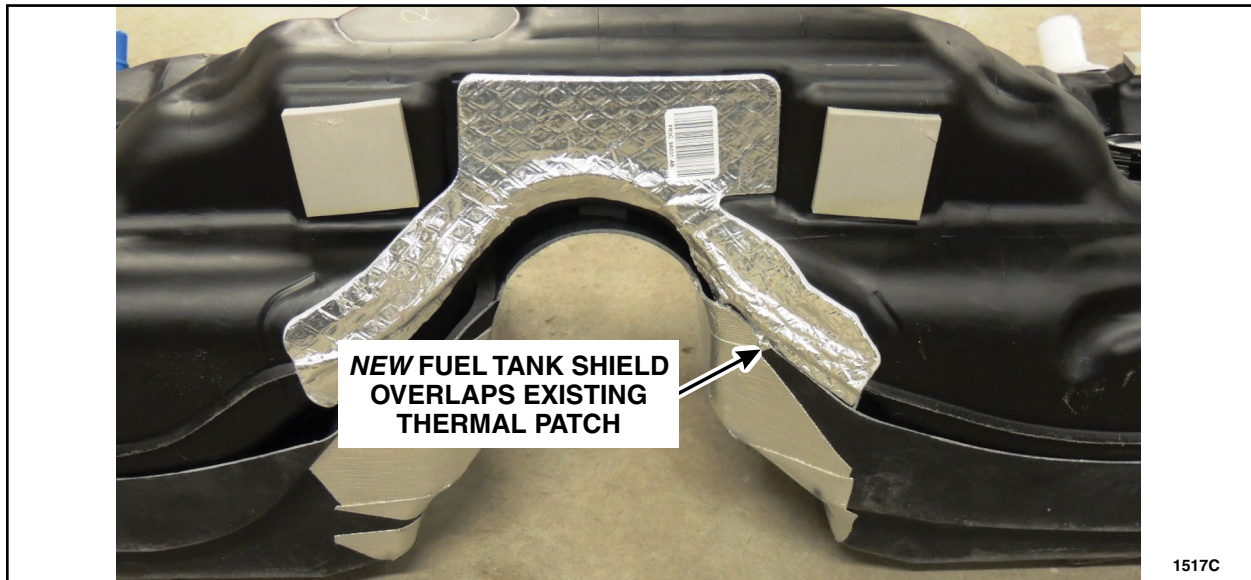
FIGURE 4

NOTE: The *new* fuel tank shield should overlap the existing thermal patch at the front of the tank.
See Figure 4.

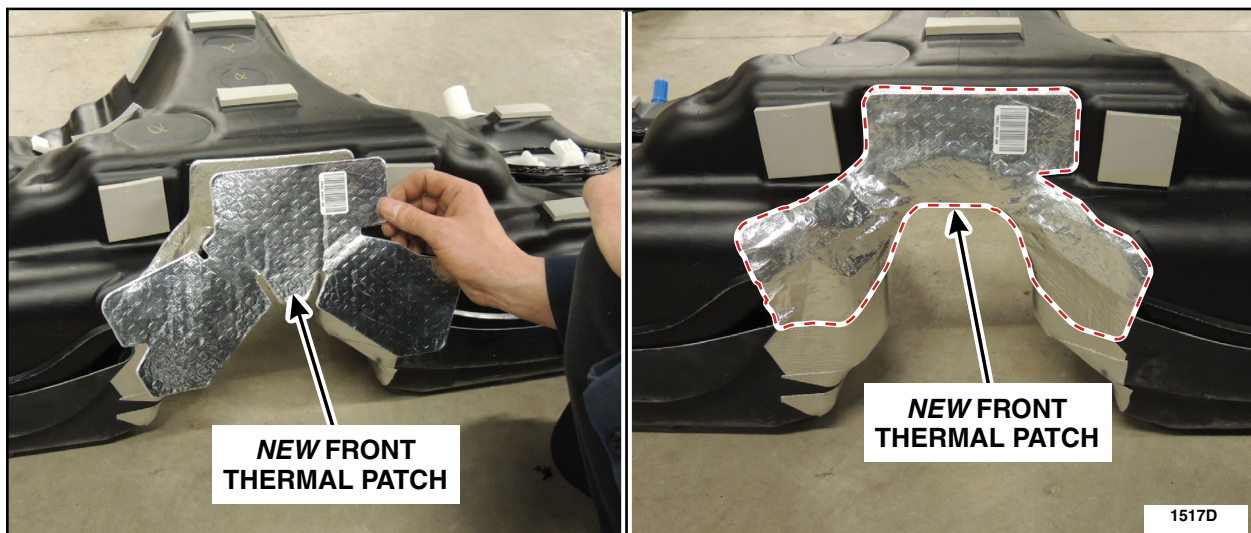
FIGURE 5

6. Apply *new* thermal patch over the existing thermal patch at the front of the fuel tank. See Figure 5.

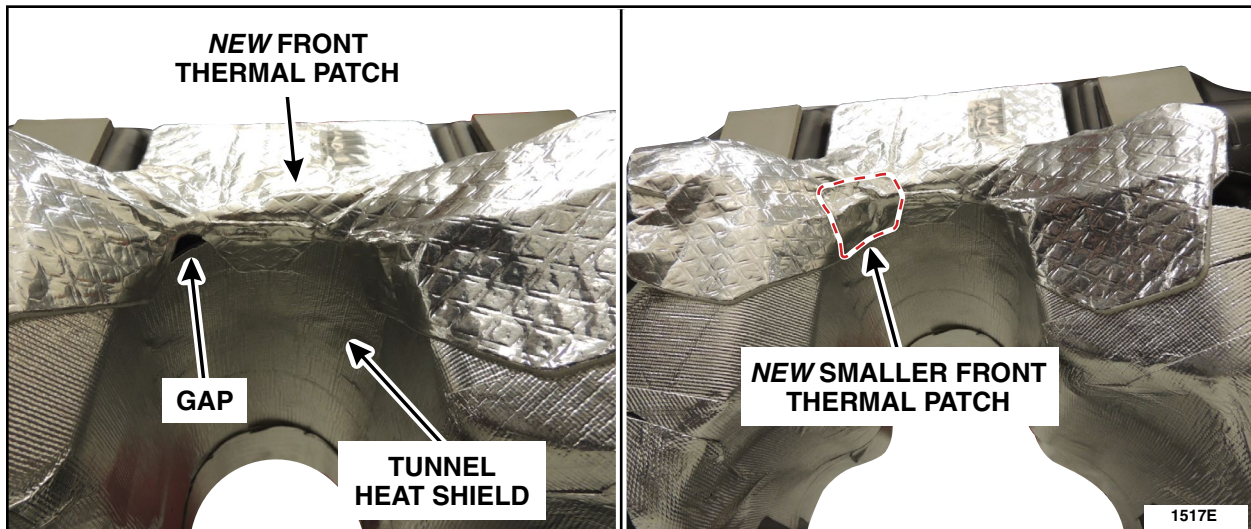
FIGURE 6

7. Apply the *new* smaller thermal patch over the gap between the tunnel heat shield and *new* front thermal patch. See Figure 6.

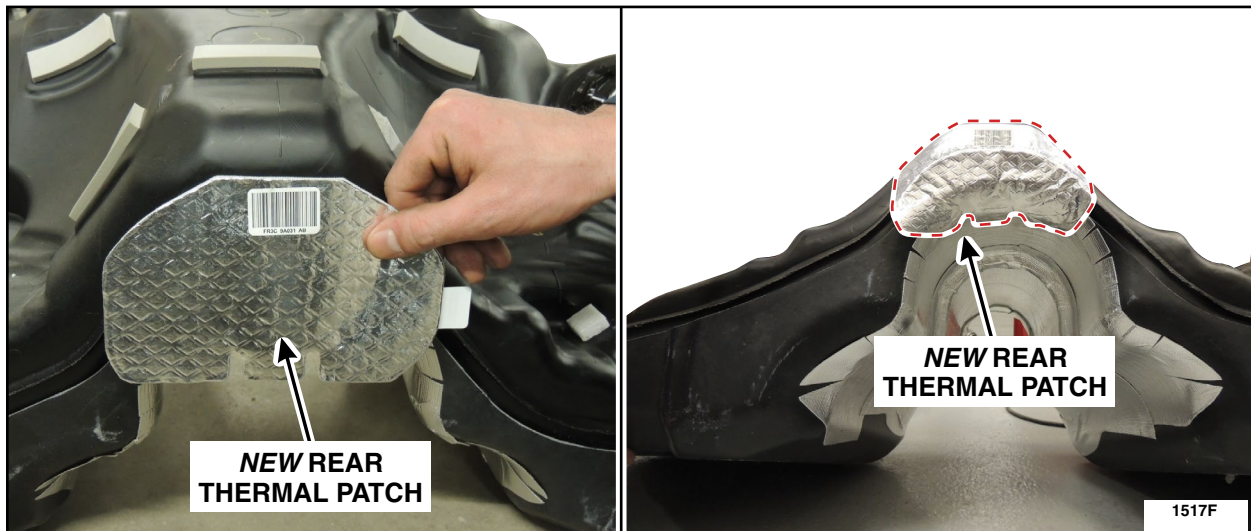
FIGURE 7

8. Apply *new* thermal patch to the rear of the tank. See Figure 7.

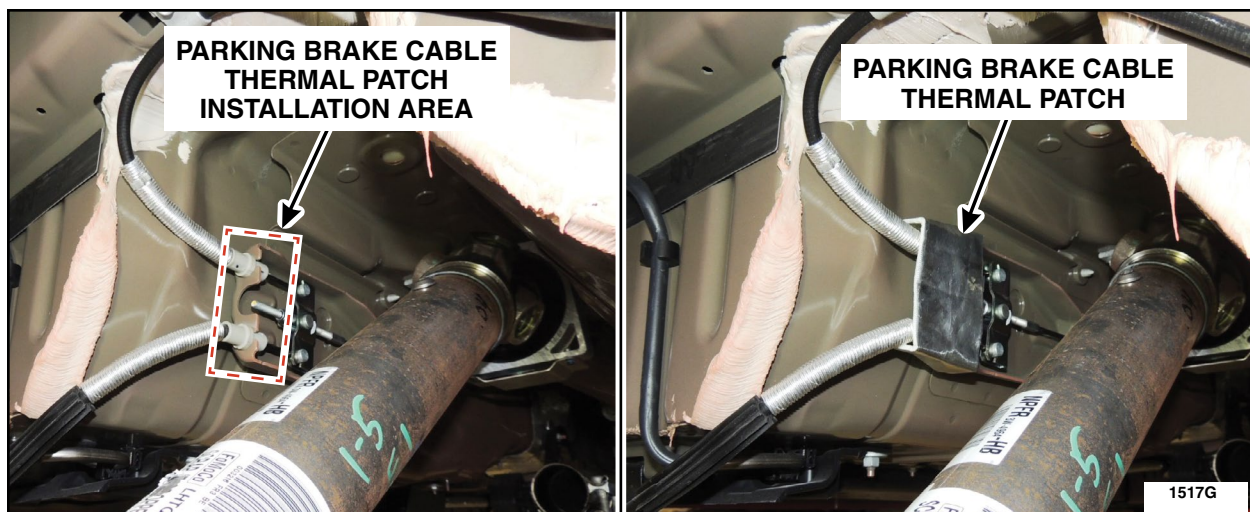
FIGURE 8

NOTE: Ensure there is no contact between the patch and the moving parts of the cable.

10. Apply *new* thermal patch over the parking brake cable retention collars. See Figure 8.

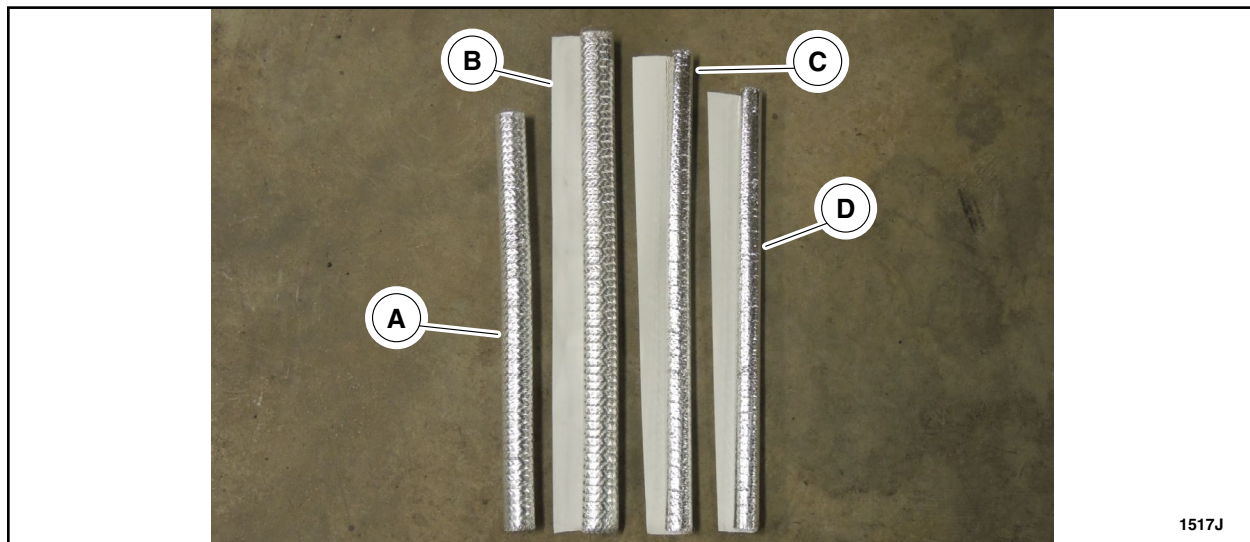
FIGURE 9

11. Install the thermal wraps onto the vapor lines above the rear sway bar. For steps 10b-10d, gradually slide the thermal wraps over the vapor lines, peeling back the protective film and folding the adhesive flap over to seal the wrap over the vapor line. See Figures 9 through 12.

- a. Remove the fresh-air hose from the rear subframe and slide the thermal wrap (19mm dia. x 300mm) over the hose. Reinstall the fresh-air hose to the frame rail.
- b. Install thermal wrap (19mm dia. x 365mm) to canister load line.
- c. Install thermal wrap (13mm dia. x 350mm) to canister recirculation line.
- d. Install thermal wrap (13mm dia. x 320mm) to purge line.
