2015 Sentra and Versa Door Lock Assembly
Voluntary Recall Campaign

Reference: PC383
Date: July 17, 2015

Door Lock Assembly Inspection Procedure

2015 Sentra/Versa Note and Rogue

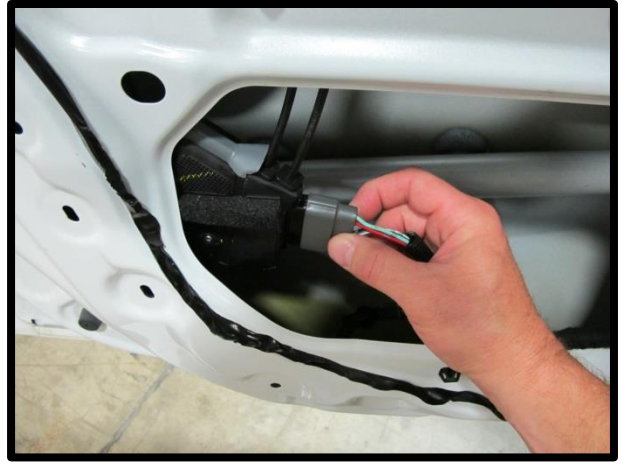
Figure 10

9. Vehicles Equipped With Power Door Locks:

Locks:
Disconnect the door lock harness connector.

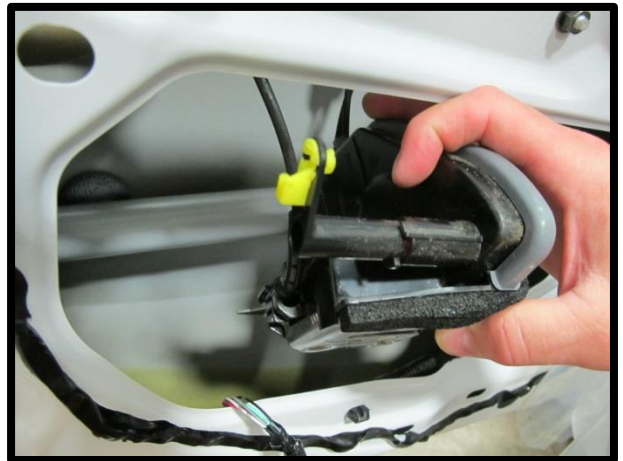
Figure 11

10. Pull the door lock assembly out of the door.

- Do not kink the door lock cables or disconnect them from the door handles.
