2015 Sentra and Versa Door Lock Assembly  
Voluntary Recall Campaign

Reference: PC383  
Date: July 17, 2015

# Door Lock Assembly Inspection Procedure

## 2015 Sentra/Versa Note and Rogue

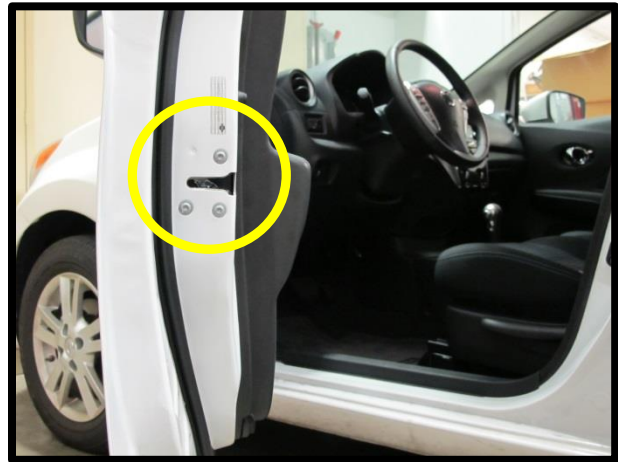
Figure 1

1. Locate door lock Julian Date on applicable vehicle door/s listed below.

- **Sentra/Versa Note:**  
Left Front and Left Rear Doors
- **Rogue:**  
Left Rear Door ONLY

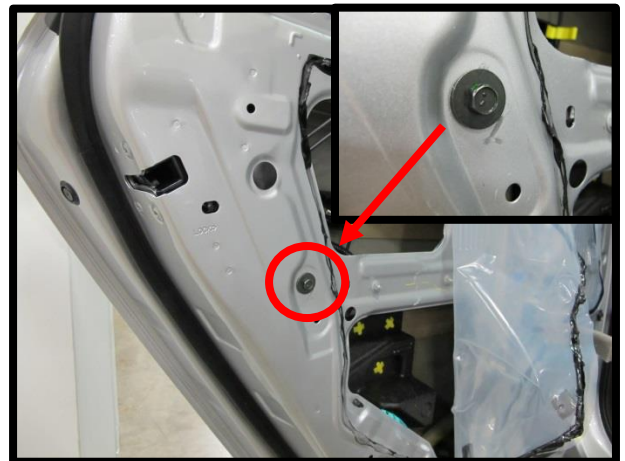
Figure 8

**Sentra Left Rear Door ONLY.** Refer to Figure 8.

- Remove the (1) 10 mm run channel retaining bolt.
- Push the bottom of rear window run back providing clearance to remove the door lock assembly.
- Do NOT attempt to remove the run channel as it is attached to the door at the top and could cause run channel damage.

**Sentra Left Rear Door**

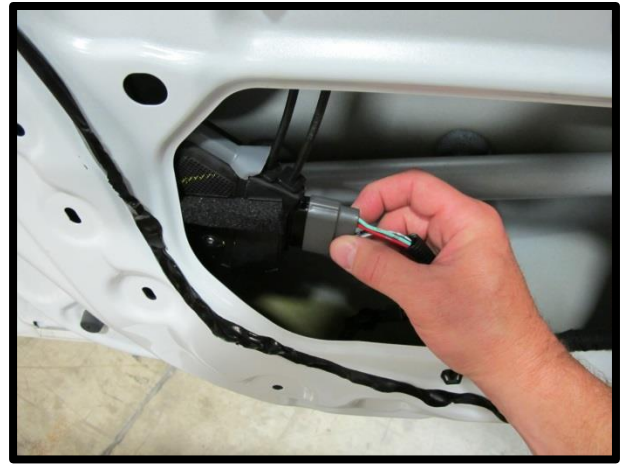
Figure 10

9. Vehicles Equipped With Power Door Locks:

Locks:  
Disconnect the door lock harness connector.

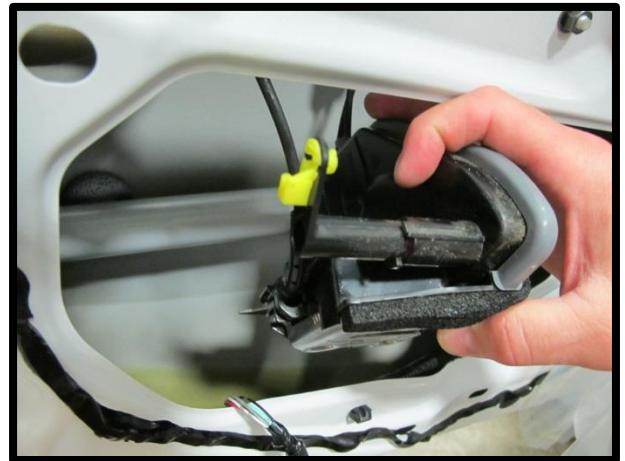
Figure 11

10. Pull the door lock assembly out of the door.

- Do not kink the door lock cables or disconnect them from the door handles.
