Motorcycle/ATV Division

GS/GSX/GSX-R No. 235

November 25, 2015

SAFETY RECALL CAMPAIGN 2A48 GSX-S1000/A/FA Front Brake Caliper

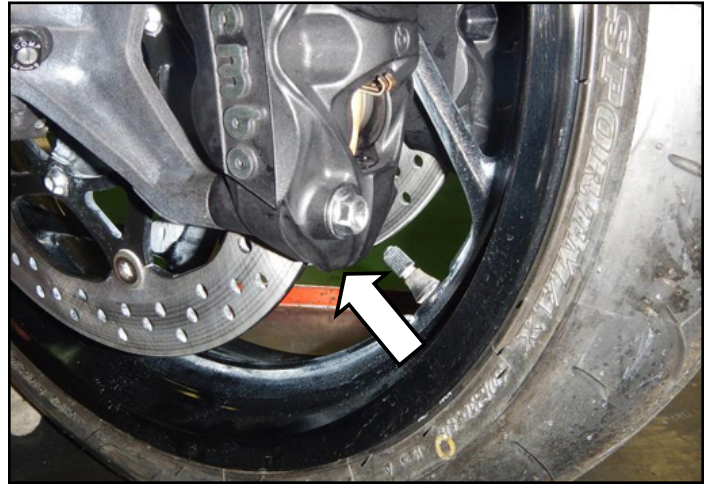
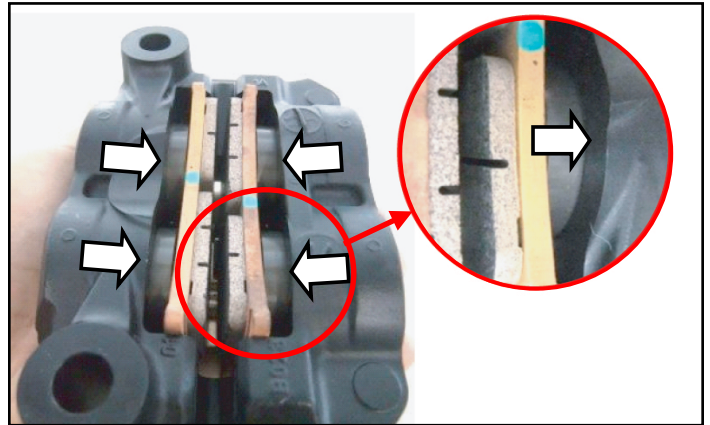
#1 Front Brake Caliper Inspection

Inspect the front brake calipers and brake pads for visible brake fluid leaks or brake fluid residue.

Check for fluid or residue around the pistons when removing the front brake calipers.

- A. If **no** leaks are visible, replace only the front brake calipers.
- B. If brake fluid **is** visible on the calipers, also inspect the brake discs.

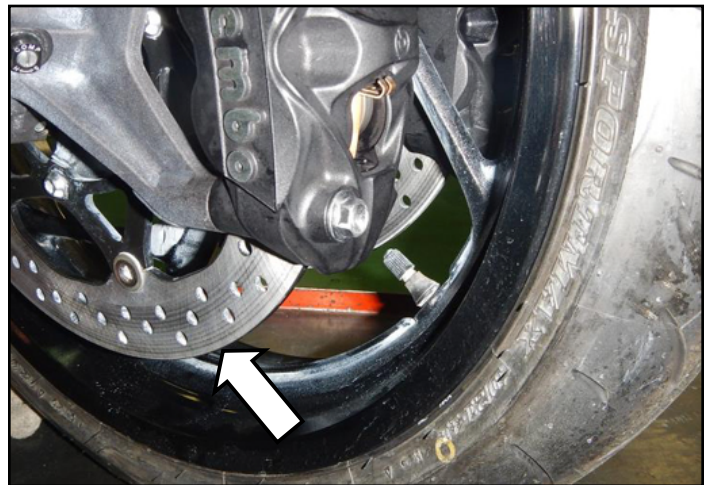
#2 Front Brake Disc Inspection

If any brake fluid is visible on the brake discs, inspect them for paint that may be peeling.

Be sure to inspect the entire circumference of the brake discs.

- A. If **no** brake fluid is visible and the paint is not peeling, replace only the front brake calipers.
- B. If brake fluid **is** visible on the brake discs and calipers, also inspect the front wheel for visible brake fluid or residue, and paint that may be peeling.

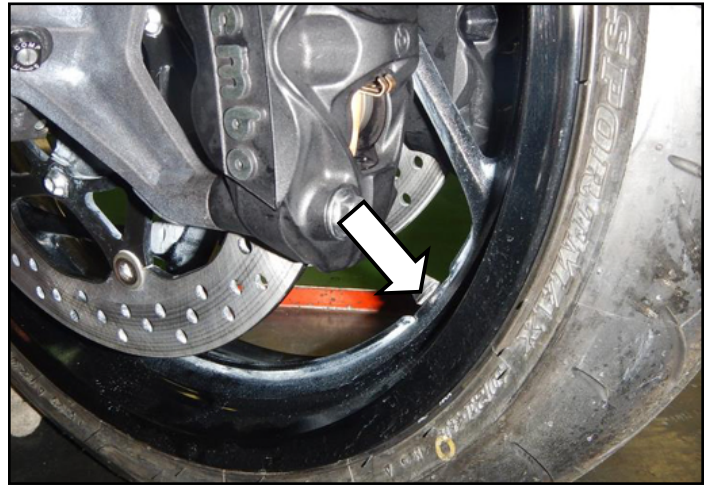
#3 Front Wheel Inspection

Inspect the front wheel for visible brake fluid or residue, and/or paint that may be peeling.

Be sure to inspect the entire circumference of the front wheel.

- A. If brake fluid is **not** visible on the front wheel and there is no evidence of paint that may be peeling or of paint damage, replace the front brake calipers and front brake discs.
- B. If the paint on the front wheel **is** peeling, replace the front brake calipers, front brake discs and the front wheel.

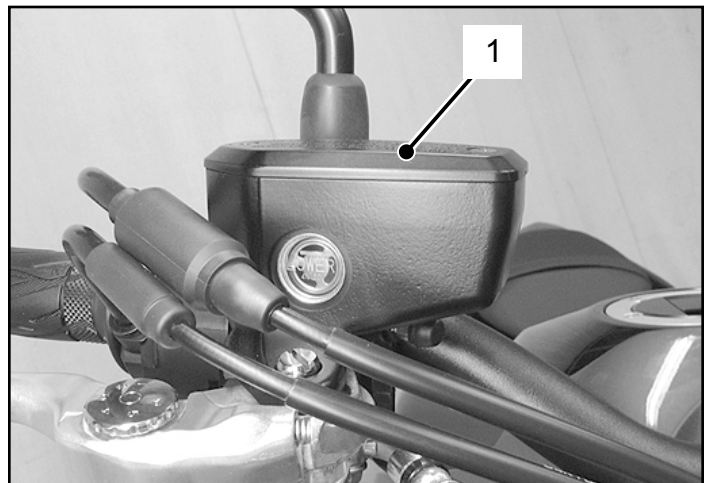
- 1) Place the motorcycle on a level surface and keep the handlebars straight.
- 2) Remove the brake fluid reservoir cap (1) and diaphragm.

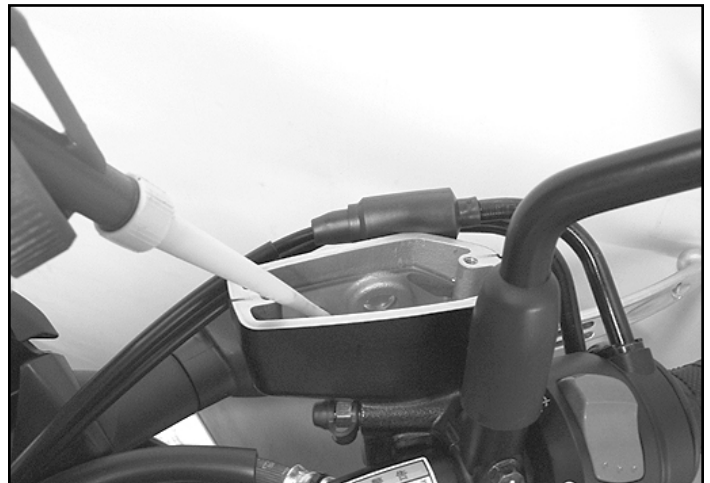
- 3) Remove the old brake fluid.

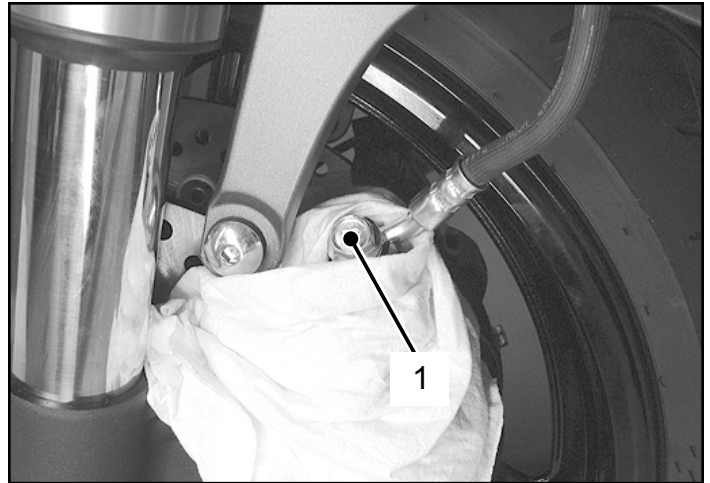
- 4) Place a shop towel under the brake caliper union bolt to absorb any spilled brake fluid.
- 5) Remove the brake hose from the caliper by removing the union bolt (1) and drain the brake fluid into a container.

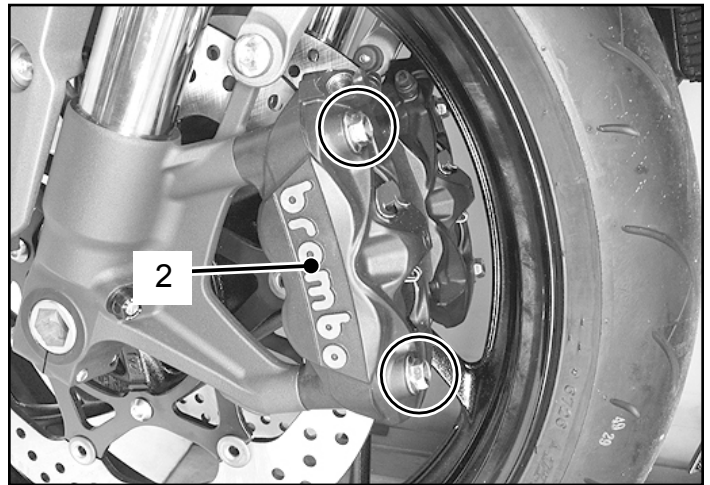
- 6) Remove the front brake caliper (2).

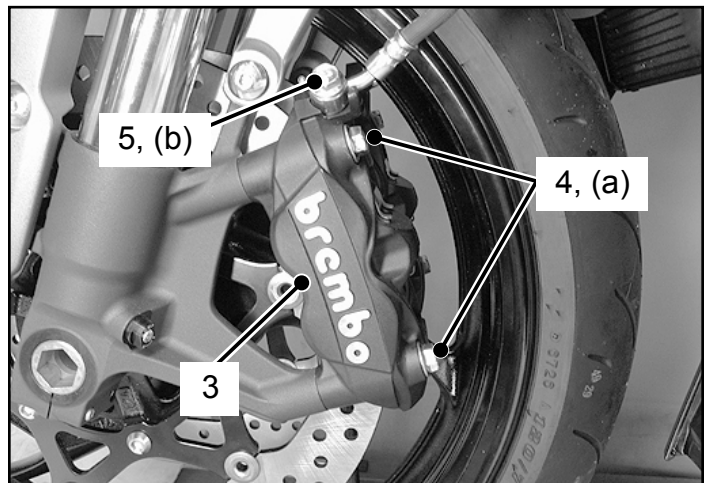
- 7) Install the new front brake caliper (3).
- 8) Tighten the front brake caliper mounting bolts (4) to the specified torque.

Front brake caliper mounting bolt (a):
39 N•m (4.0 kgf-m, 29.0 lbf-ft)

- 9) Install the brake hose union bolt (5) and new brake hose washers.
- 10) After setting the brake hose union to the stopper, tighten the union bolt (5) to the specified torque.

Brake hose union bolt (b):
23 N•m (2.3 kgf-m, 17.0 lbf-ft)

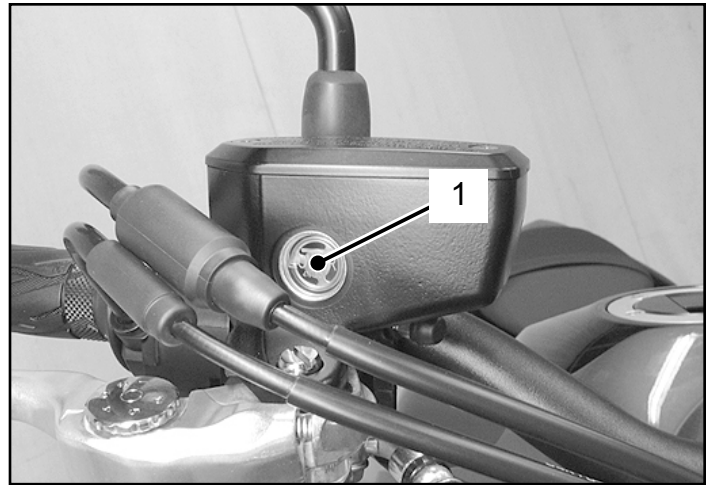
- 1) Remove the reservoir cap and diaphragm.
- 2) Fill the master cylinder reservoir with new DOT 4 brake fluid to the top of the inspection window (1).

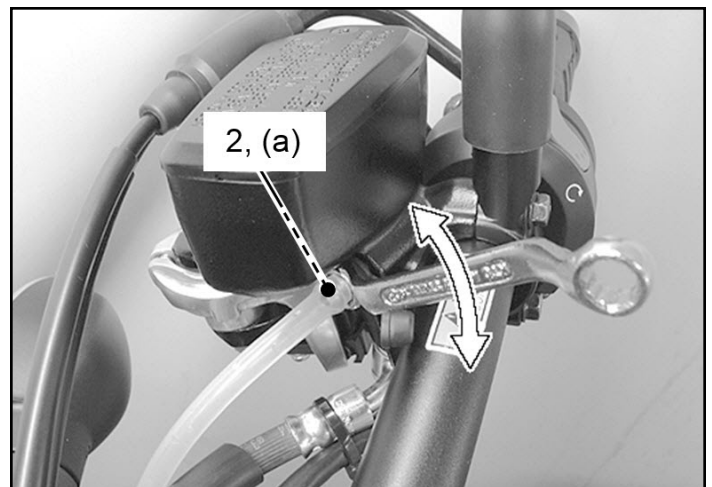
- 3) Attach a clear hose to the air bleeder valve (2) on the front brake master cylinder, and insert the free end of the hose into a container.

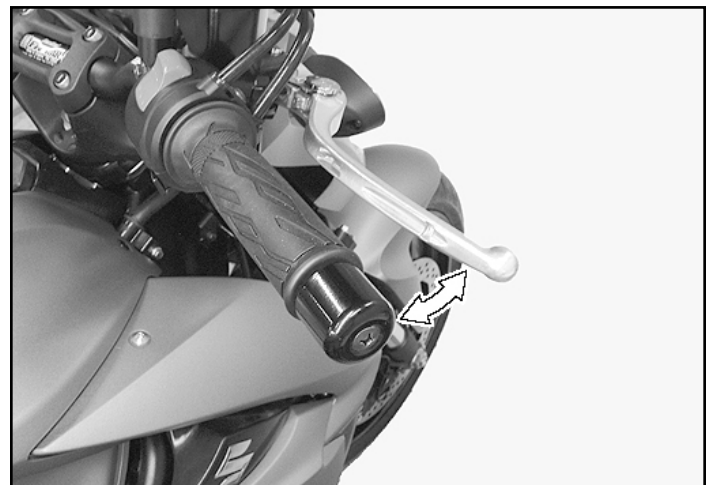
- 4) Pump the brake lever several times and, while keeping the lever pulled in, loosen the bleeder valve (2) and drain the brake fluid into a container.
- 5) Tighten the bleeder valve (2) and release the brake lever slowly.
- 6) Repeat the steps 5 and 6 until the fluid is flowing out without bubbles.
- 7) Tighten the bleeder valve (2) to the specified torque.

Front brake master cylinder air bleeder valve (a):

6.0 N•m (0.61 kgf-m, 4.45 lbf-ft)

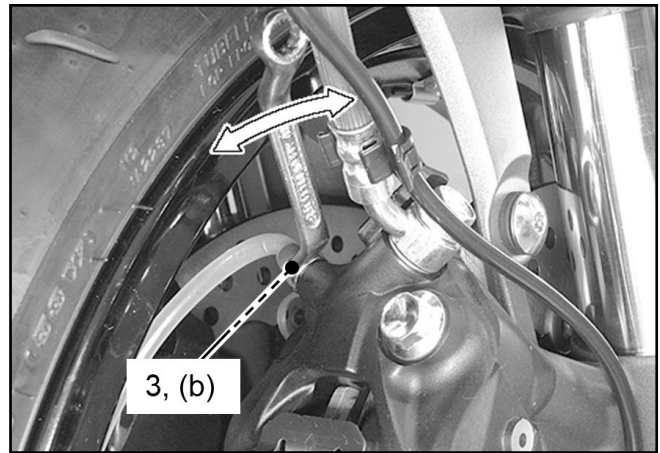
- 8) Starting at the left front brake caliper, attach a clear hose to the air bleeder valve on the brake caliper (3), and insert the free end of the hose into a container.

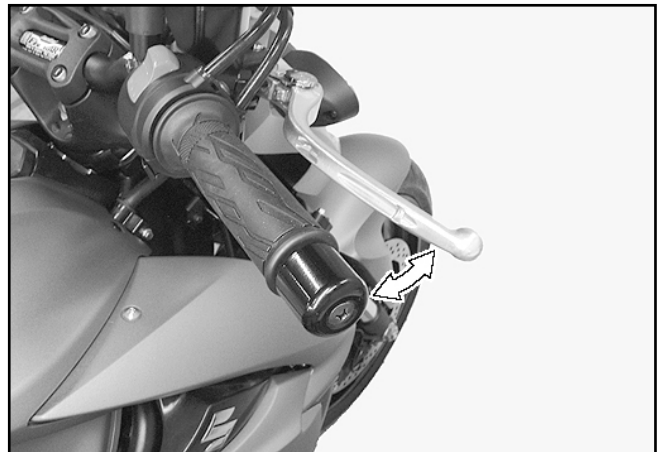
- 9) Pump the brake lever several times and, while keeping the lever pulled in, loosen the bleeder valve (3) and drain the brake fluid into a container.
- 10) Tighten the air bleeder valve (3) and release the brake lever slowly.
- 11) Repeat the steps 10 and 11 until the fluid is flowing out without bubbles.

- 12) Tighten the air bleeder valve (3) to the specified torque.

Front brake caliper air bleeder valve (b):
7.5 N•m (0.76 kgf-m, 5.55 lbf-ft)

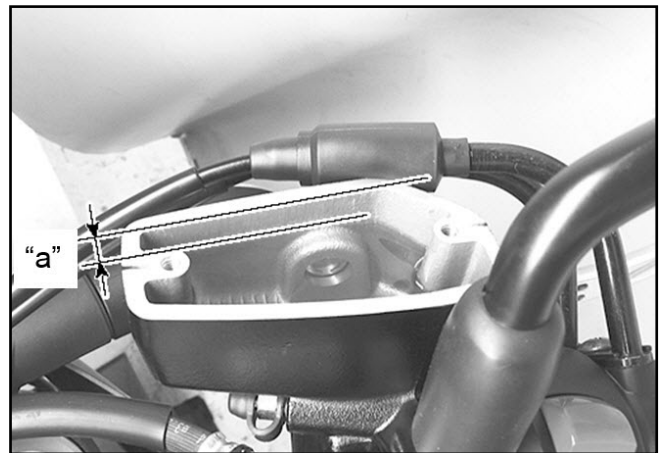
- 13) Repeat steps 9 - 13 on the right brake caliper.
- 14) Fill the reservoir with brake fluid to the depth "a" of 7 mm (0.3 in) from the reservoir tank edge.

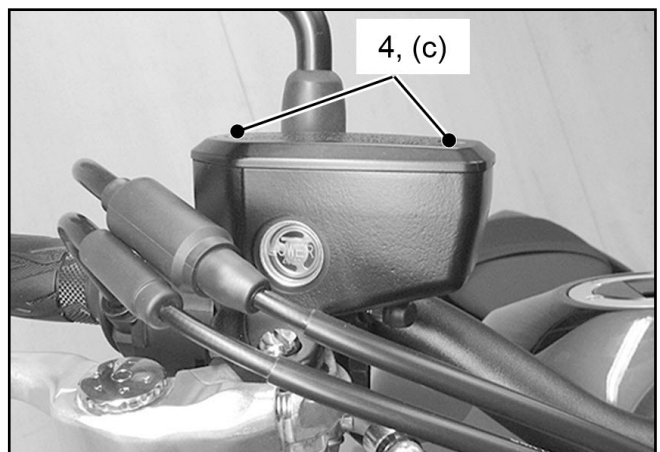
- 15) Install the diaphragm and reservoir cap.
- 16) Tighten the reservoir cap screws (4) to the specified torque.

Front reservoir cap screw (c):
1.5 N•m (0.15 kgf-m, 1.10 lbf-ft)

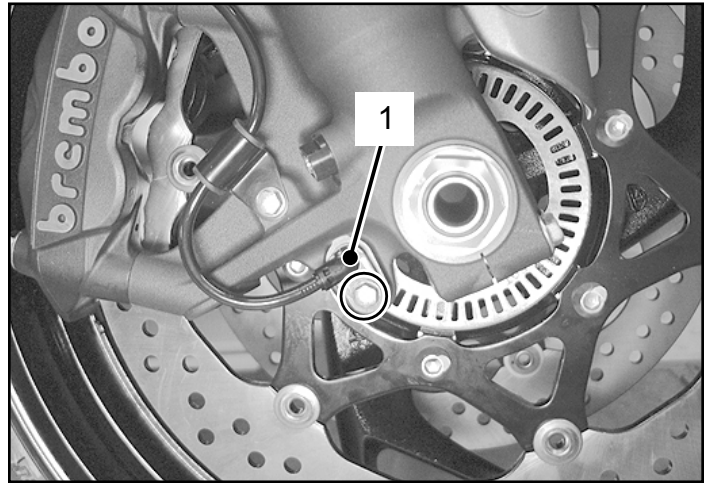
- 1) Remove the front wheel speed sensor (1).

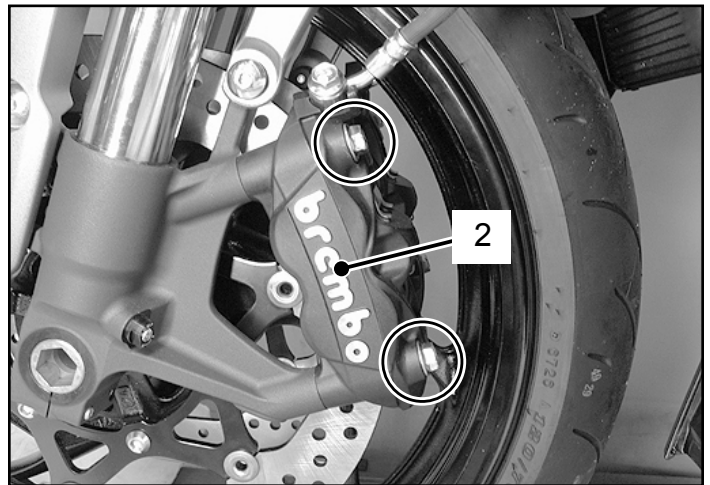
- 2) Remove the front brake calipers (2).

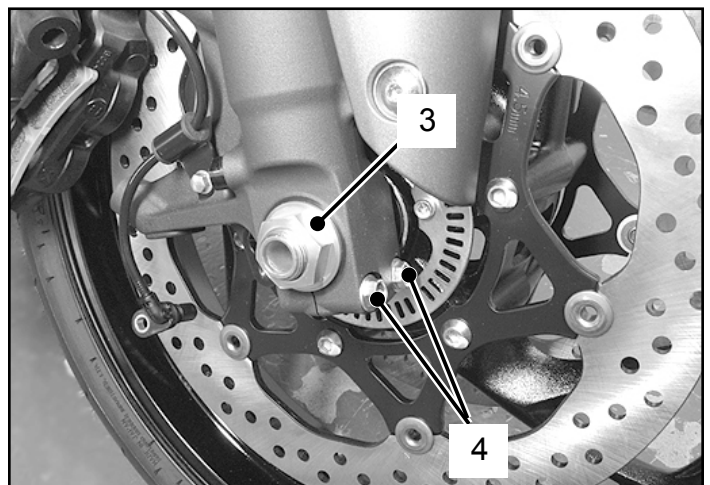
- 3) Remove the front axle nut (3).
- 4) Loosen the two axle pinch bolts (4) on the right front fork leg.
- 5) Raise and support the front wheel off the ground.

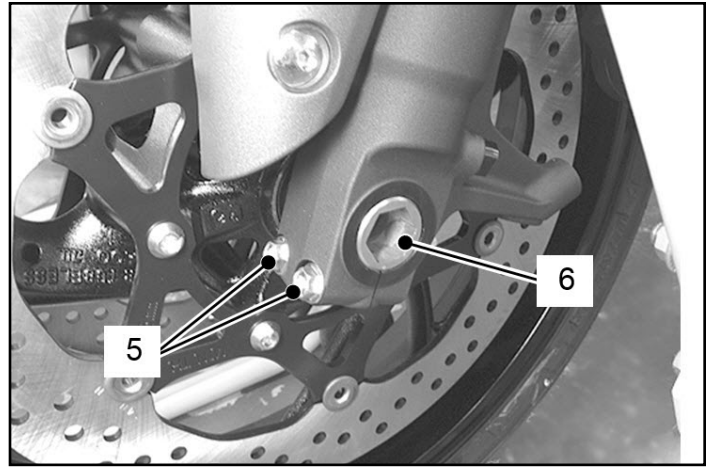
- 6) Loosen two axle pinch bolts (5) on the left front fork leg.
- 7) Draw out the front axle (6) and remove the front wheel.

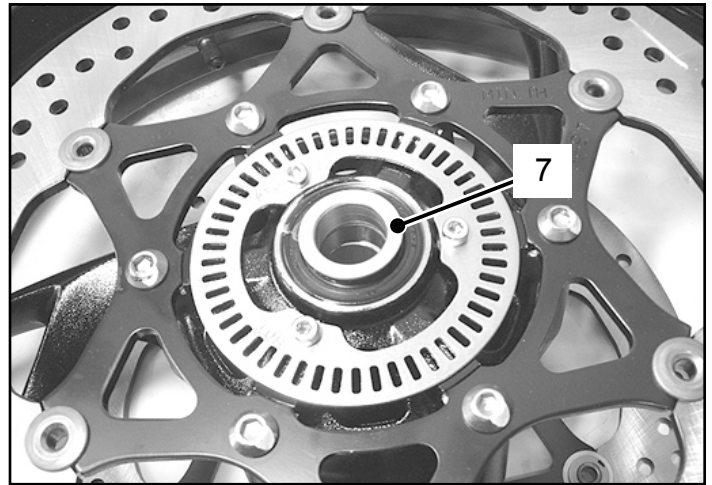
- 8) Remove the right-side spacer (7).

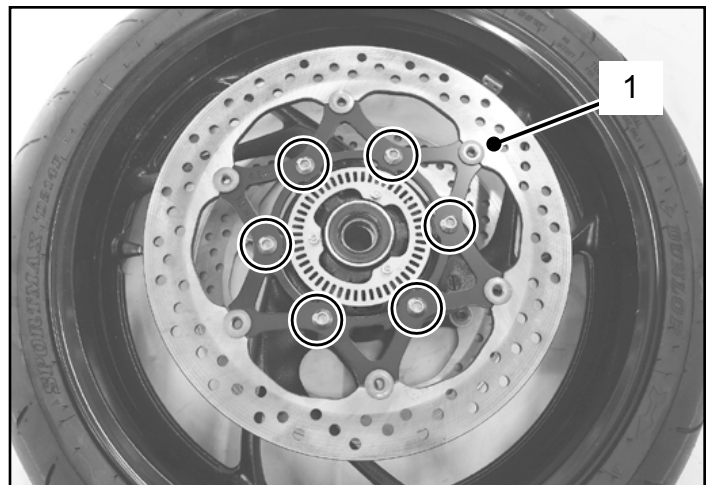
Only replace the front brake disc and disc bolts on the side of the wheel where the paint is peeling or brake fluid is visible.

- 9) Remove the front brake disc(s) (1).
- 10) Make sure the new front brake discs are clean and free of any grease.

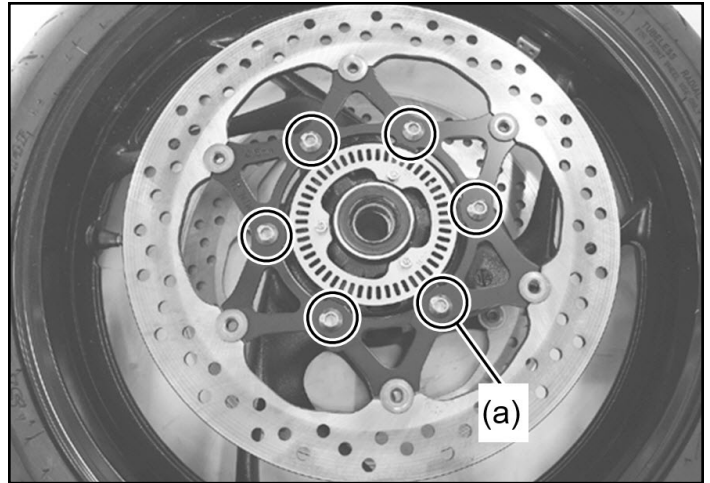
- 11) Install the new front brake disc(s) and new front brake disc bolts.
- 12) Tighten the front brake disc bolts to the specified torque.

18 N•m (1.8 kgf-m, 13.5 lbf-ft)

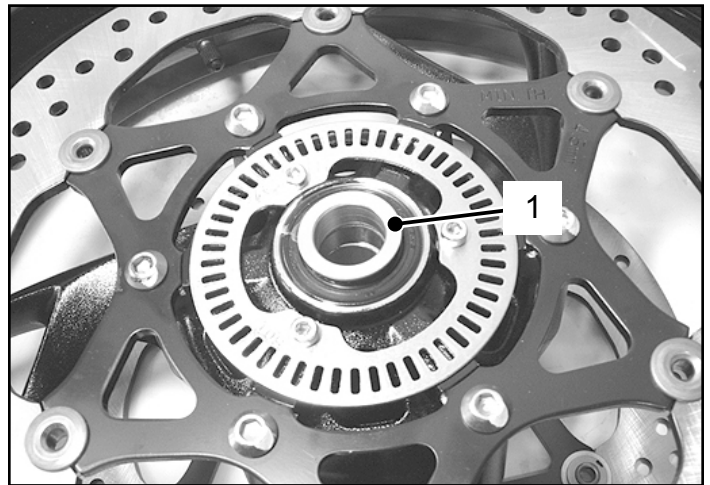
- 13) Install the spacer (1) into the right side of the wheel.

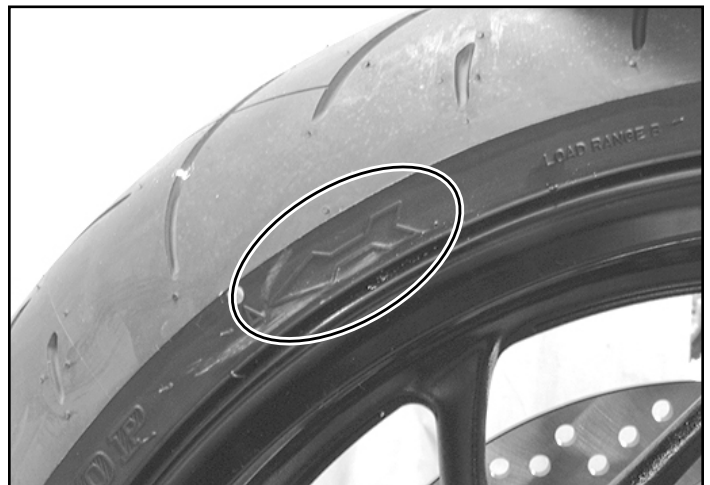
- 14) Install the front wheel with the front axle and temporarily tighten the front axle nut.

If the directional arrow on the tire is not pointing forward with the direction of wheel rotation, the tire may not function properly, resulting in a crash.

Be sure to install the tire on the wheel with the directional arrow pointing forward toward the direction of wheel rotation.

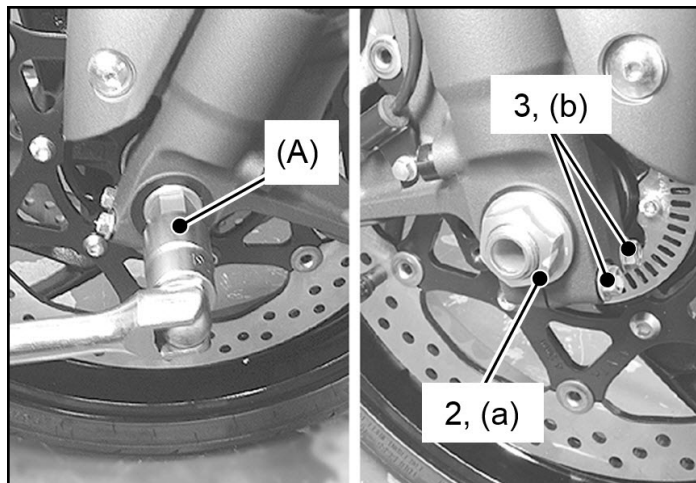
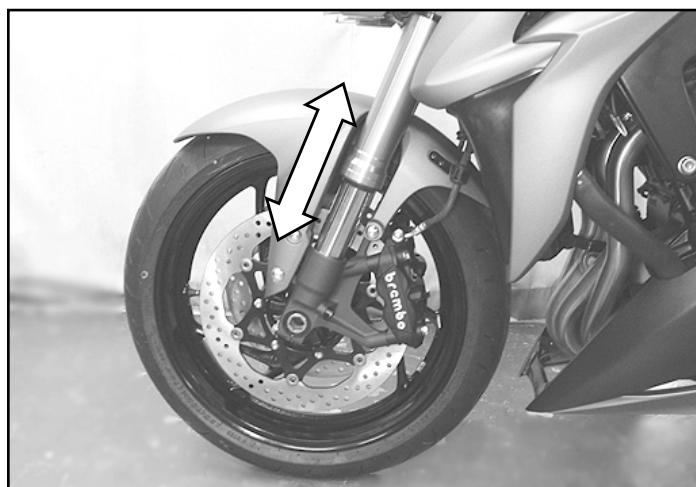
- 16) Hold the front axle with the special tool and tighten the front axle nut (2) to the specified torque.

Special tool
(A): 09944-28321

Tightening torque
Front axle nut (a):
100 N•m (10.2 kgf-m, 74.0 lbf-ft)

- 17) Tighten the two axle pinch bolts (3) on the right fork leg to the specified torque.

Tightening torque
Front axle pinch bolt (b):
23 N•m (2.3 kgf-m, 17.0 lbf-ft)

- 18) Move the front fork up and down 4 or 5 times to stabilize the front axle.

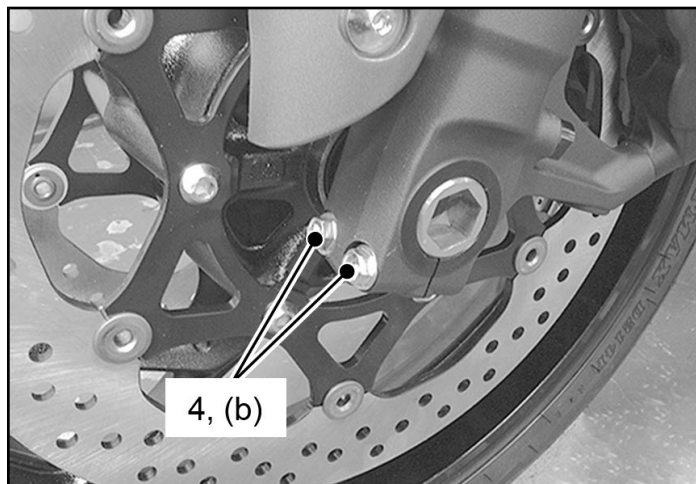
- 19) Tighten the two axle pinch bolts (4) on the left fork leg to the specified torque.

Tightening torque
Front axle pinch bolt (b):
23 N•m (2.3 kgf-m, 17.0 lbf-ft)

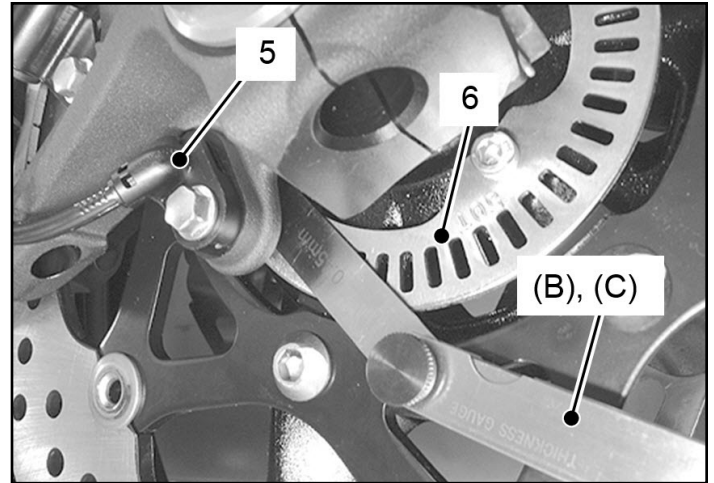
- 20) Install the front wheel speed sensor (5).
- 21) Check the clearance between the front wheel speed sensor (5) and sensor rotor (6) using the thickness gauge.

If the clearance is out of specification, check that the related parts have been installed correctly.

Front wheel speed sensor – Sensor rotor clearance

[Standard]: 0.38 – 1.05 mm

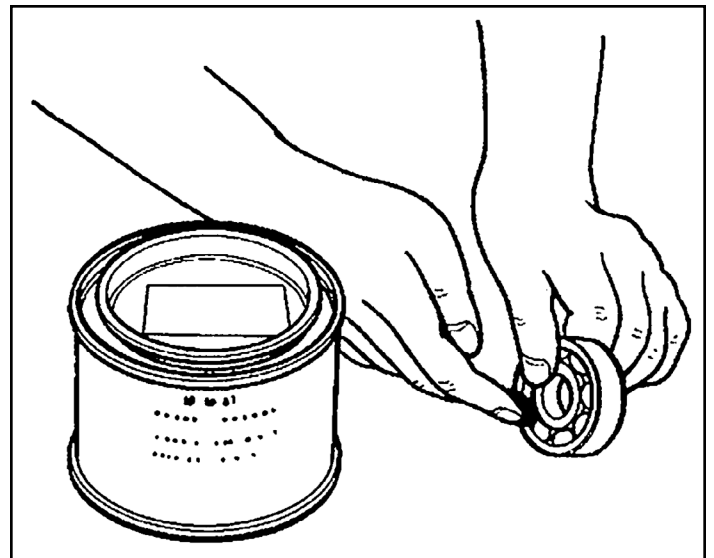
- 1) Remove the front wheel.
- 2) Remove the undamaged front brake discs. (You will re-install these later.)
- 3) Remove the front tire from the wheel.
- 4) Install the new air valve on the new front wheel.
- 5) Re-install the tire on the new front wheel.
- 6) Apply the new wheel tape to the new front wheel.
- 7) Apply grease to the new wheel bearings.

Grease 99000-25011 (SUZUKI SUPER GREASE A)

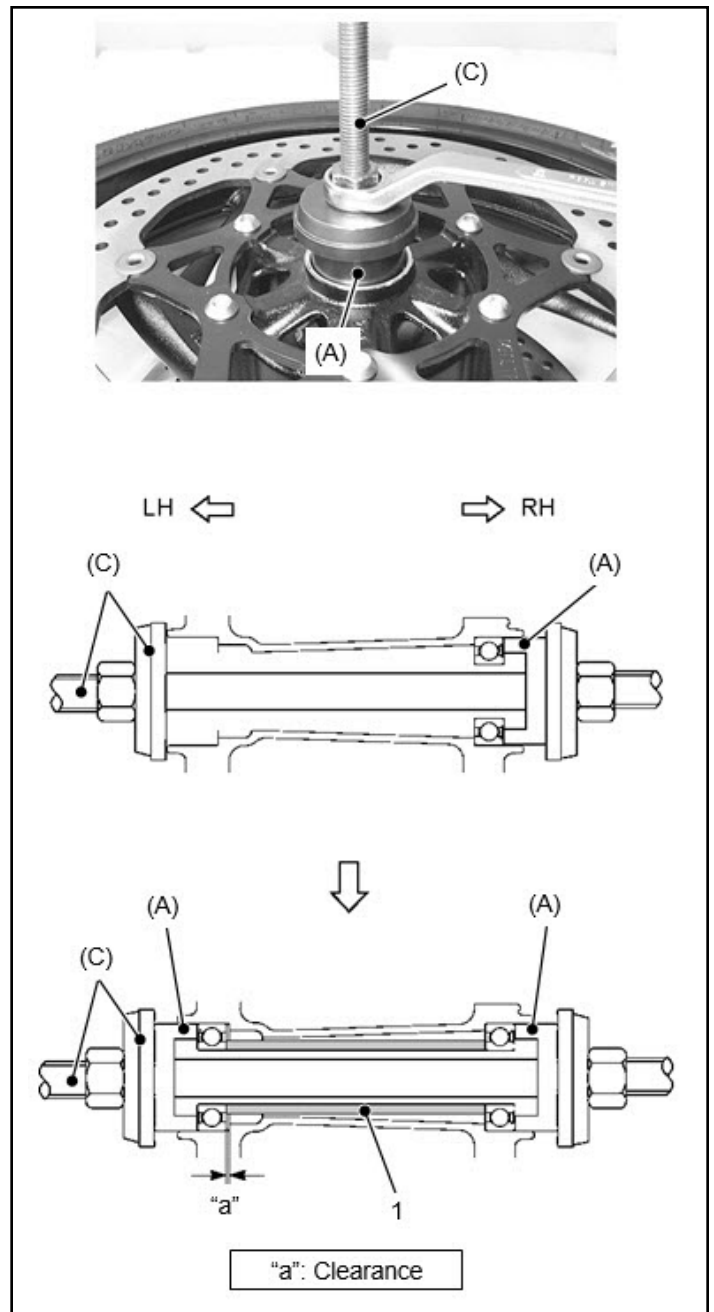
- 8) Install the new right wheel bearing, then install the new spacer (1) and new left wheel bearing with the special tools.

The sealed cover of the bearing must face outside.

(A): 09913-70210

(C): 09941-34513

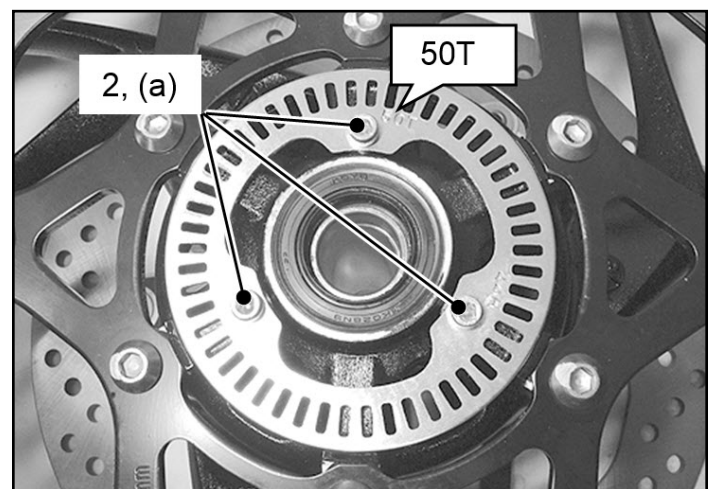
- 9) Install the new front brake disc(s) or re-install the old discs if they are undamaged.

Install the new front wheel speed sensor rotor with the letters "50T" facing outside.

Tighten the new front wheel speed sensor rotor bolts (2) to the specified torque.

6.5 N•m (0.66 kgf-m, 4.80 lbf-ft)

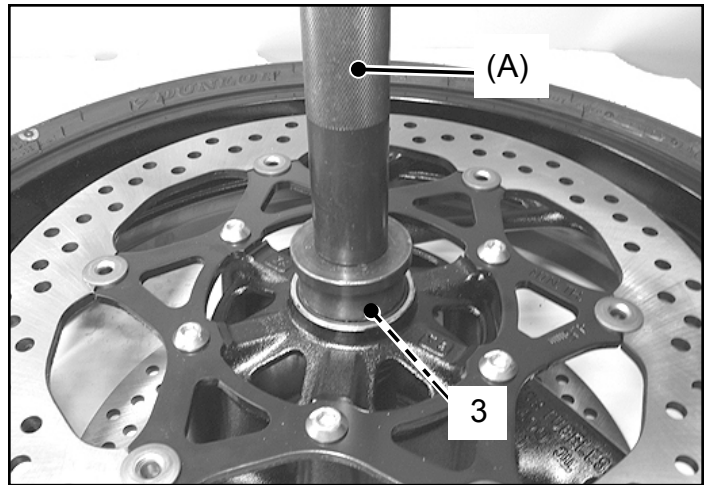
- 10) Install the new dust seals (3) on both sides with the special tool.

Special tool
(A): 09913-70210

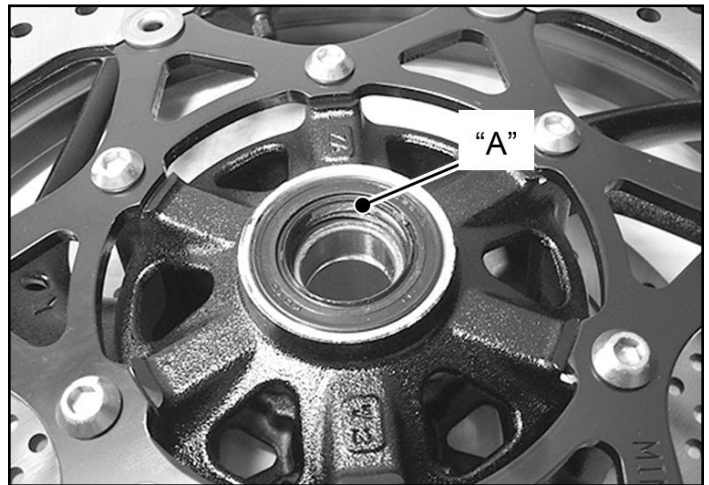
- 11) Apply grease to the lip of the dust seals.

“A”: Grease 99000-25011 (SUZUKI SUPER GREASE A)

- 12) Adjust the tire balance.
13) Install the front wheel.
