# Recall Campaign

February 2016  
FL697A-E  
NHTSA #15V-842  
Transport Canada #15-015

## Subject: TBB Spectal Pushout Windows

**Models Affected:** Specific Saf-T-Liner C2 model vehicles manufactured May 1, 2015, through August 1, 2015, with certain Spectal tempered glass pushout windows.

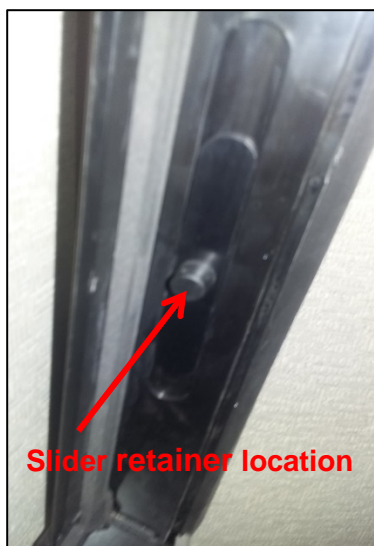
Figure 1, Slide Retainer Installation

1. Turn the vehicle off, place in park, and chock the wheels.
2. Open the emergency window and locate slider retainer. See **Figure 1**.

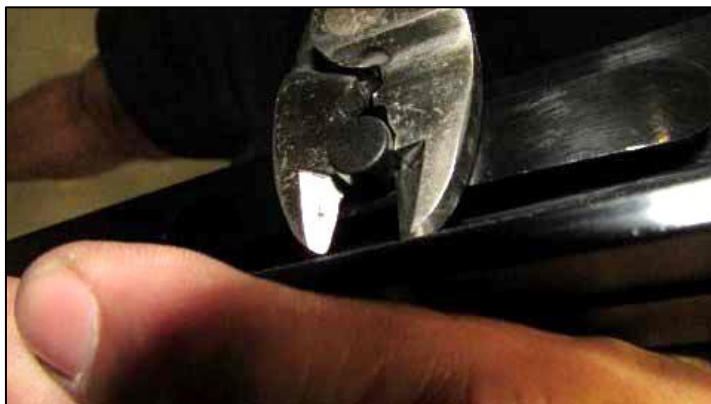
**Figure 2 Removing the Lower Slider Retainer**

NOTE: When using pliers, be sure not to damage the window frame.

3. Remove the lower slider retainer using a pair of pliers. Discard old retainer. See **Figure 2**.

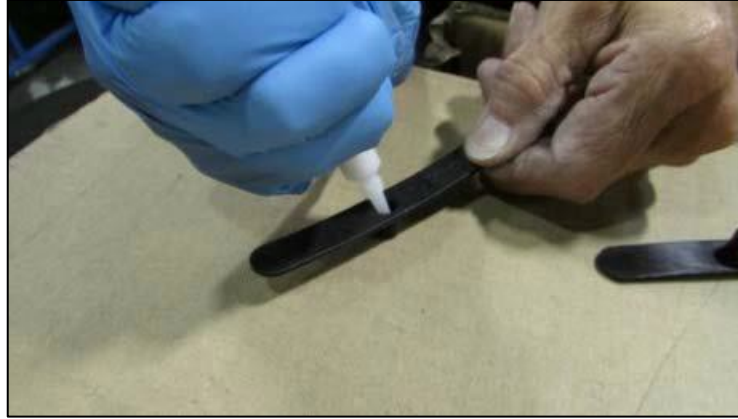
**Figure 4: Filling Retainer Cavity Halfway**

NOTE: If the retainer cavity is overfilled, the excess glue can seep into other parts of the window causing incorrect operation.

5. Using the new retainer, turn over and locate the cavity where glue will be applied. Using a recommended glue, fill cavity at most halfway. See **Figure 4** and **Table 1**.

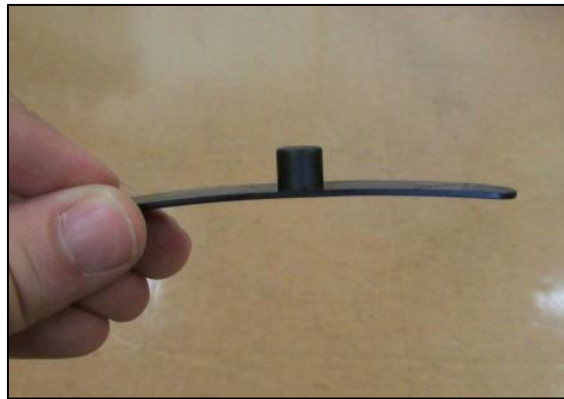
**Figure 5: Testing the Viscosity of the Glue**

6. Once the glue is inserted, make sure the viscosity of the glue is correct. Turn the slider retainer upside down. The glue should not drip out of the cavity. See **Figure 5**. If it does, use the other recommended glue shown in **Table 1**

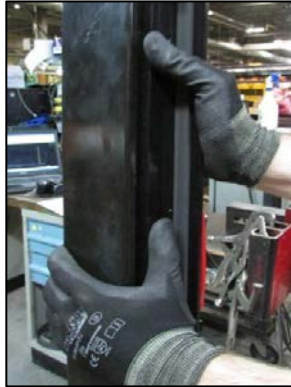
**Figure 6, Pushing Handle-Side Window Frame Against the Bus Structure**

7. Push evenly on the frame section that has the handle. This pushes the pins out to make it easier to install. See **Figure 6**.

8. Using a rubber hammer, install the retainer on the pin. Make sure the retainer is properly installed. No space should be between the slide of the retainer and the window frame
9. After 30 seconds test locking mechanism to make sure window works properly.
10. Close window and lock. Repeat for all affected windows.
11. When all windows are complete, remove the chocks from the wheels.
