SUBJECT: SAFETY RECALL: FRONT AXLE BRAKE HOSE ROUTING

Ref.: **NHTSA # 15V-001**

Service Bulletin No. 420

MODEL	J4500 Series	TYPE	Field Change Program	SECTION/GROUP	1-Front Axle	DATE	March 2, 2015
SUBJECT	FRONT AXLE BRAKE HOSE ROUTING						
CONDITIONS

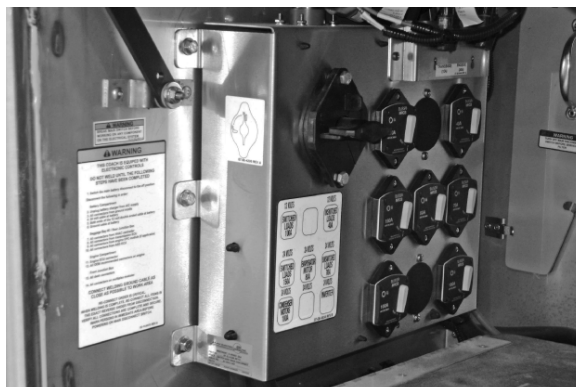
Figure 2. Battery compartment.

- a. Turn the Main Disconnect Switch (MDS) OFF.
- b. Turn all circuit breakers to the OFF position.
- c. Disconnect all battery and equalizer cables.

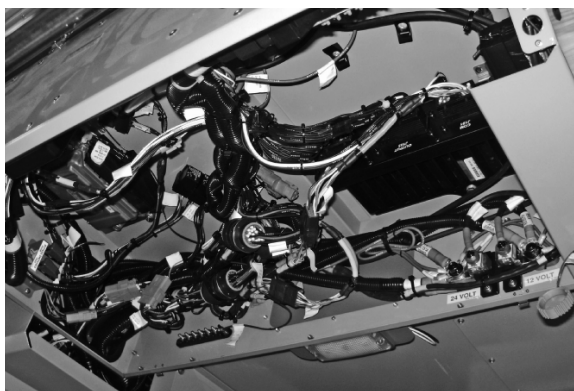
Figure 6. Rear junction box.

- a. Disconnect all connectors from PMM3.
- b. Disconnect all connectors from the transmission Electronic Control Unit (ECU).
- c. Disconnect all connectors from the engine Electronic Control Module (ECM).
- d. Disconnect all connectors from the Antilock Brake System (ABS) module.

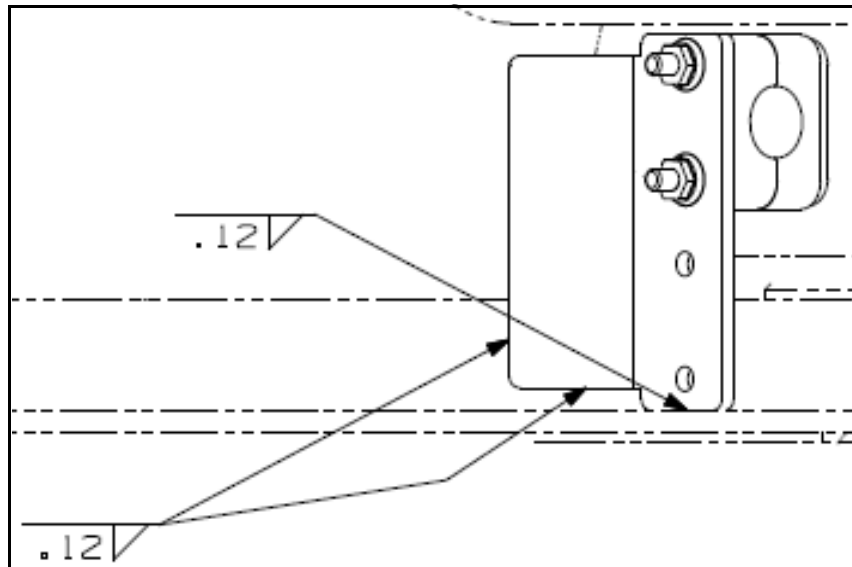
Figure 7. Clamp mount bracket weld symbols.

10. Cut and discard the tyrap securing the ABS sensor to the front brake hose assembly. Disconnect the front brake hose assembly from the front axle brake chamber port. Discard the existing front brake hose assembly. Retain the mounting hardware to be re-installed at a later step in this procedure.
11. Position the new clamp mount bracket, p/n 03-53-1618, on the bogie channel as outlined as Item 1 / Figure 8. Mark a chalk outline around the entire bracket. Remove bracket. Repeat step to opposite side.
12. Using a wire brush, thoroughly clean the surface area of dirt or grease from the installation area where the brackets will be welded.
13. Weld the clamp mount bracket according to the weld symbol in Figure 7, using the following method,

SHIELDED METAL ARC WELDING (SMAW)

Stainless Steel - Alloy type, 309L / 1/8 inch, 80A-100A

GAS METAL ARC WELDING (GMAW)

Stainless Steel - Alloy type, 309L / 0.035 Dia., 300-350 IPM, 23V-25V.

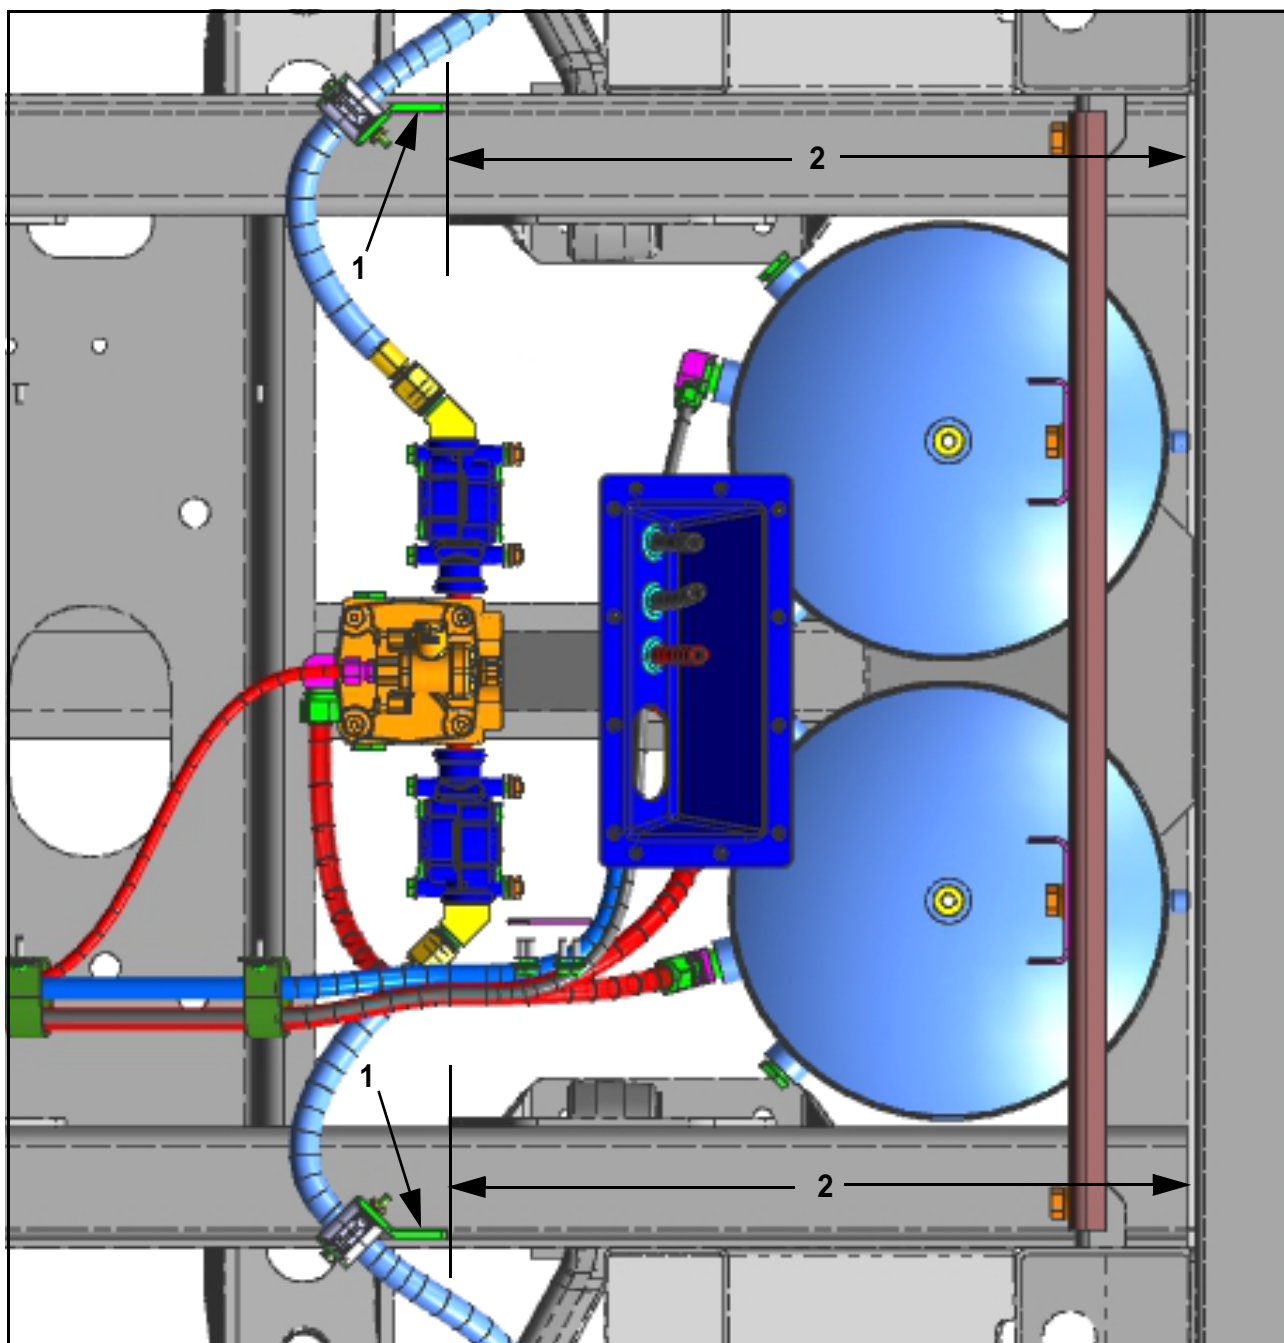
Figure 8. Clamp mount bracket location.

Item	Figure 8 Description
1	clamp mount bracket, p/n 03-53-1618
2	20.75 inch

25. Route the front brake hose assembly to the clamp mount bracket welded to the bogie channel. Remove and retain clamp assembly and the existing mounting hardware from the old mounting location (replaced by the new welded clamp mount bracket). Mount the clamp assembly and front brake hose assembly to the clamp mount bracket. Tighten clamp to secure the front brake hose assembly in position (refer to Figure 8).

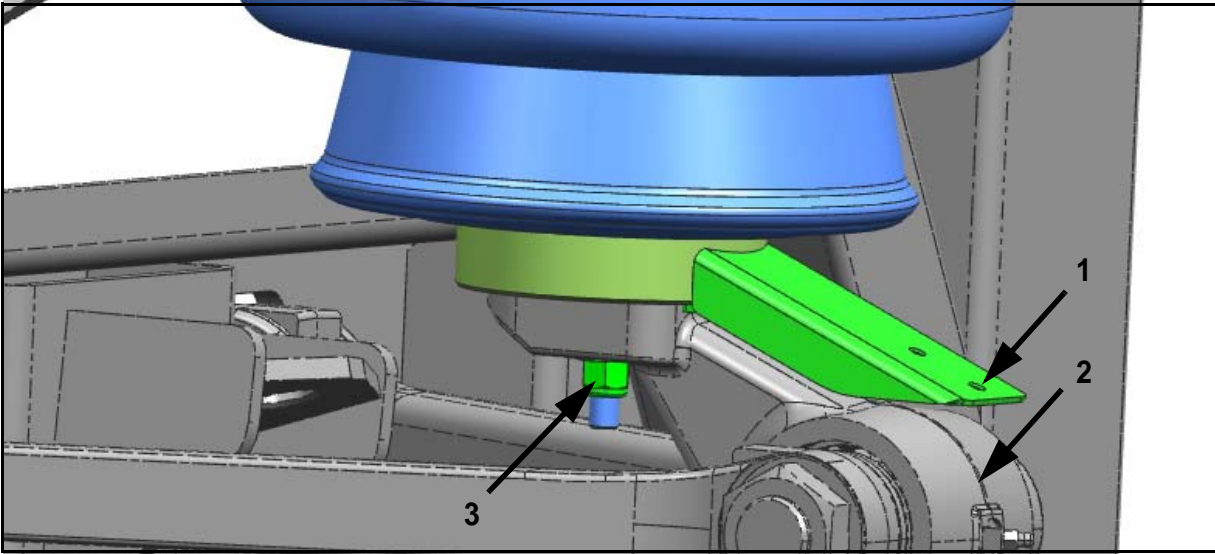
Figure 9.

Item	Figure 9 Description
1	brake hose clamp holes
2	center of kingpin
3	nylock nut

15. Using a square or straight edge, ensure that the geometry of the first brake hose clamp is parallel to the center of the kingpin (refer to Figures 9 and 11)

If adjustment is required, loosen (do not remove nut from stud) the nylock nut on the airspring assembly and orient to achieve the brake hose clamp parallel to the center of the kingpin (refer to Figure 9). Torque nylock nut to 40-50 ft-lbs.

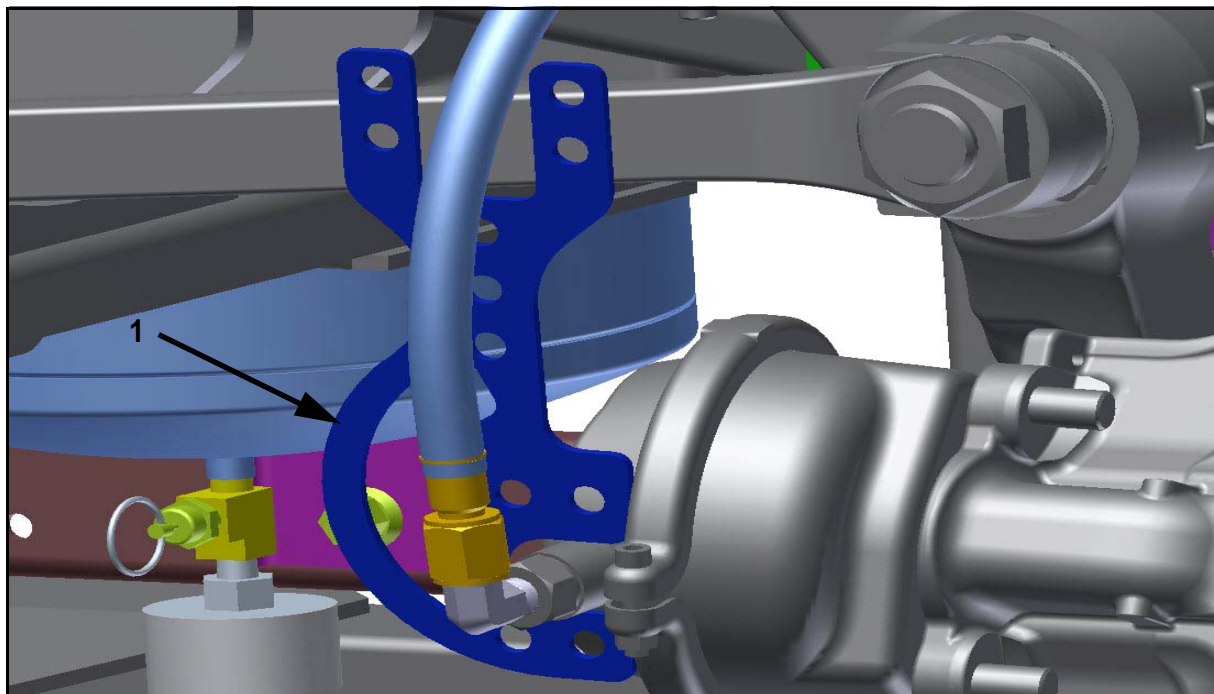
Figure 10. Front brake line gauge location.

Item	Figure 10 Description
1	front brake line gauge

16. Apply drops of lubricant to the swivel section on the new front brake hose assembly, p/n 04-20-1726.
17. Orient and connect the new front brake hose assembly to the 90 degree fitting on the front brake chamber as shown in Figure 10.
18. Starting at the front brake chamber, route the front brake hose assembly to the first brake hose bracket (refer to Figure 11). Using the existing mounting hardware, mount (fingertight) the clamp assembly to the brake hose bracket.
19. Orient the front brake line gauge, p/n 20-04-0028, against the front brake chamber clamp as shown in Figure 10. Center the hose routing with the upper opening of the front brake line gauge and tighten the swivel nut to secure in position, ensuring that there is no twist or flex at any point throughout the routing. Torque nut to 56-60 ft-lbs.

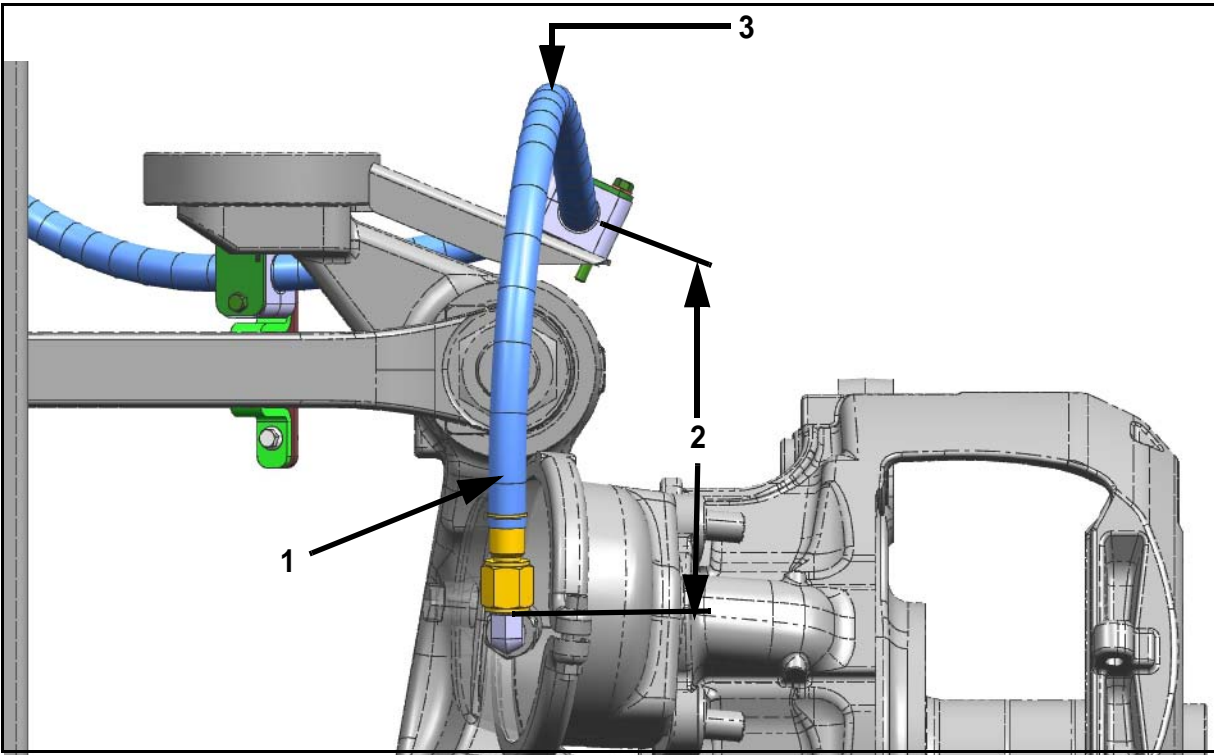
Item	Figure 11 Description
1	front brake hose assembly, p/n 04-20-1726
2	22.00 inch of hose length from bottom of swivel fitting to inside face of clamp
3	measurement to be taken along the top section of the front brake hose assembly

20. Using a measuring tape, ensure that the front brake hose length is the 22.00 inches between the bottom of the swivel fitting to the inside face of the clamp as shown in Figure 11. Tighten clamp to secure in position.

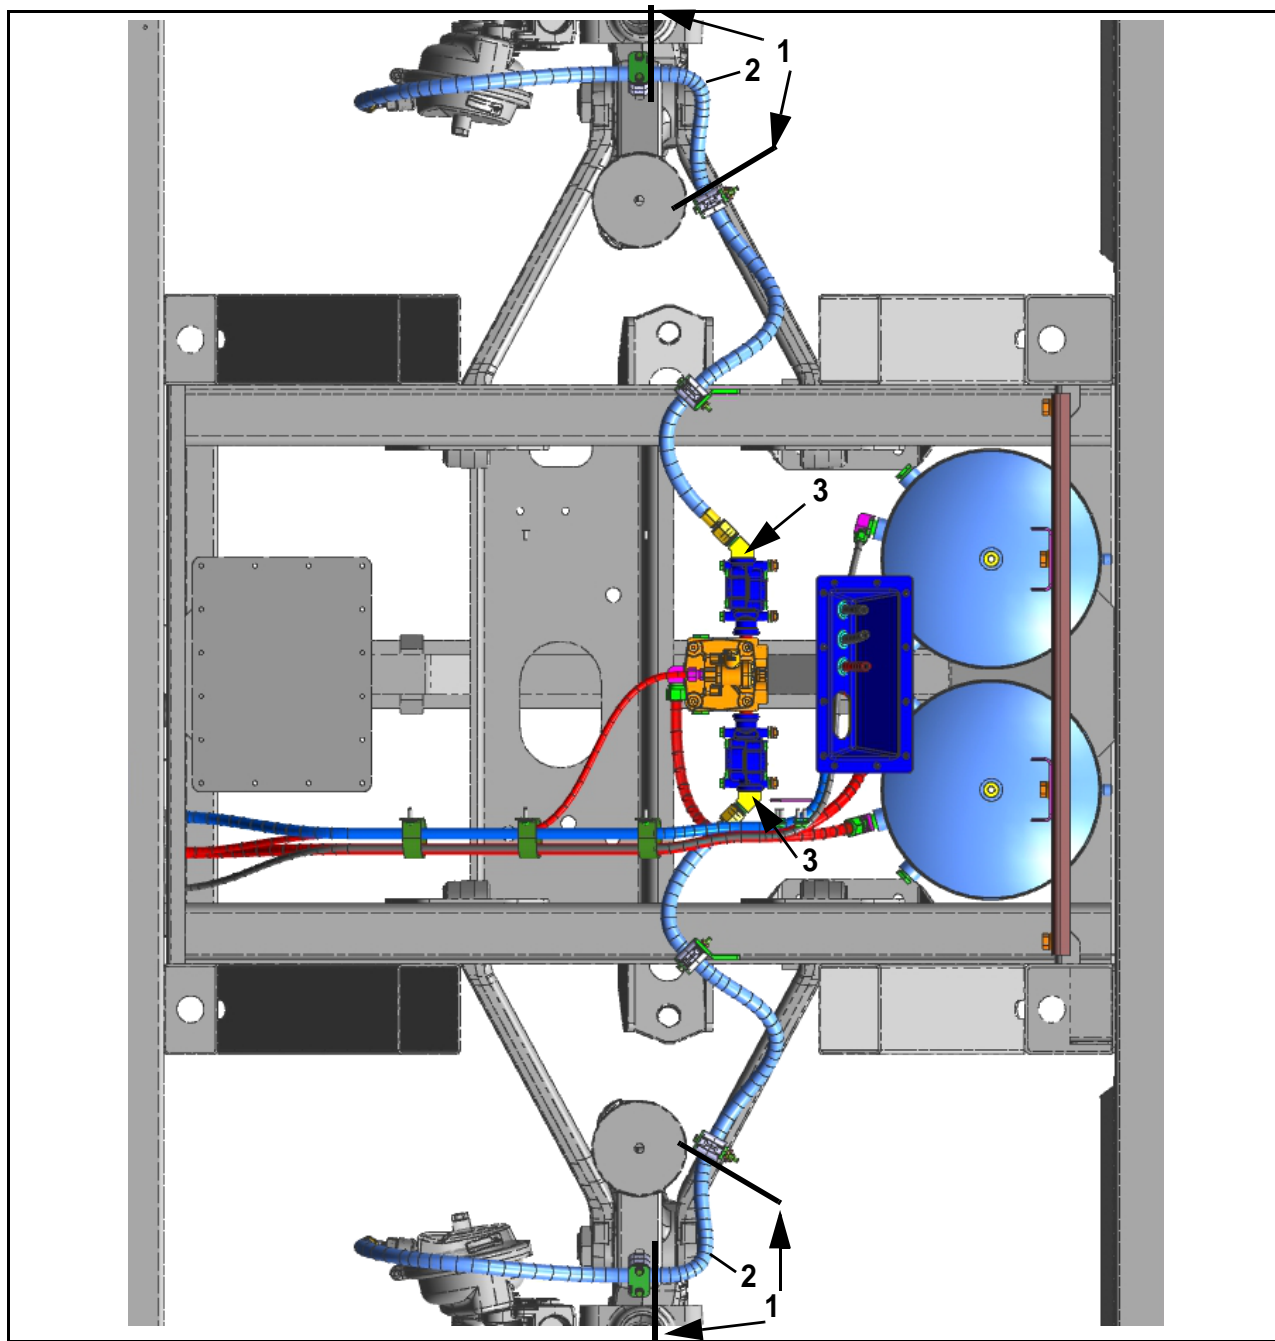
Item	Figure 12 Description
1	8.00 to 8.25 inches of hose length from face to face of clamps
2	measurement to be taken along the outboard section of the front brake hose assembly
3	45 degree fitting, p/n 19-10-1956

21. Route the front brake hose assembly to the next (second) brake hose bracket. Using the existing mounting hardware, mount the clamp assembly to the brake hose bracket.
22. Using a measuring tape, ensure that the front brake hose assembly routing length is the 8.00 to 8.25 inches of hose length from face to face of the clamps while maintaining a minimum bend radius of 2.25 inches as shown in Figure 12.
23. Tighten clamps to secure in position.

26. Using two (2) wrenches, remove and discard the straight fitting from the front brake module. Apply a pair of drops of sealant to the NPT threads of the 45 degree fitting, p/n 19-10-1956. Install the 45 degree fitting, fingertight, in the front brake module as shown in Figure 12. Using two (2) wrenches, tighten the fitting 2.50 turns. Tighten fitting to orientation shown in Figure 12.

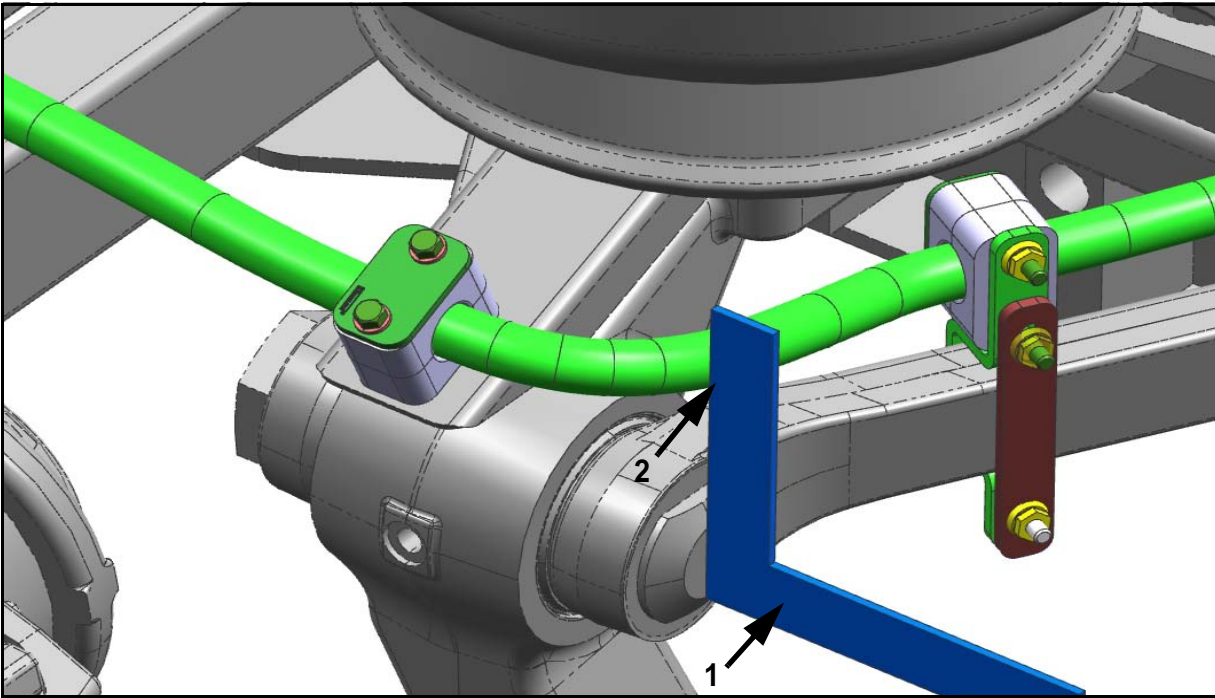
Figure 13.

Item	Figure 13 Description
1	position square across the face of the suspension arm bolt head
2	minimum clearance of 0.06 inch between the edge of the front brake hose assembly and the edge of the square

24. Position a square across the face of the suspension arm bolt head (refer to Figure 13). Using a measuring tape, ensure that there is a minimum clearance of 0.06 inch between the edge of the front brake hose assembly and the edge of the square.

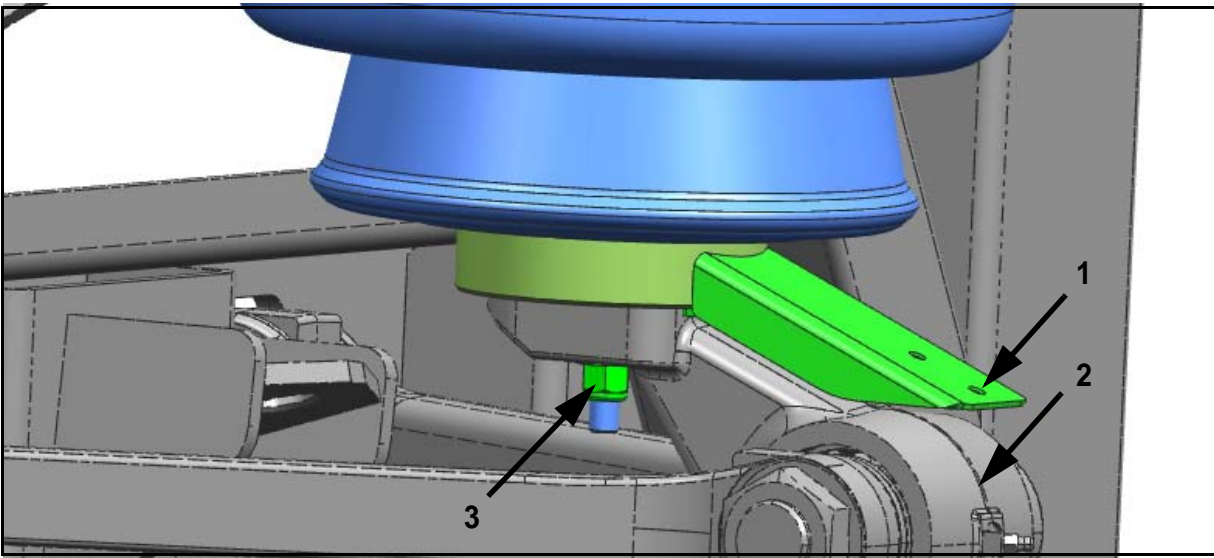
Figure 14.

Item	Figure 14 Description
1	brake hose clamp holes
2	center of kingpin
3	nylock nut

35. Cut and discard the tyrap securing the ABS sensor to the front brake hose assembly.
36. Disconnect the front brake hose assembly from the front axle brake chamber port. Discard the existing front brake hose assembly. Retain the mounting hardware to be re-installed at a later step in this procedure.
37. Using a square or straight edge, ensure that the geometry of the first brake hose clamp is parallel to the center of the kingpin (refer to Figures 14 and 16).

If adjustment is required, loosen (do not remove nut from stud) the nylock nut on the airspring assembly and orient to achieve the brake hose clamp parallel to the center of the kingpin (refer to Figure 14). Torque nylock nut to 40-50 ft-lbs.

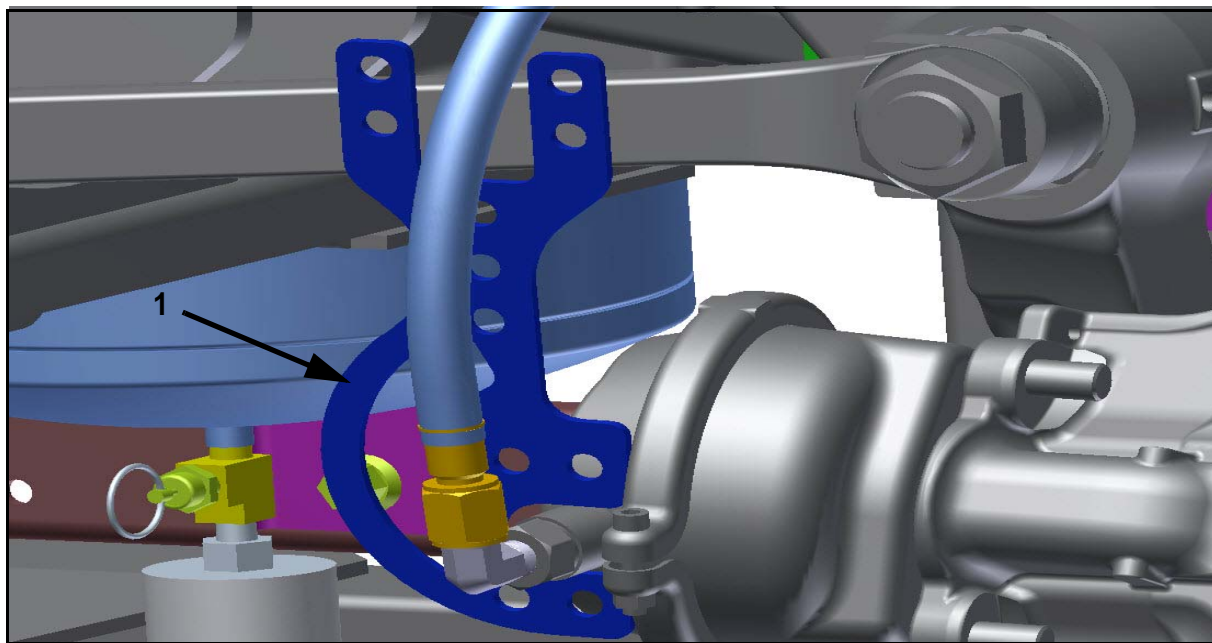
Item	Figure 15 Description
1	front brake line gauge

38. Apply a pair of drops of lubricant to the swivel section on the new front brake hose assembly, p/n 04-20-1726.
39. Orient and connect the new front brake hose assembly to the 90 degree fitting on the front brake chamber as shown in Figure 15.
40. Starting at the front brake chamber, route the front brake hose assembly to the first brake hose bracket (refer to Figure 16). Using the existing mounting hardware, mount (fingertight) the clamp assembly to the brake hose bracket.
41. Orient the front brake line gauge, p/n 20-04-0028, against the front brake chamber clamp as shown in Figure 15. Center the hose routing with the upper opening of the brake line alignment tool and tighten the swivel nut to secure in position, ensuring that there is no twist or flex at any point throughout the routing.

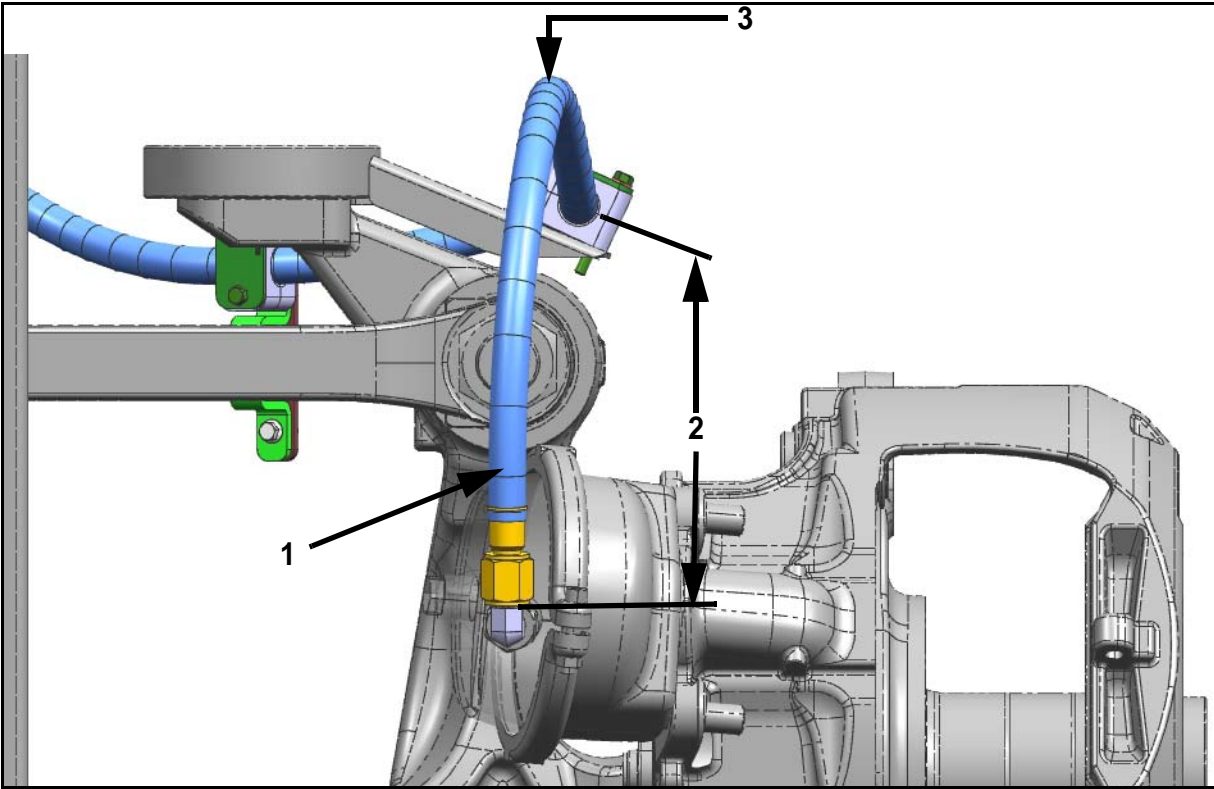
Item	Figure 16 Description
1	front brake hose assembly, p/n 04-20-1726
2	22.00 inch of hose length from bottom of fitting to inside face of clamp
3	measurement to be taken along the top section of the front brake hose assembly

42. Using a measuring tape, ensure that the front brake hose length is the 22.00 inches between the bottom of the swivel fitting to the inside face of the clamp as shown in Figure 16. Tighten clamp to secure in position.

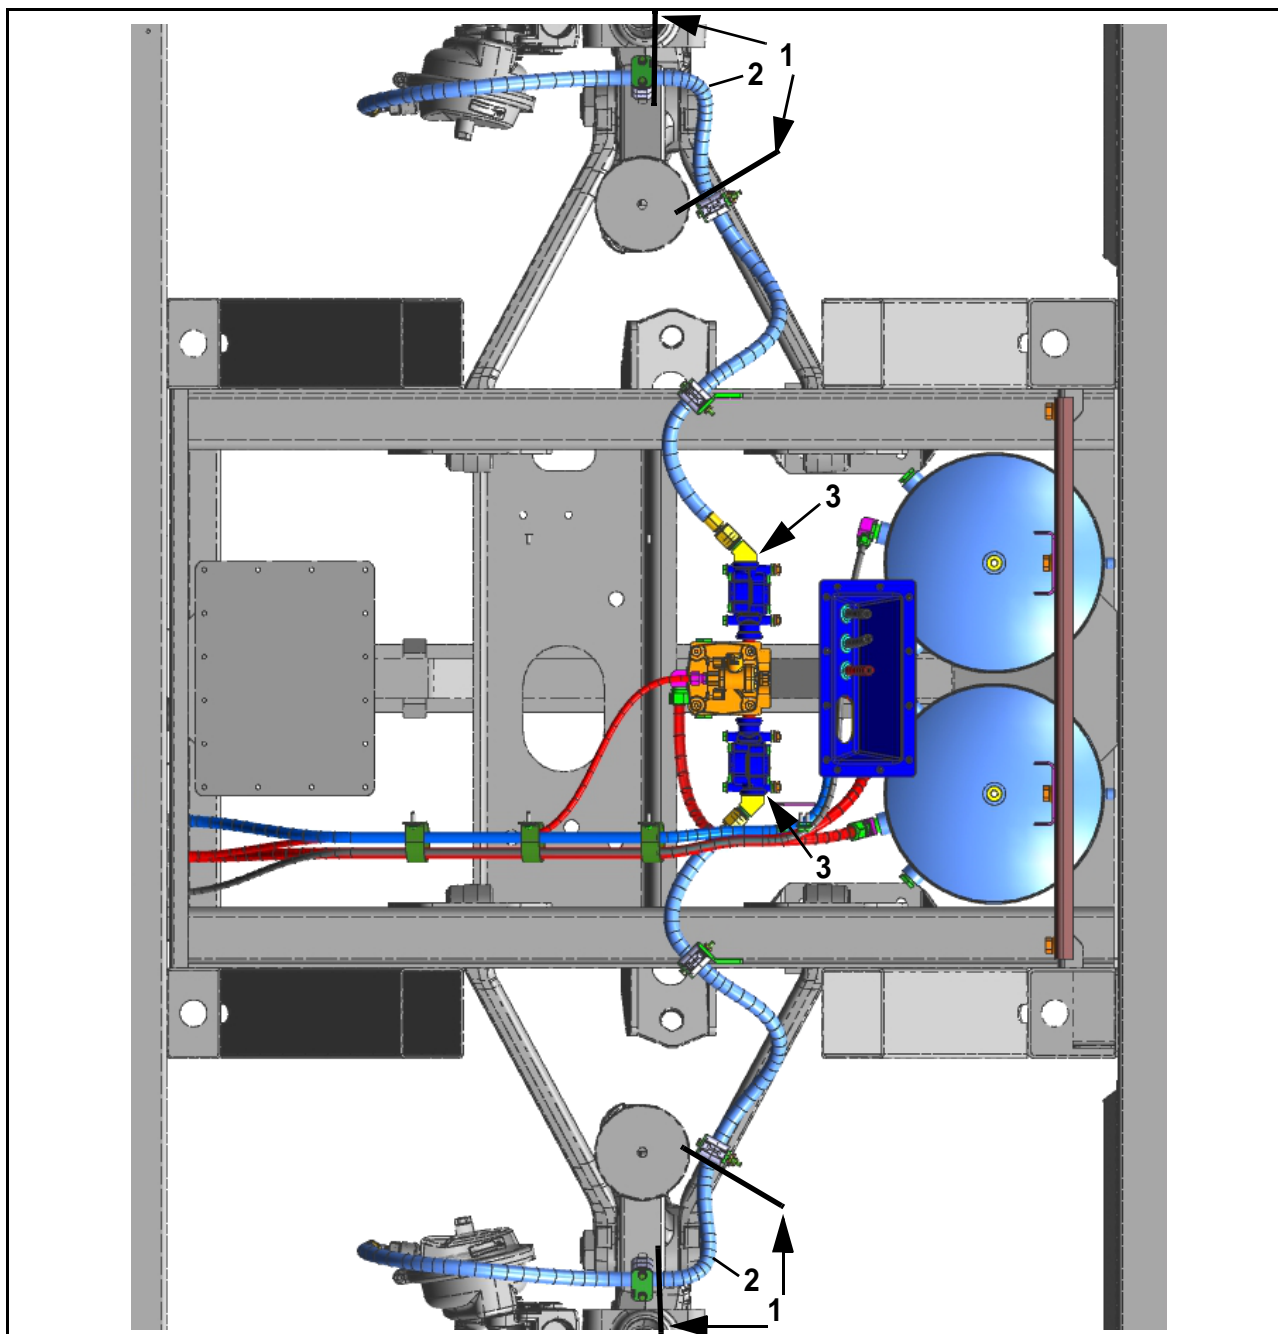
Item	Figure 17 Description
1	8.00 to 8.25 inches of hose length from face to face of clamps
2	measurement to be taken along the outboard section of the front brake hose assembly
3	45 degree fitting on the front brake module valve

43. Route the front brake hose assembly to the next (second) brake hose bracket. Using the existing mounting hardware, mount the clamp assembly to the brake hose bracket.
44. Using a measuring tape, ensure that the front brake hose assembly routing length is the 8.00 to 8.25 inches of hose length from face to face of the clamps while maintaining a minimum bend radius of 2.25 inches as shown in Figure 17.
45. Tighten clamps to secure in position.

47. Route the front brake hose assembly to the next brake hose bracket. Tighten clamp to secure the front brake hose assembly in position (refer to Figure 17).
48. Orient and connect, using two (2) wrenches, the end of the brake hose assembly to the 45 degree fitting on the front brake module valve(refer to Figure 17). Torque to 56-60 ft-lbs.
49. Using tyrap, secure the ABS sensor to the front brake hose assembly.
50. Repeat steps to opposite side of coach.

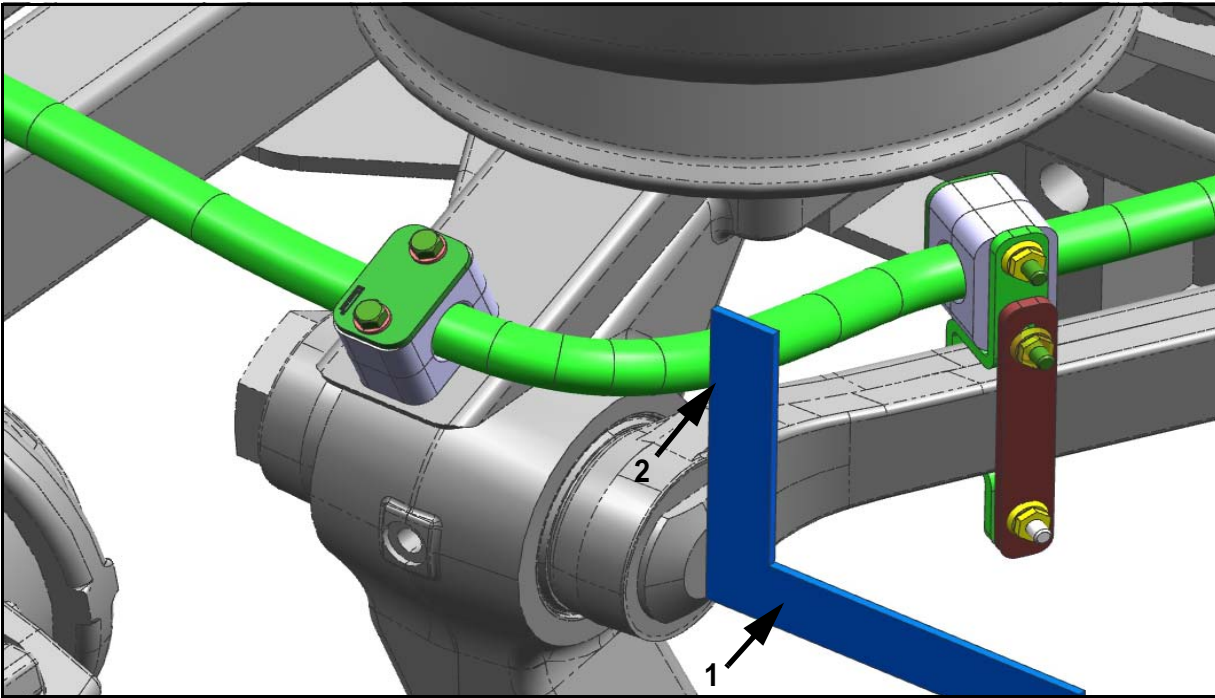
Figure 18.

Item	Figure 18 Description
1	position square across the face of the suspension arm bolt head
2	minimum clearance of 0.06 inch between the edge of the front brake hose assembly and the edge of the square

46. Position a square across the face of the suspension arm bolt head (refer to Figure 18). Using a measuring tape, ensure that there is a minimum clearance of 0.06 inch between the edge of the front brake hose assembly and the edge of the square.
