NHTSA Safety Recall 15V-625

TO: Winnebago Industries, Inc. Dealers
SUBJECT: Campaign #138 – High-Pressure LP Hose

REASON FOR THIS RECALL

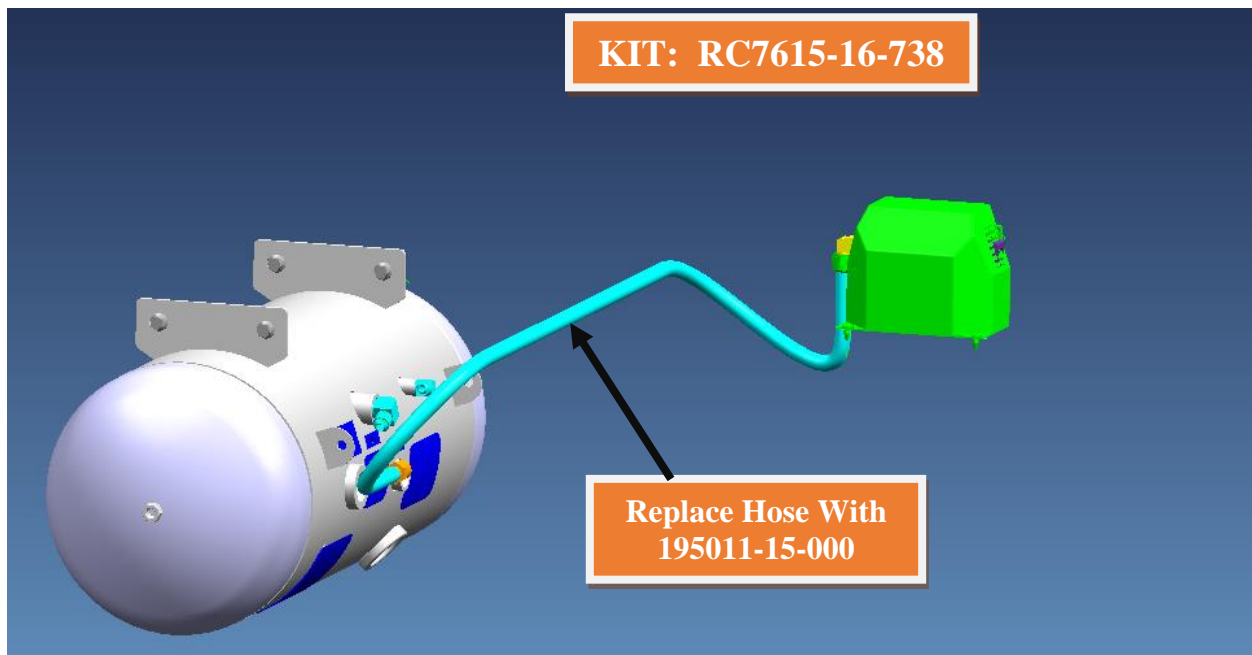
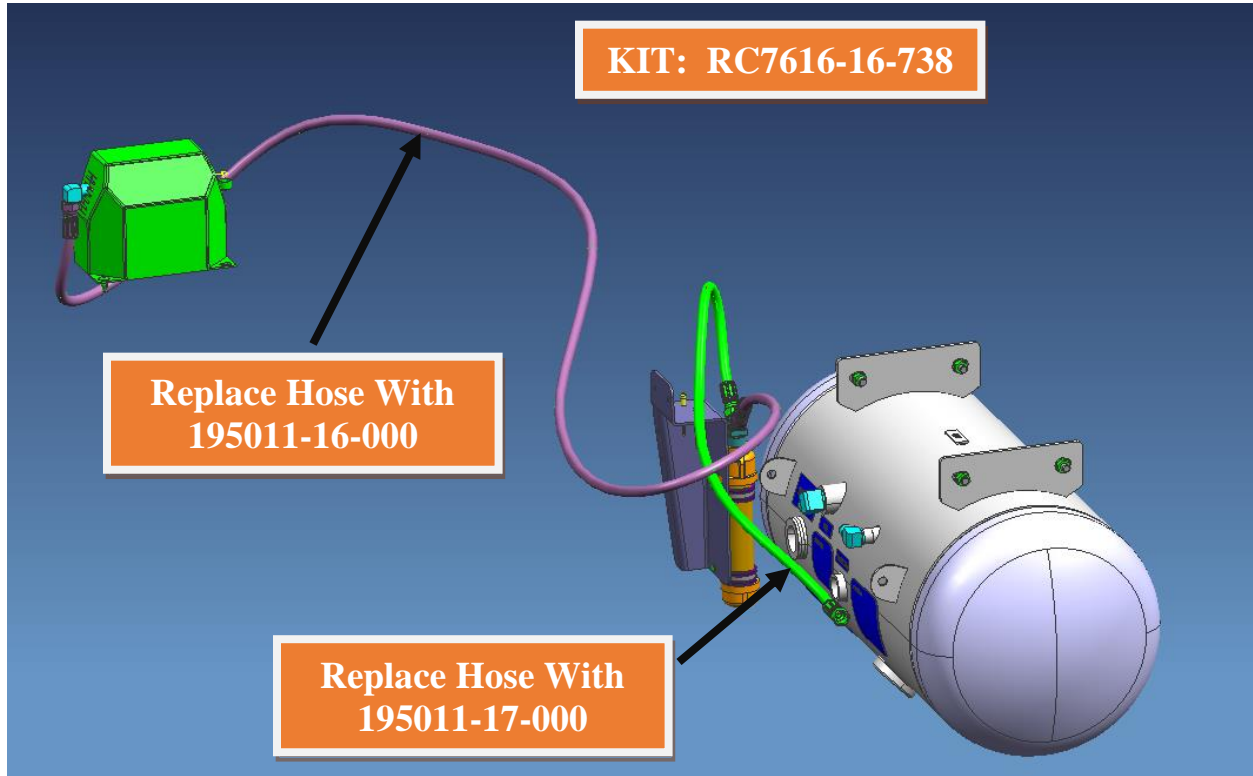
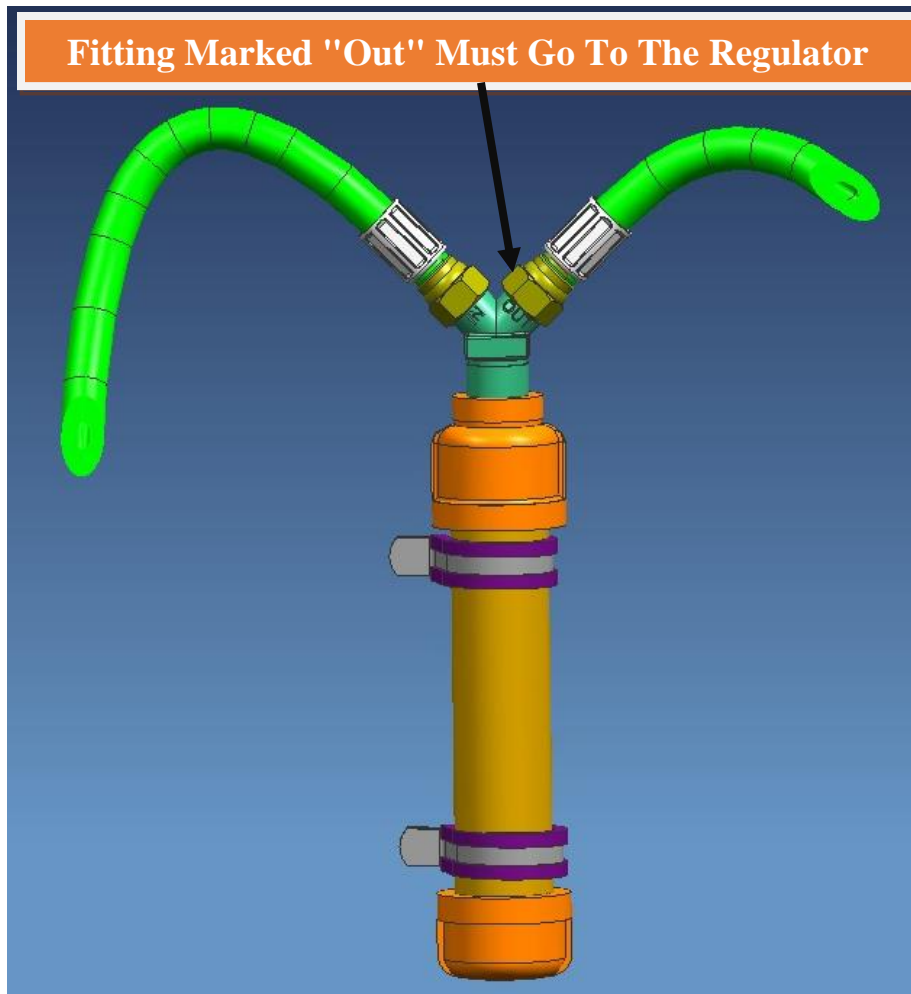
Replace high-pressure liquid propane (LP) hose.

- Turn coach battery to on position.
- Turn both two (2) LP switches to off position (one internal and one exterior).
- Turn valve off at tank.
- Light stove until any LP is burned from lines.
- Turn stove off.
- Unhook LP hose from tank and high-pressure side of regulator (use a backup wrench on all fittings when tightening or disconnecting any fittings).
- Connect new LP hose to regulator.
- Connect other end of LP hose to tank.
- Turn LP valve on tank to "on" position and turn switches back on.
- Follow testing procedure (below).

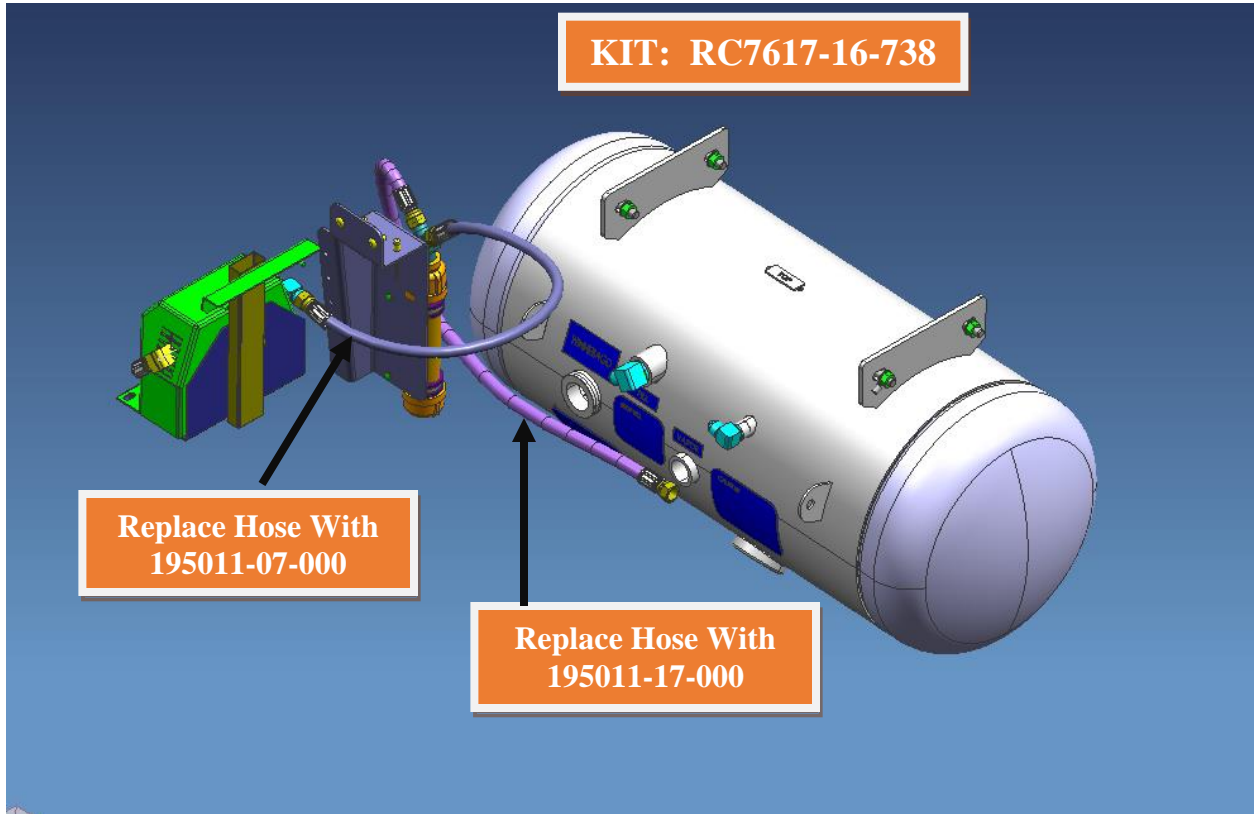
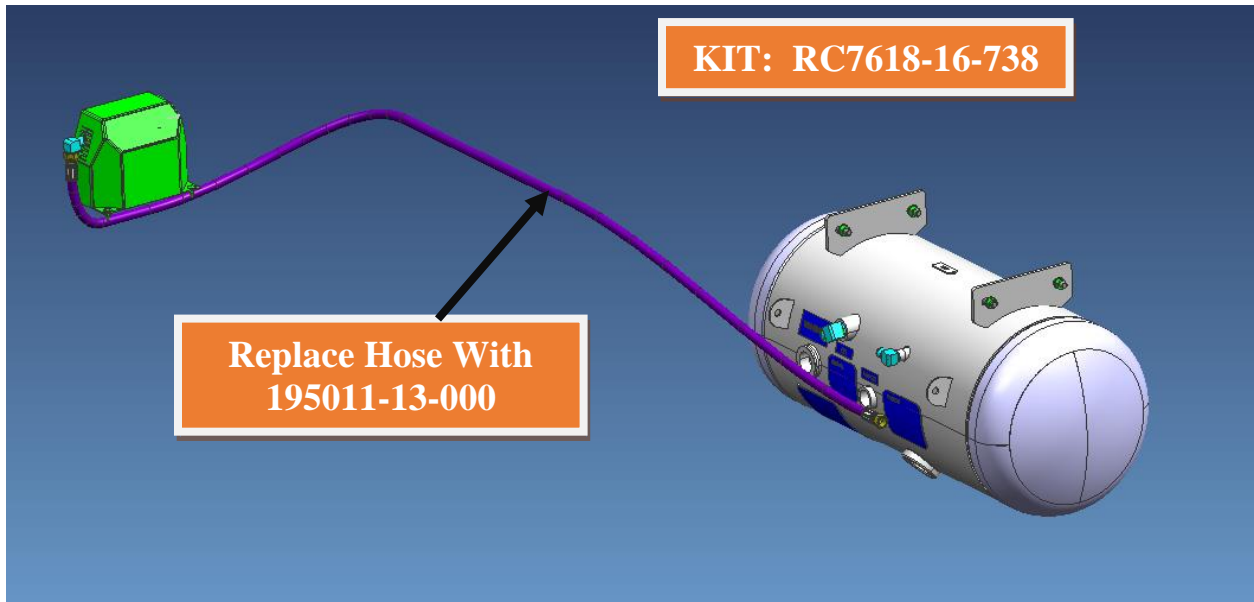
Replace high-pressure liquid propane (LP) hoses.

- Turn coach battery to on position.
- Turn both two (2) LP switches to off position (one internal and one exterior).
- Turn valve off at tank.
- Light stove until any LP is burned from lines.
- Turn stove off.
- Unhook LP hose from tank, from black pipe manifold, and high-pressure side of regulator (use a backup wrench on all fittings when tightening or disconnecting any fittings).
- Unhook drop tube assembly from bracket.
- Detach hoses from drop tube and replace with proper LP hoses for the unit.
- Carefully place drop tube assembly back on to bracket while routing hoses in position required to attain the necessary route to tank or regulator.

- Remove regulator. Remove adapter and elbow from regulator. Remove any Teflon tape residue from regulator. Remove adapter from elbow. Place Teflon tape on elbow and attach elbow to regulator. Throw away adapter as it is no longer needed.
- Place regulator back on coach.
- Connect LP hose from drop tube to regulator.
- Connect LP hose to tank.
- Connect low-pressure hose from regulator to manifold.
- Follow attached testing procedure (below).
