**NHTSA Safety Recall 15V-625**

**TO: Winnebago Industries, Inc. Dealers**  
**SUBJECT: Campaign #137 – High-Pressure LP Hose**

**REASON FOR THIS RECALL**

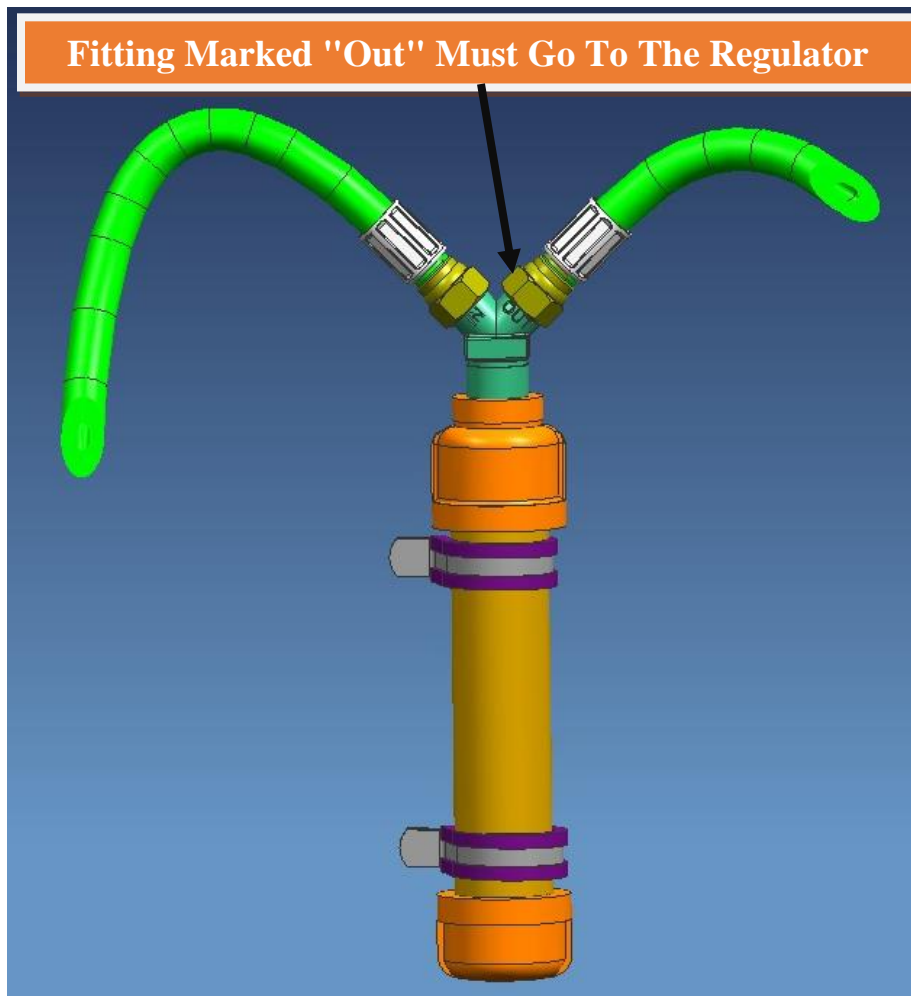
Replace high-pressure liquid propane (LP) hose.

- Turn coach battery to on position.
- Turn both two (2) LP switches to off position (one internal and one exterior).
- Turn valve off at tank.
- Light stove until any LP is burned from lines.
- Turn stove off.
- Unhook LP hose from tank and high-pressure side of regulator (use a backup wrench on all fittings when tightening or disconnecting any fittings).
- Connect new LP hose to regulator.
- Connect other end of LP hose to tank.
- Turn LP valve on tank to "on" position and turn switches back on.
- Follow testing procedure (below).

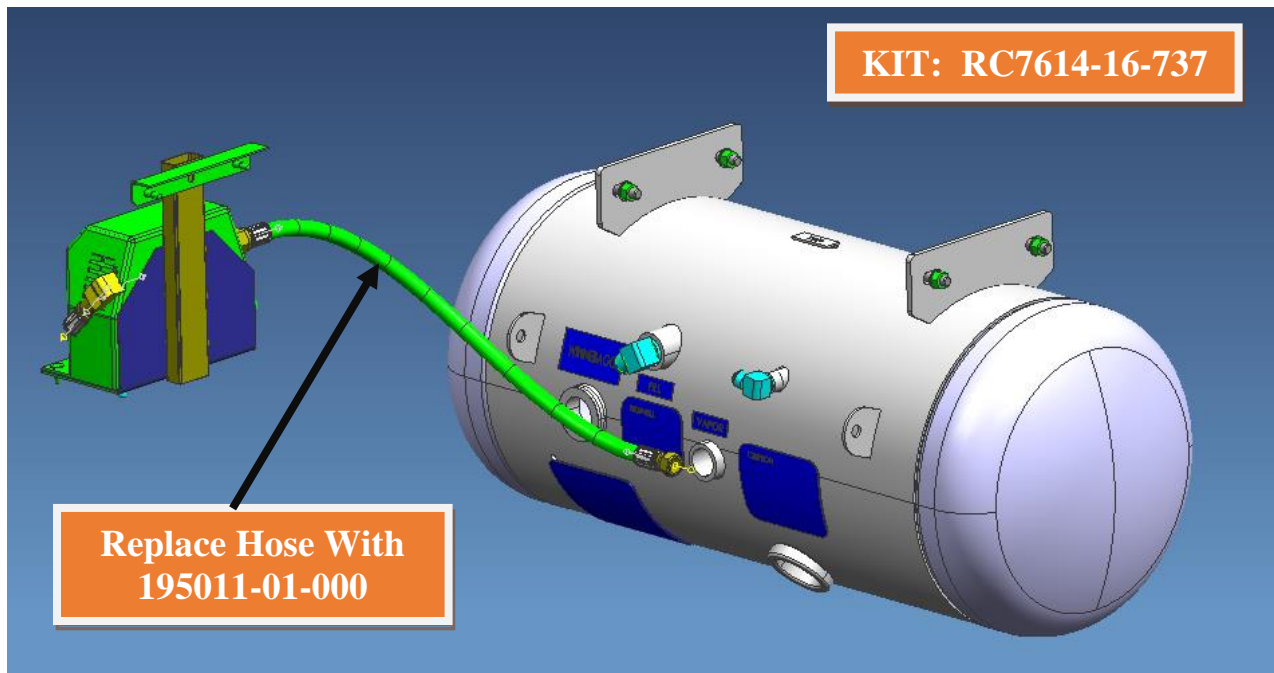
If Equipped with Drop Tube.

- Remove regulator. Remove adapter and elbow from regulator. Remove any Teflon tape residue from regulator. Remove adapter from elbow. Place Teflon tape on elbow and attach elbow to regulator. Throw away adapter as it is no longer needed.
- Place regulator back on coach.
- Connect LP hose from drop tube to regulator.
- Connect LP hose to tank.
- Connect low-pressure hose from regulator to manifold.
- Follow attached testing procedure (below).
