SAFETY RECALL NOTICE

IMPORTANT SAFETY RECALL RVXX1507 NHTSA RECALL # 15V-643

Subject: Service Bulletin - Ultra LT Fifth Wheel Damage Caused by Improper Coupling

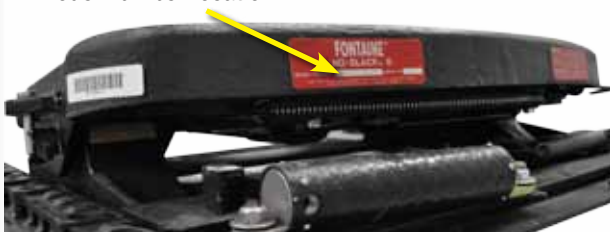
Model number location

Method 1: Identify the Model Number
