**RV QUAD STEP 24" x 8 x 8, RIVET REPLACEMENT**

**SRP 1502-0001**

**ISSUE:**

HSM has determined that the rivets marked as #96 or rivets marked as #55, which connect the 2nd & 3rd step at the hinge point (2nd and 3rd step, defined as the 2nd step from the ground level and the 3rd step from the ground level) of the Quad step, may shear or pull out under load. HSM has further determined that on these RV Step configurations, the inboard rivets marked as #08 or 80, which connect the top step tread (top step, defined as the 4th step from the ground level) to the upper hinge bracket of the Quad Step, may shear or pull out under load.

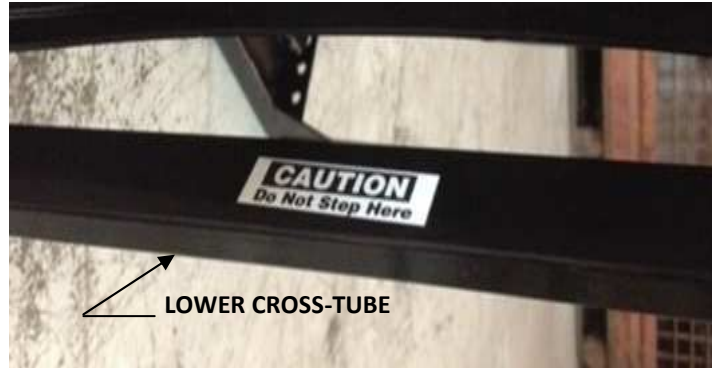
LOWER CROSS-TUBE

4.3 Does the step have an outboard lower cross-tube connecting the two end plates.

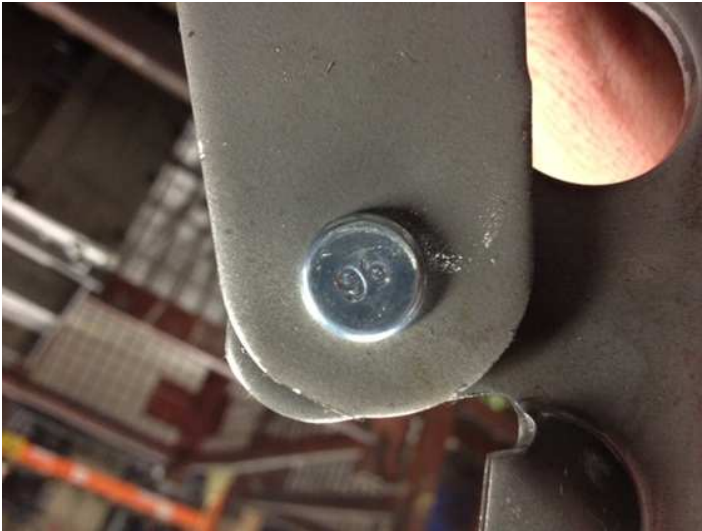
**HINGE POINT RIVET MARKED #96 @ 2<sup>nd</sup> & 3<sup>rd</sup> STEP**

5.1.1 This configuration has a hinge point rivet marked with the #96 at the 2<sup>nd</sup> & 3<sup>rd</sup> Step (2<sup>nd</sup> & 3<sup>rd</sup> step, defined as the 2<sup>nd</sup> step from the ground level and the 3<sup>rd</sup> step from the ground level).

**NOTE: CONFIGURATION “A” - MUST BE REPAIRED IN ACCORDANCE WITH SRP-APPENDIX “A” .**

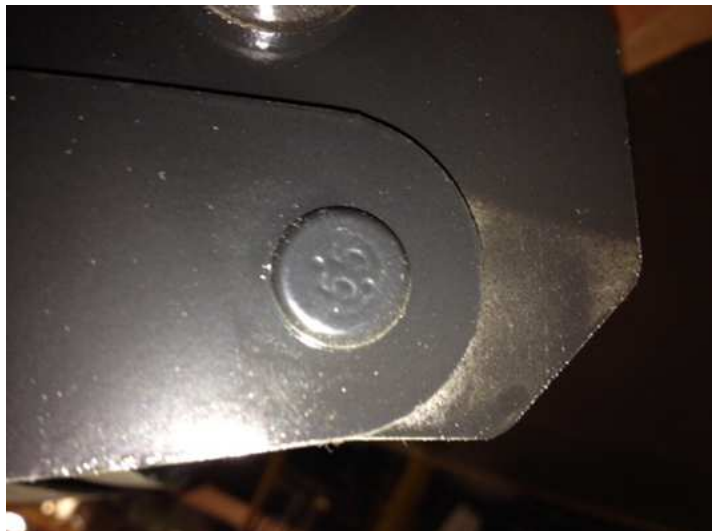
**HINGE POINT RIVET MARKED #55 @ 2<sup>nd</sup> & 3<sup>rd</sup> STEP**

5.2.1 This configuration has a hinge point rivet marked with the #55 at the 2<sup>nd</sup> & 3<sup>rd</sup> Step (2<sup>nd</sup> & 3<sup>rd</sup> step, defined as the 2<sup>nd</sup> step from the ground level and the 3<sup>rd</sup> step from the ground level).

**NOTE: CONFIGURATION “B” - MUST BE REPAIRED IN ACCORDANCE WITH SRP-APPENDIX “B” .**
