RECALL CAMPAIGN BULLETIN

NTB15-003

VOLUNTARY SAFETY RECALL CAMPAIGN 2014 – 2015 ROGUE AND PATHFINDER FRONT HUB AND TORQUE MEMBER BOLT TORQUE

APPLIED VEHICLES: 2014 – 2015 Rogue (T32)
2014 – 2015 Pathfinder (R52)

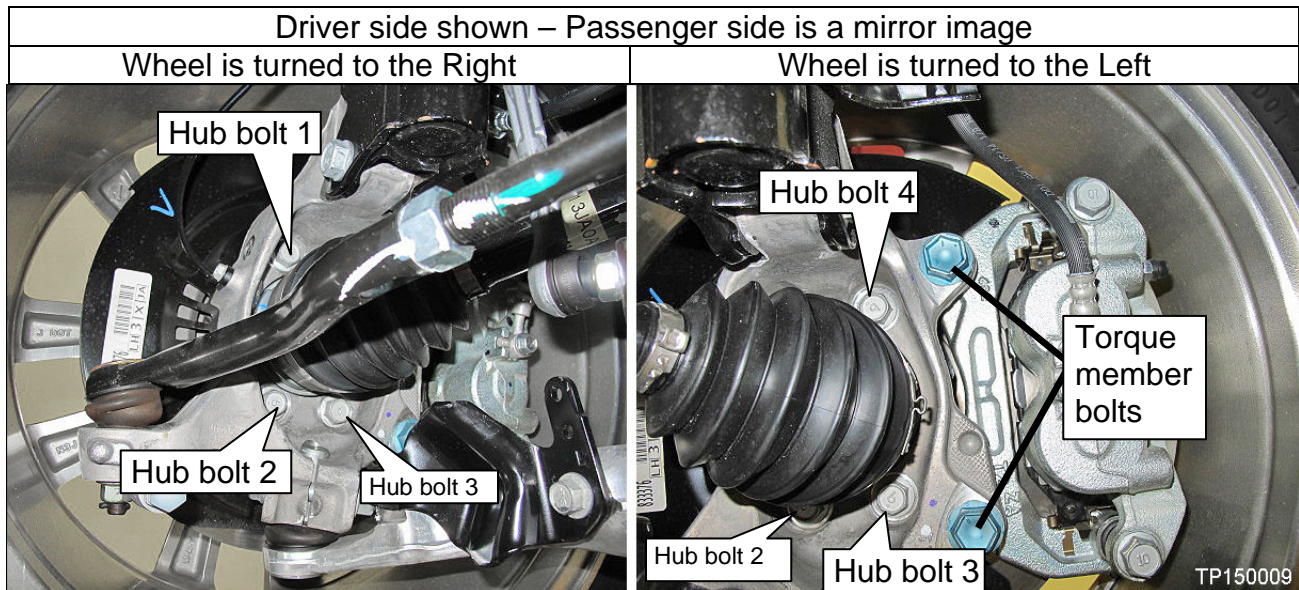
Figure 1

1. Lift the vehicle.
2. Locate and torque the 4 hub bolts and 2 torque member bolts on each front wheel hub assembly (see Figure 1).

Hub bolts: Torque to 88.3 N·m (9.0 kg-m, **65 ft-lb**).

Torque member bolts:

Pathfinder - torque to 123 N·m (13.0 kg-m, **91 ft-lb**).

Rogue - torque to 165 N·m (17.0 kg-m, **122 ft-lb**).

NOTE: Make sure to perform the above torque procedure on BOTH (driver and passenger side) front hub assemblies.

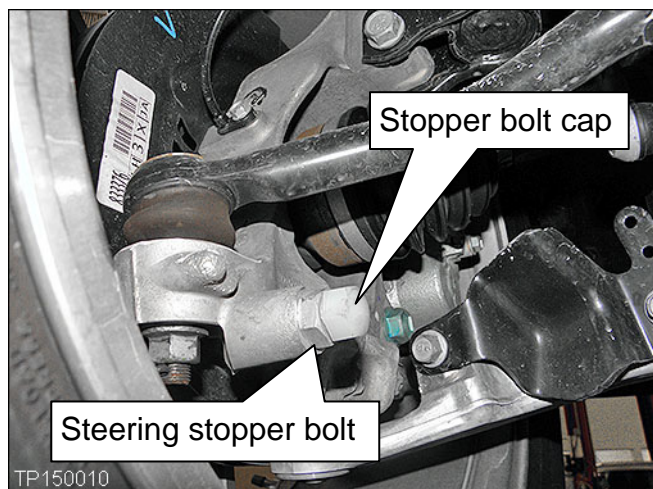
Figure 2

3. **For Pathfinder only:**

Torque the steering stopper bolts (both sides) to 63 N·m (6.4 kg-m, **46 ft-lb**).

- A 19 mm deep socket will fit over the stopper bolt cap.
- Make sure to perform the above torque procedure on BOTH (driver and passenger side).
