TECHNICAL INSTRUCTIONS
FOR
SAFETY RECALL CAMPAIGN F0D
CERTAIN 2011-2012 MODEL AVALON
PREMIUM AUDIO SYSTEM - REAR SUB-WOOFER

The subject vehicles are equipped with a 12-speaker, premium audio system package which includes a sub-woofer mounted inside the trunk. Large or loose cargo located in the trunk could contact one of the sub-woofer wires, and move it out of its normal position. If one of these wires contacts the metal frame of the sub-woofer, it may result in an intermittent short circuit. If this occurs, the sub-woofer could overheat, increasing the risk of a fire.

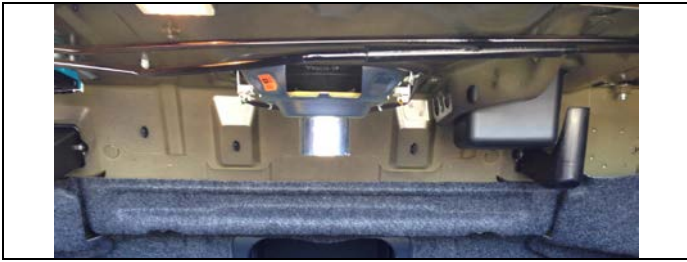
1. INSTALL SUB-WOOFER PROTECTIVE COVER

- a) Locate the sub-woofer in the trunk on the parcel shelf.
- b) Check that the area around the woofer is clear of any external objects.

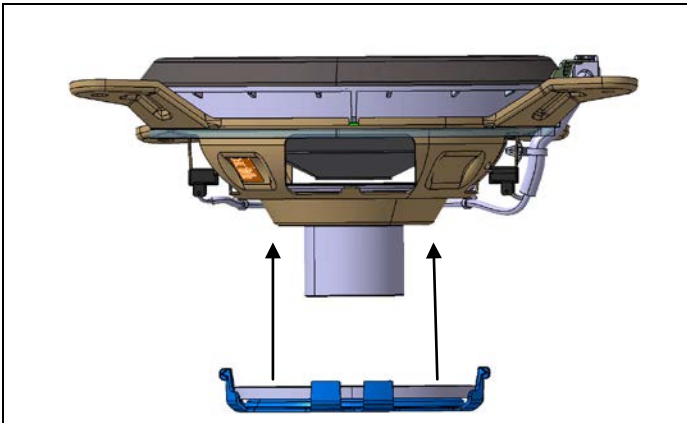
- e) Install the protective cover onto the woofer.

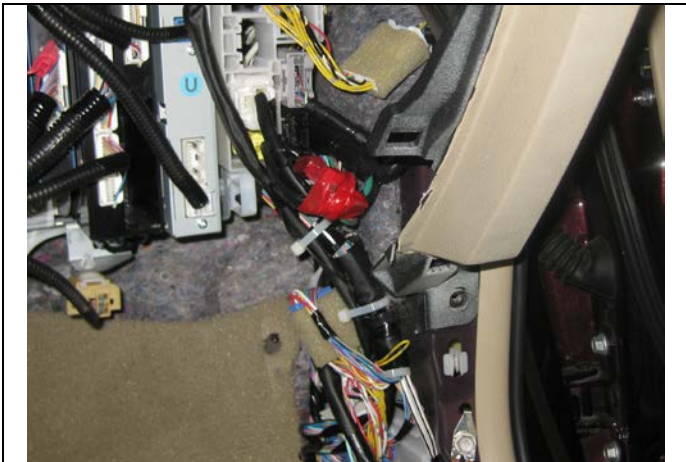
4. LOCATE THE REAR SPEAKER CONNECTOR

- a) Locate the black connector in the area of the junction block.

NOTE: The connector in the interim procedure was to be secured to an adjacent wire harness with electrical tape.

- b) Unwrap the electrical tape.

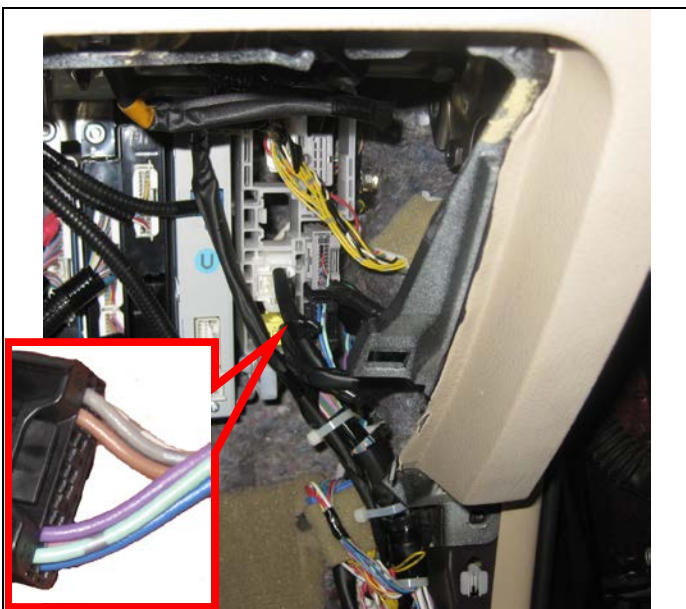
5. REINSTALL THE CONNECTOR

- a) Reinstall the rear speaker connector into the junction block.

NOTE: The connector cavity is in the lower right hand corner of the J/B.

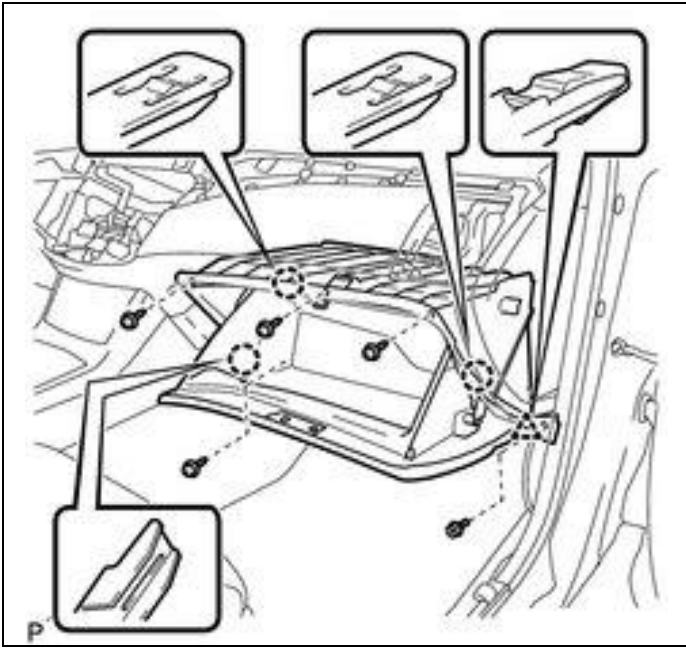
6. REINSTALL THE LOWER INSTRUMENT PANEL

- a) Engage the 3 claws and clip.
- b) Reinstall the 4 screws and bolts.
