Spartan Motors Chassis, Inc.

SERVICE BULLETIN

RSB15-260-001

SUBJECT: Steering slip shaft

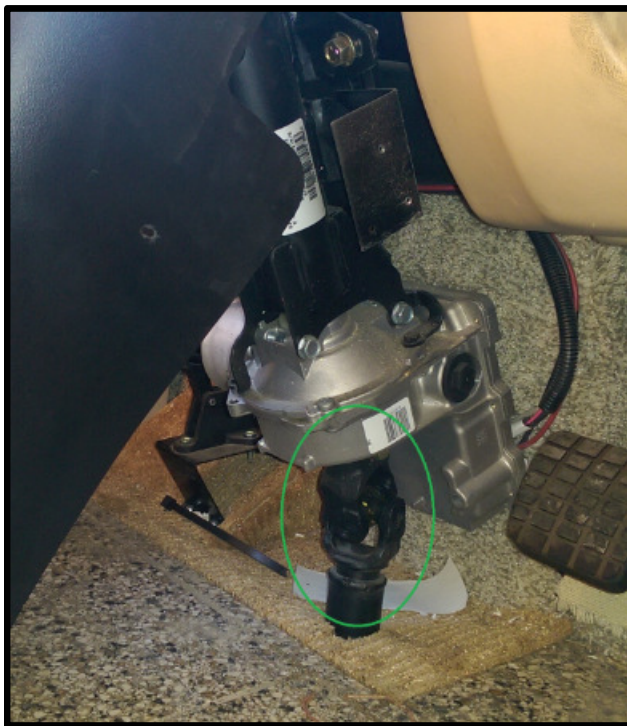
3. To gain access to the pinch bolt at the top of the slip shaft (circled in green), remove the screws holding the steering column cover (circled in red) and shift cover out of the way. Retain screws for reuse. Refer to FIG. 2-1 & 2-2.

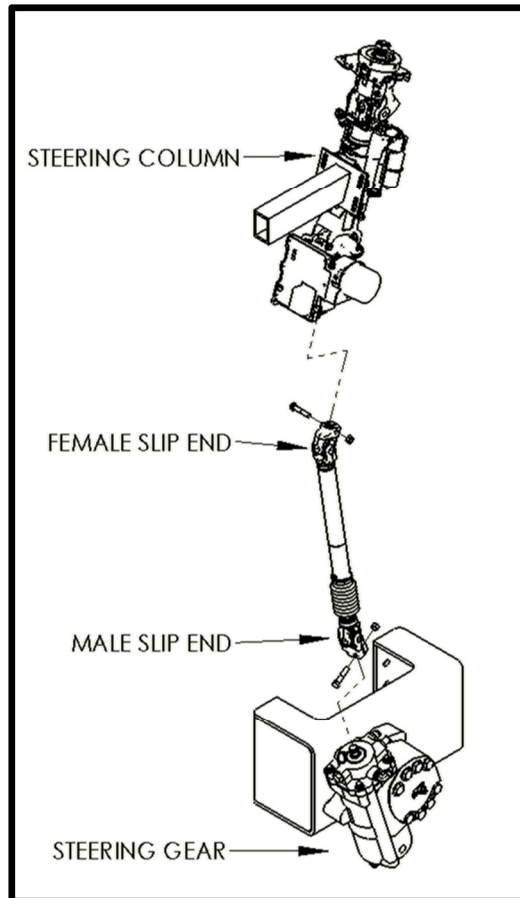
FIG. 3-1

4. Remove M10 pinch bolt at steering column end of steering slip shaft. Properly dispose of hardware. Refer to FIG. 3-1.

5. Remove 7/16" pinch bolt at gear box end of the steering slip shaft. Properly dispose of hardware.
6. Remove steering slip shaft and return to Spartan Motors Chassis, Inc. using the return material authorization process.
7. Install new slip shaft in reverse order using new hardware. Refer to installation drawing for fastener torque values.
8. Reattach steering column cover.
