**TECHNICAL INSTRUCTIONS**  
**FOR**  
**SAFETY RECALL F0E**  
**STEERING INTERMEDIATE SHAFT ASSEMBLY**  
**CERTAIN 2014 MODEL YEAR FJ CRUISER**

The steering system contains an intermediate shaft, which connects the steering wheel to the steering gear box. The intermediate shaft in the subject vehicles could have received an inadequate weld. Under some circumstances, the weld could separate, resulting in the loss of steering control and increasing the risk of a crash.

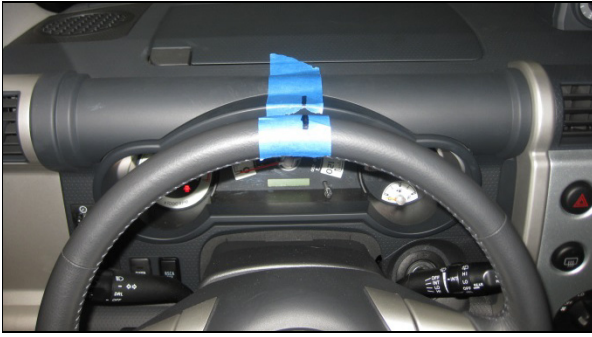
3. CONFIRM THAT THE STEERING WHEEL IS IN THE STRAIGHT AHEAD POSITION

- a) Place the steering wheel in the straight ahead position.
- b) Install tape on the steering wheel and dash and place a match at the center position as shown.

**Note:** This mark will help ensure the new part is installed with the correct phasing.

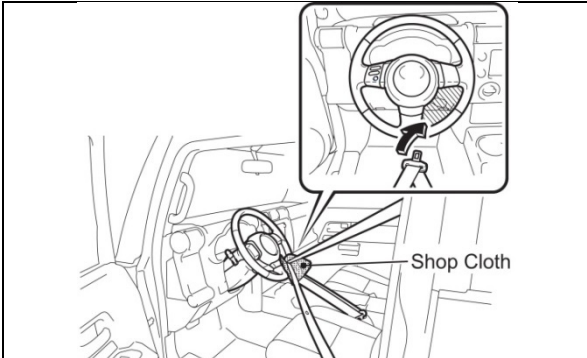
4. SECURE THE STEERING WHEEL IN POSITION

- a) Pass the seat belt through the steering wheel as shown to secure the wheel.

**Note:** Place a soft cloth between the seat belt and the steering wheel to prevent damage.

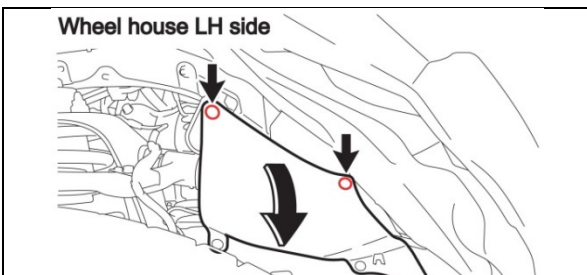
5. FOLD DOWN THE LH FENDER SPLASH SHIELD

- a) Disengage the 2 clips using the clip remover and discard .

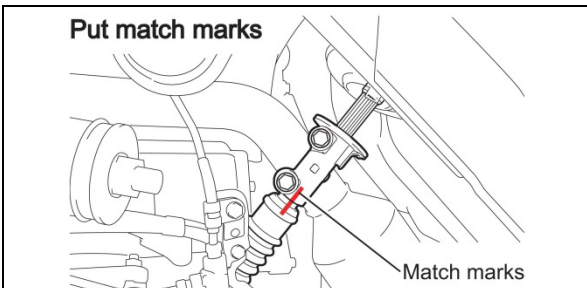
6. REMOVE STEERING SLIDE YOKE

- a) Put match marks on the slide yoke and the No. 2 steering intermediate shaft sub-assembly.

**NOTE:** The match marks will assist with aligning the new intermediate shaft.

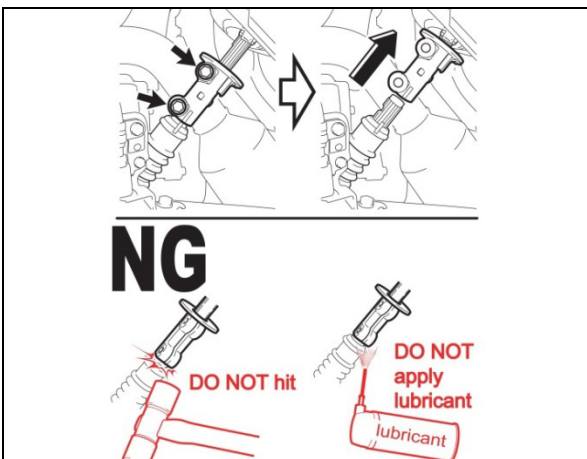
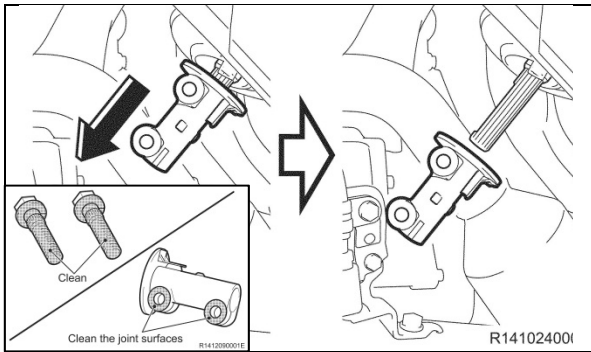
- b) Remove the 2 bolts and slide the sliding yoke upward to separate it from the No. 2 intermediate shaft.

**STOP** *If the sliding yoke is stuck on the intermediate shaft DO NOT hammer or apply lubrication.*

- c) If the shaft is stuck use a screw driver to gently open the yoke.

- d) Remove the sliding yoke from the intermediate shaft.
- e) Clean the bolt threads and the grease from the bolt head seating surface of the yoke.

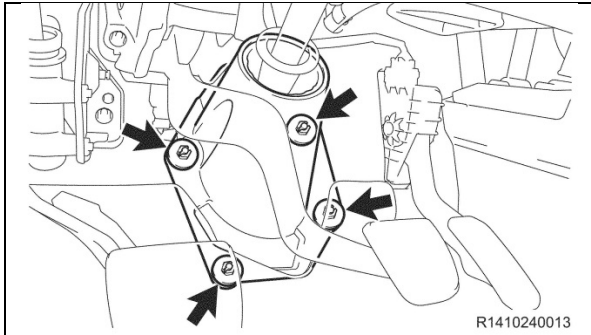
**7. REMOVE STEERING COLUMN COVER**

- a) Disengage the 4 clips and remove the column cover.

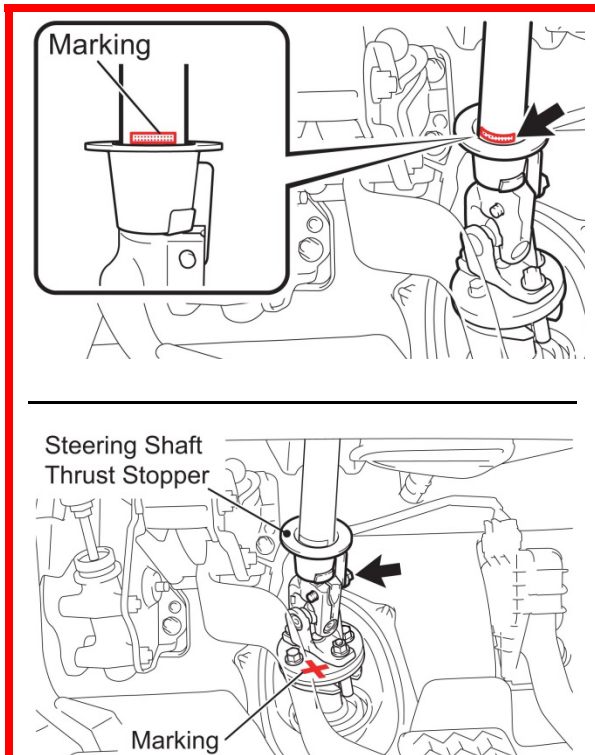
- a) Turn the steering wheel clockwise approximately 90 degrees to gain access to the bolt.

**Note: DO NOT rotate the steering wheel past 90 degrees or damage to the spiral cable could occur. Loosening of the seat belt will be necessary to turn the steering wheel.**

- b) Mark the main shaft as shown to ensure that the NEW intermediate shaft is installed to the correct depth.

**STOP** *Marking the shaft is crucial to ensure the NEW intermediate shaft is installed to the correct depth. If the new part is not installed properly a loss of steering can occur do to separation.*

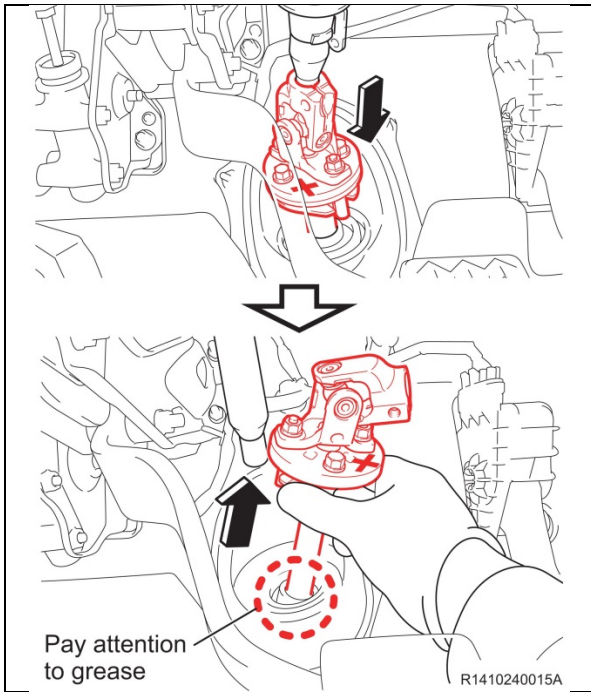
- c) Mark the No. 2 intermediate shaft assembly to ensure it is not reused.

- d) Separate the intermediate shaft and steering thrust stopper from the steering column.

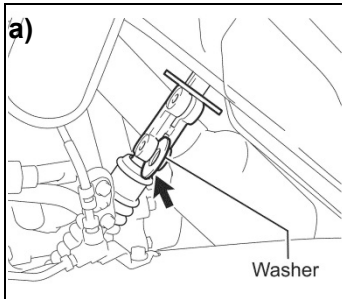
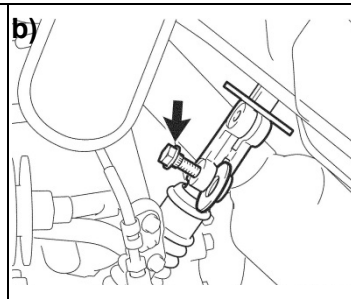
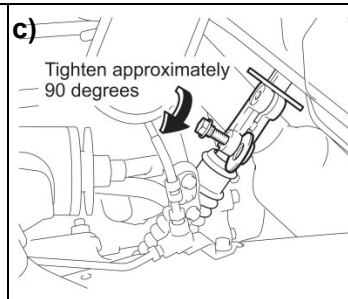
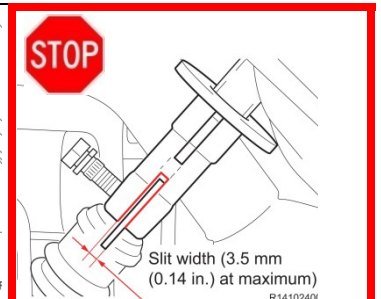
**IF INTERMEDIATE SHAFT IS STUCK**

- a) Place a washer in the gap of the intermediate shaft yoke.  
 b) Insert the intermediate shaft bolt on the threaded side of the yoke and hand tighten until it bottoms out against the washer.  
 c) After the bolt has seated against the washer, tighten the bolt 90 degrees to spread the yoke.

**Use caution when performing this step or damage the steering shaft could occur. DO NOT exceed a gap greater than 3.5 mm (.14 in.).**

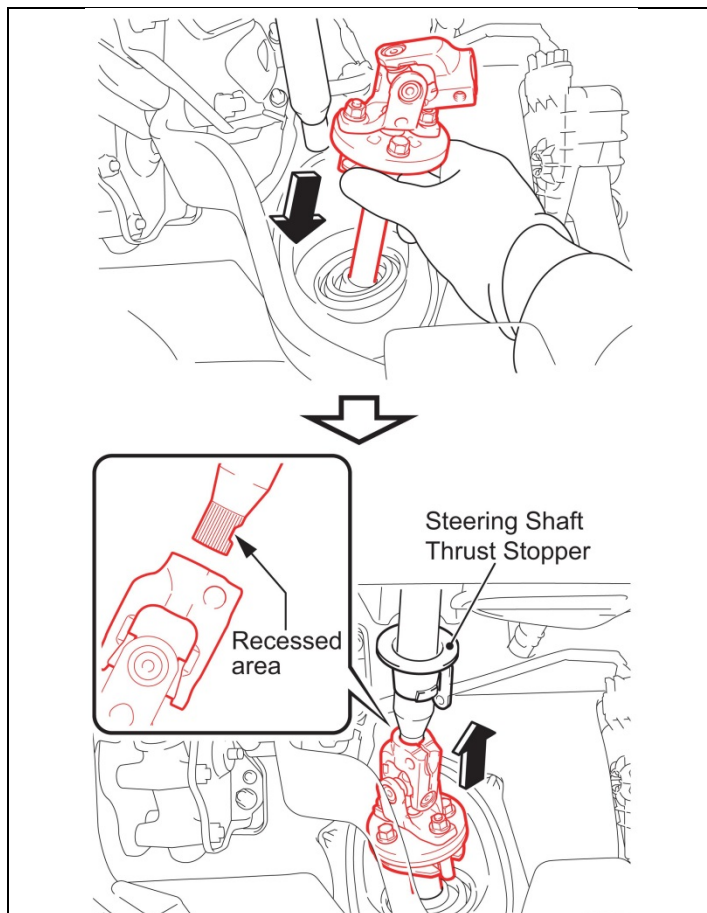
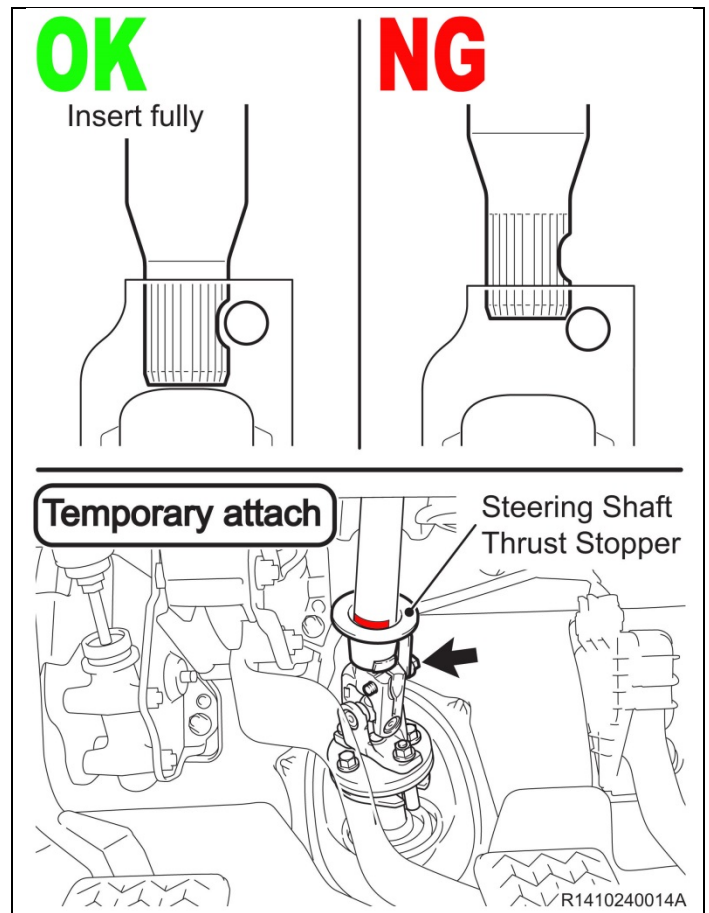
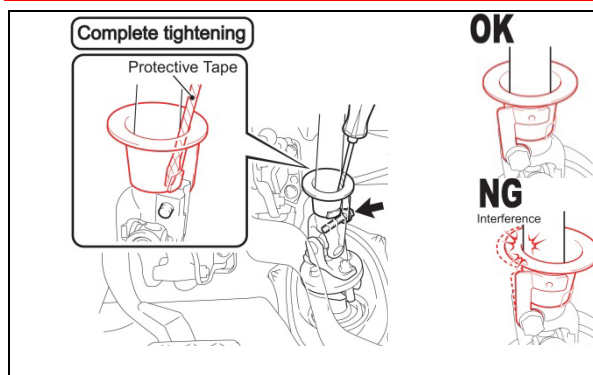
- a) Pass the **NEW** intermediate shaft through the dust boot.

- b) Attach the steering shaft thrust stopper over the main shaft assembly.  
c) Connect the intermediate shaft to the main shaft so that the recess aligns with the bolt.

**Ensure the main shaft is fully seated into the intermediate shaft as shown.**

- d) Temporarily reinstall the bolt onto the intermediate shaft yoke.

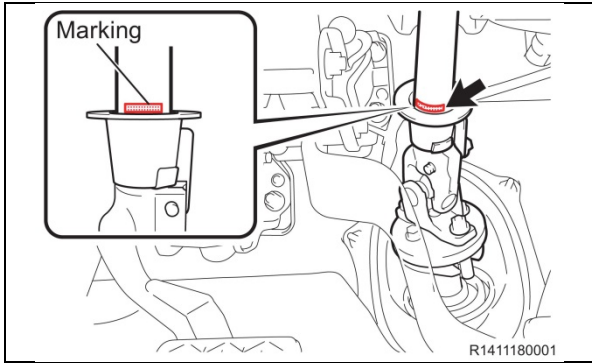
- e) Insert a flat tip screw driver wrapped with tape into the gap between the shaft and the thrust stopper as shown while torquing the intermediate shaft bolt.

**Torque: 27 ft.lbs (36 N\*m, 367 kgf\*cm)**

**A screw driver must be inserted because the thrust stopper will turn as the bolt is tightened and interfere with the steering shaft. After tightening the bolt ensure there is no interference between the thrust stopper and steering shaft.**

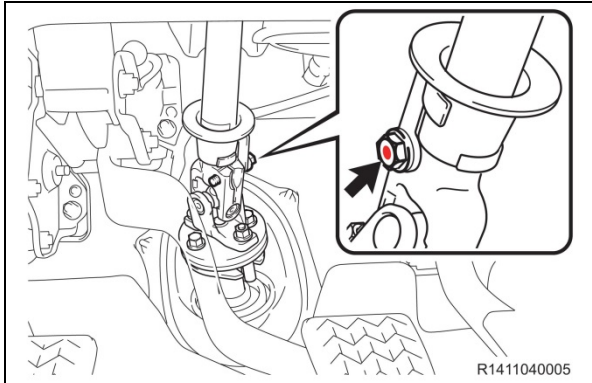
f) Check the mark on the main shaft, to ensure that the intermediate shaft is fully installed on to the main shaft.

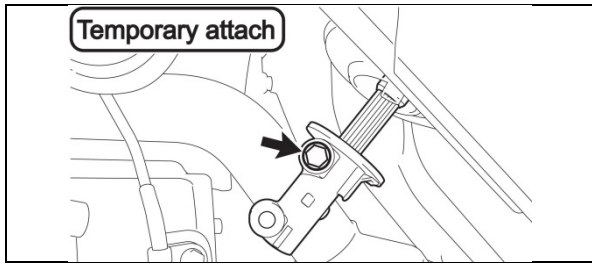
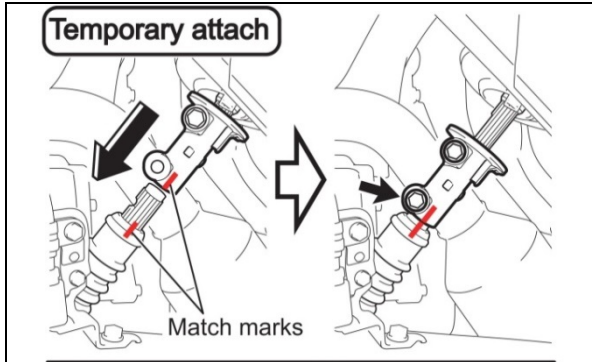
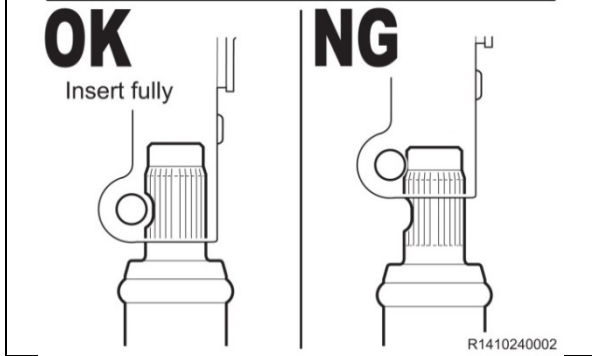
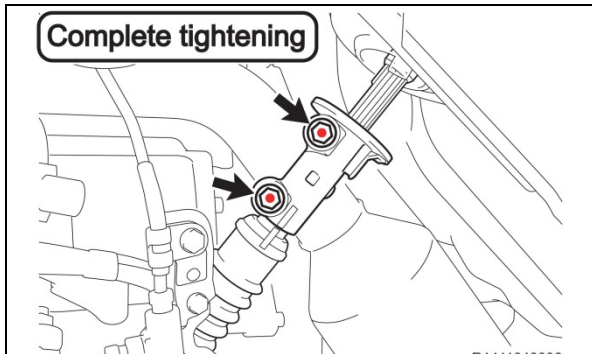
a) Insert the sliding yoke over the intermediate shaft ensuring to align the flat with the bolt holes as shown.

**STOP** *If grease transfers to the bolt surface clean it to ensure proper torqueing.*

b) Temporarily reinstall the upper bolt.

- c) Align the match marks, and reconnect the No. 2 steering intermediate shaft sub-assembly.
- d) Fully seat the sliding yoke and ensure that the bolt hole aligns with the recessed area.
- e) Temporarily reinstall the bolt.

**STOP** *Ensure that the No. 2 steering intermediate shaft is fully installed.*

f) Torque the two bolts.

**Torque: 27 ft.lbs (36 N\*m, 367 kgf\*cm)**

g) Mark the two bolts to identify that they have been torqued properly.

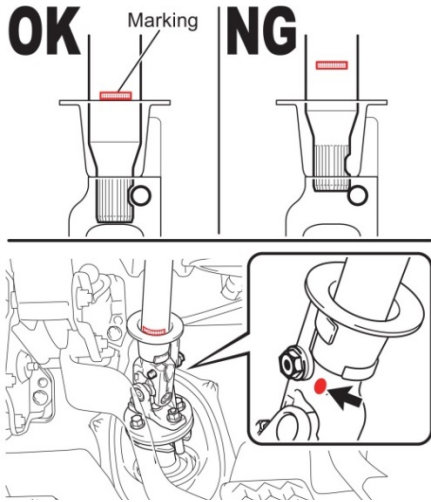
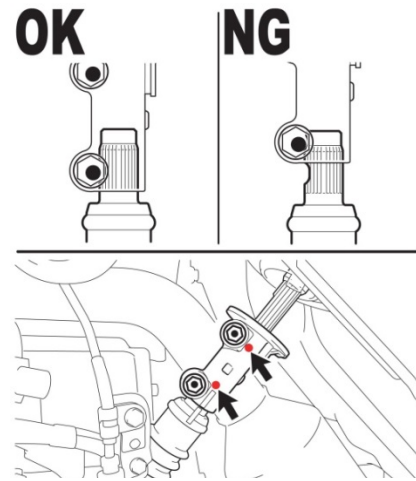
**STOP****INSPECT THE INTERMEDIATE SHAFT TO ENSURE IT IS INSTALLED PROPERLY****STOP**
