SERVICE PROCEDURE

15501

SUBJECT: SAFETY RECALL

Powertrain Harness on certain CE school bus models built 3 October 2013 thru 4 September 2014 with ISB engines

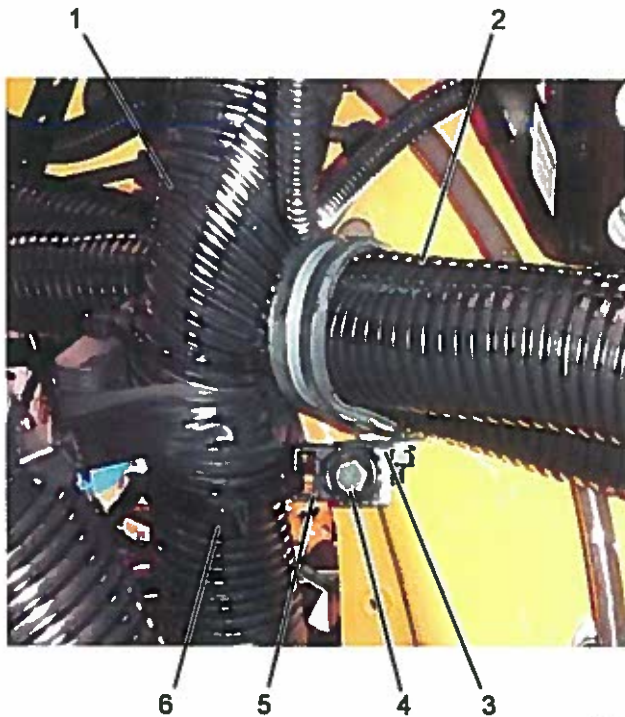
Figure 1. Powertrain Harness.

1. Powertrain harness
2. Heater hose
3. Extension bracket
4. M6X20 bolt
5. Tie mount
6. Cable tie strap

5. Install tie mount (Figure 1, Item 5) onto M6X20 bolt (Figure 1, Item 4) and install bolt to end of extension bracket (Figure 1, Item 3) at driver side of engine tunnel.
6. Install M6 nut (not shown) onto M6X20 bolt (Figure 1, Item 4) and tighten.
7. Use cable tie strap (Figure 1, Item 6) to secure powertrain harness (Figure 1, Item 1) to tie mount (Figure 1, Item 5). Do not tighten cable tie strap at this time.

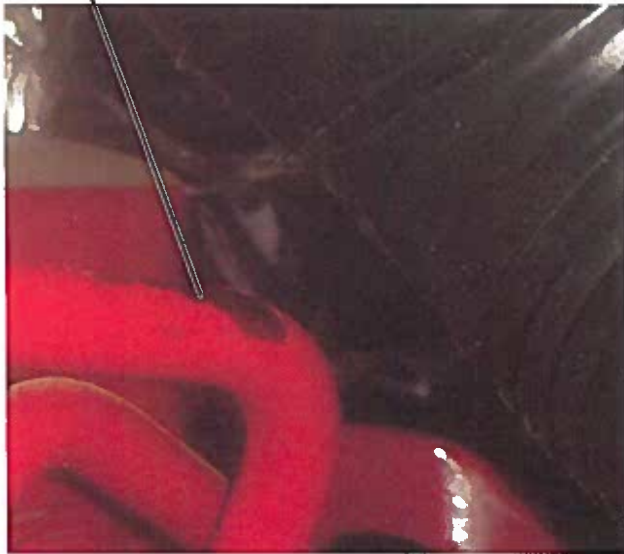
Figure 3. Paint Abrasion.

1. Paint abrasion, injector 5 high-pressure fuel line

9. Inspect injector 5 high-pressure fuel line for paint worn off from abrasion (Figure 3, Item 1).
 - a. If **ONLY** paint is worn from abrasion, properly clean area and protect with new paint.
 - b. If fuel line metal surface is worn from abrasion, take picture and open a technical service case file for approval to order from Cummins, part number 4935974, and replace fuel line according to Cummins replacement procedures. If a fleet is performing the inspection and a fuel line is required, contact your local dealer and have them submit the case file.
10. Close and latch hood.
11. Remove wheel chocks.
