RECALL CAMPAIGN BULLETIN

NTB15-023

VOLUNTARY SAFETY RECALL CAMPAIGN 2013 - 2015 ALTIMA SECONDARY HOOD LATCH LUBRICATION

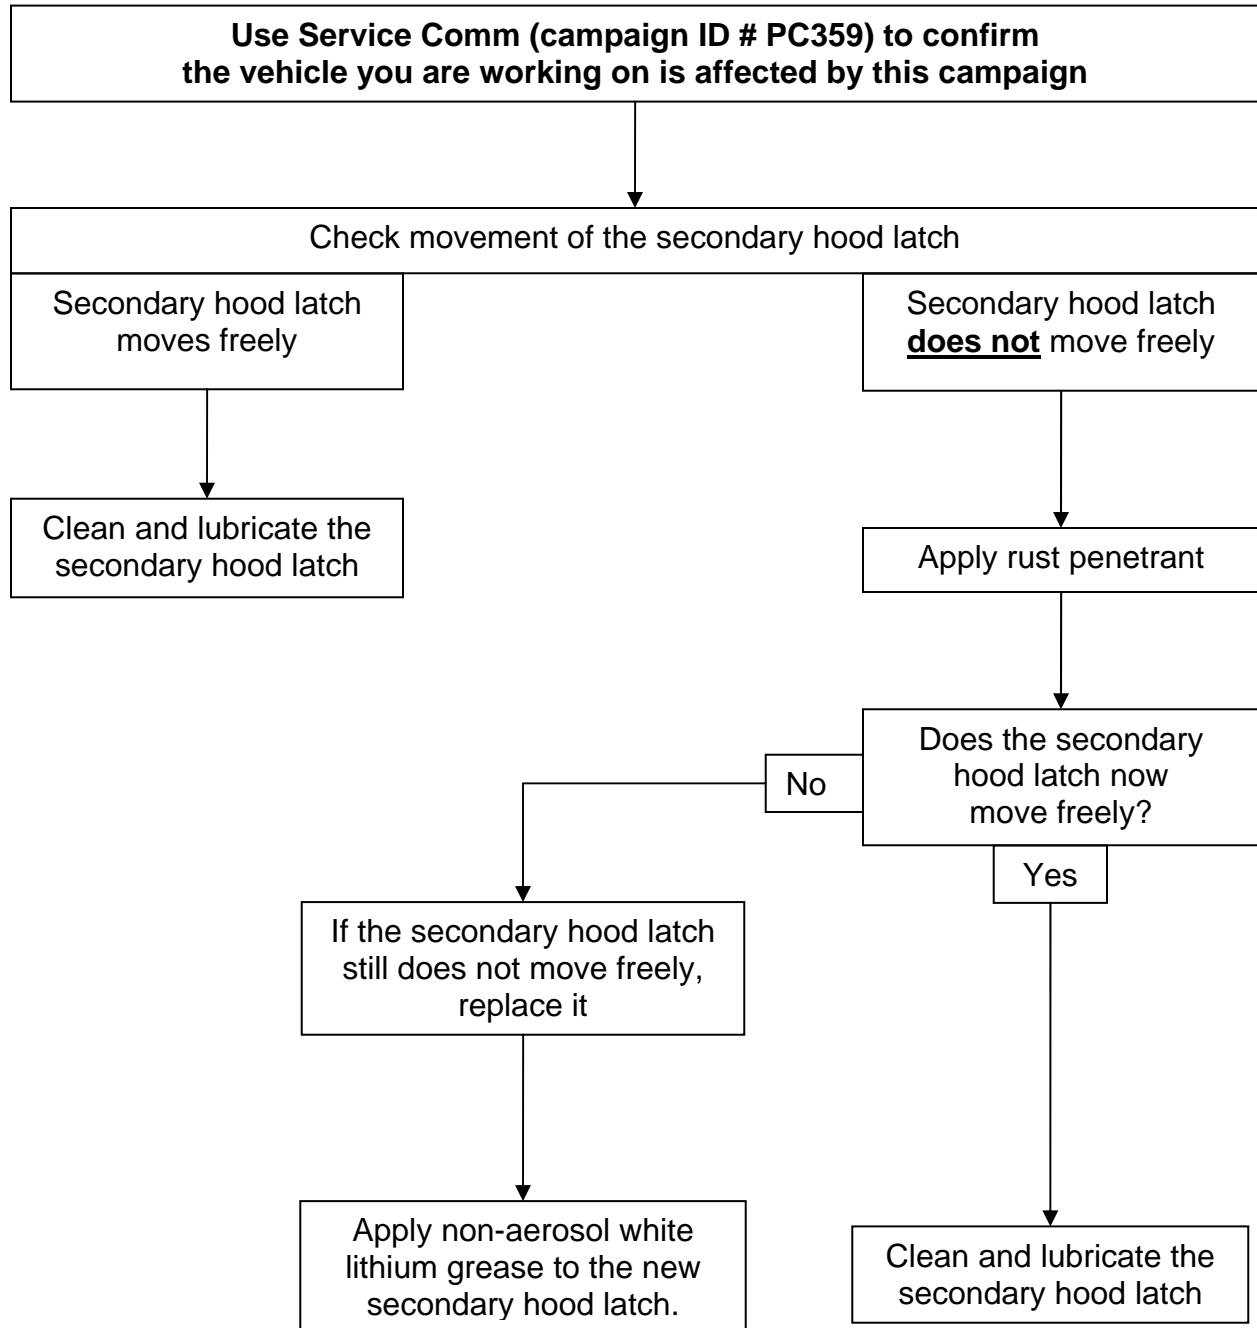
REPAIR OVERVIEW

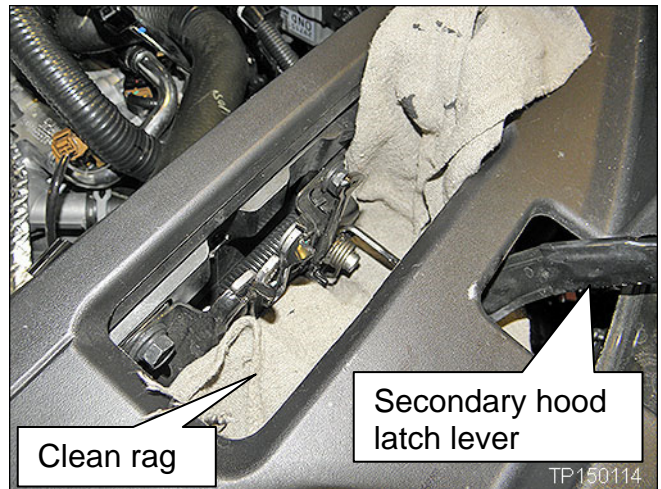
Figure 1

1. Open the engine hood.
2. Place a clean rag under the hood latch assembly as shown in Figure 1.

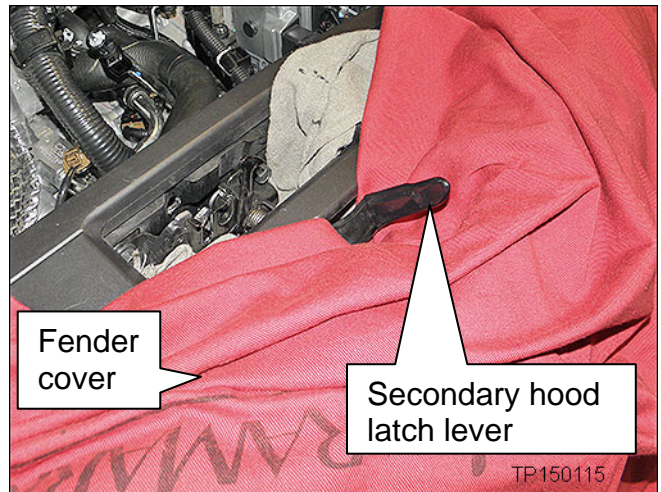
Figure 2

3. Place a clean fender cover to protect the front fascia as shown in Figure 2.
 - Allow the secondary hood latch lever to be above the fender cover as shown.

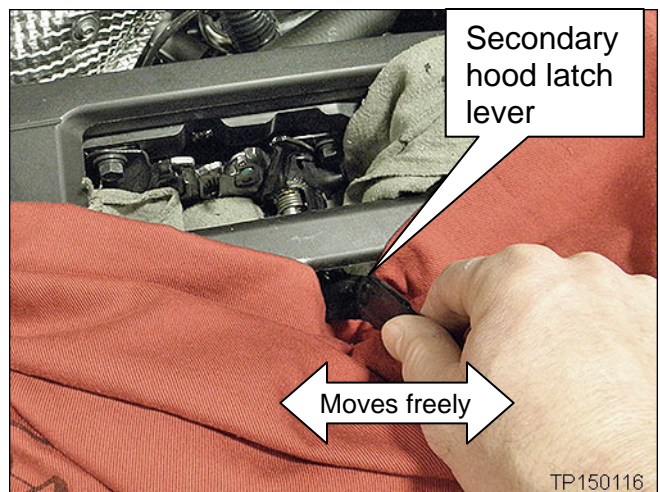
Figure 3

4. Move / cycle the secondary hood latch lever five times.

When the latch is released; does the latch move back to the fully closed position without sticking, as compared to a new latch?

- Yes – skip to step 7.
- No – go to the next step (step 5).

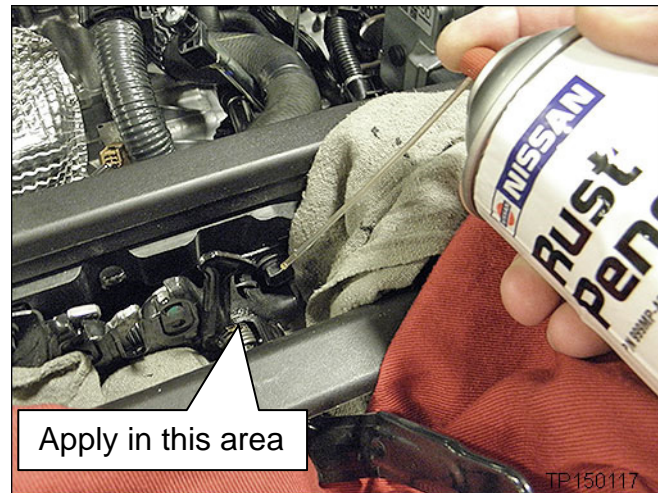
Figure 4

5. **Only if secondary hood latch sticks in step 4:**

Apply aerosol rust penetrant to the secondary hood latch.

- Use Nissan Rust Penetrant or equivalent.
- Use a spray extension tube to help direct the application.
- Apply to the pivot pin area and between latch lever and latch body.

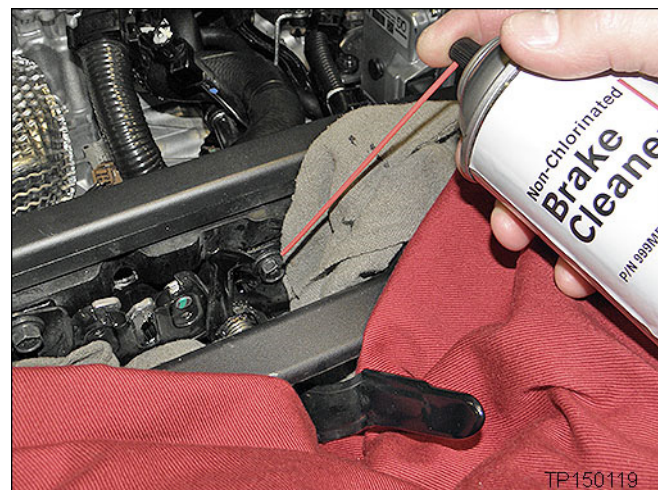
Figure 6

7. Remove / clean previous lubricants and debris from the secondary hood latch.

- Use brake clean or equivalent type cleaner that complies with local regulations.
- Use a spray extension tube to help direct the application.
- Clean the pivot pin area, and clean between latch lever and latch body.

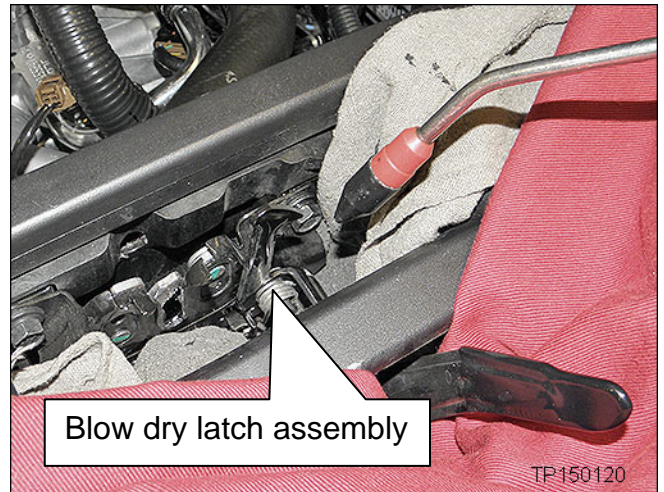
Figure 7

8. Use shop air to blow-dry the latch assembly before proceeding to the next step.

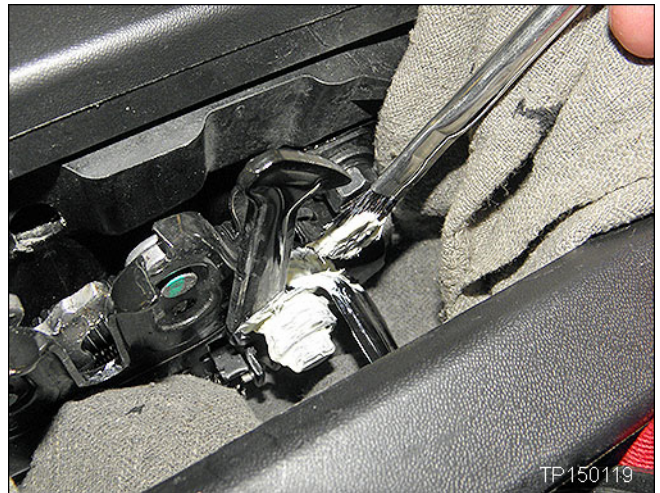
Figure 8

9. Apply non-aerosol white lithium grease to the secondary hood latch.
 - Do not use “spray-on” grease.
 - Apply the grease with a small brush
 - With the brush, work the grease onto the pivot pin area and between latch lever and latch body.
