## AFTERTREATMENT HYDROCARBON INJECTOR (AHI) – HARD FUEL LINE INSPECTION / REPLACEMENT

Prevost vehicles

**THIS SPECIAL BULLETIN CONSTITUTES THE SERVICE CENTER INSPECTION & REPAIR PROCEDURES APPLICABLE TO SAFETY RECALL SR15-04.**

## FSB 258-020, Aftertreatment Hydrocarbon Doser Fuel Line Change

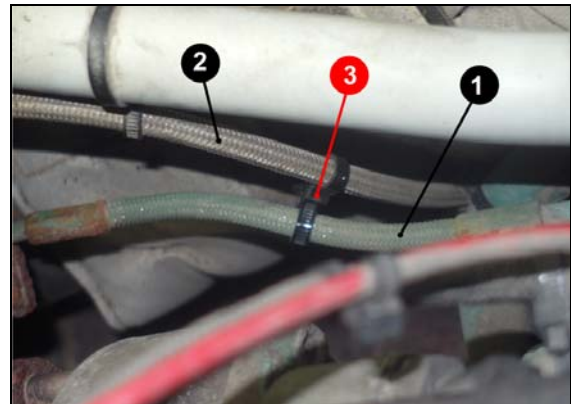
**FIGURE 2: PROPER INSTALLATION** (seen from above)  
1- AHI's hard fuel line  
2- Coolant line  
3- Double loop nylon tie

- 3) If the double loop nylon tie is present as shown in FIGURE 2, then the installation is correct. This completes this bulletin, no part replacement is required.

- 1) Service technicians, for the complete procedure, refer to Volvo document **FSB 258-020** available on Impact. **DO NOT FORGET TO INSTALL A DOUBLE LOOP NYLON TIE** as shown on FIGURE 2. Take note that a partial draining of the cooling system is enough while performing the replacement.

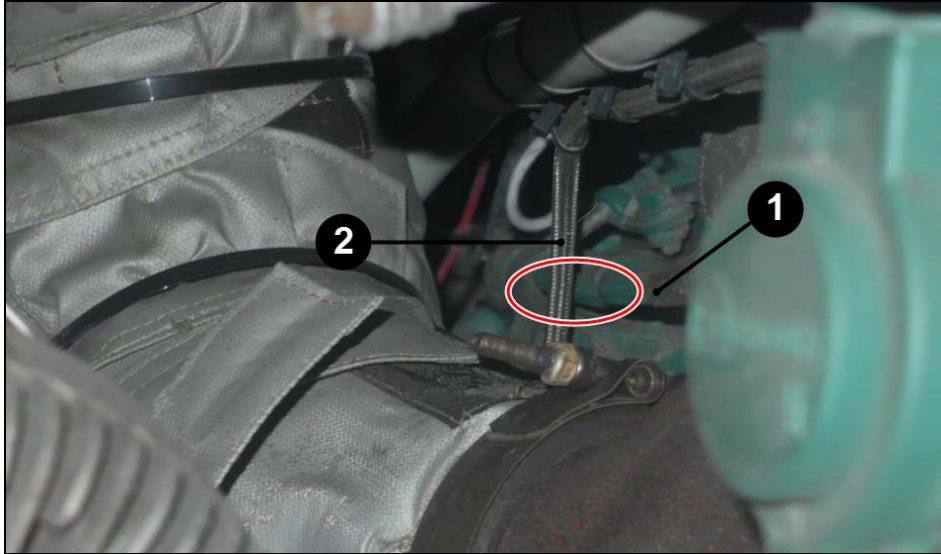
**FIGURE 3: MISSING DOUBLE LOOP NYLON TIE**  
1- AHJ's hard fuel line  
2- Coolant line

- 4) If, as in FIGURE 3 , **the nylon tie is missing or an inappropriate nylon tie is installed** (standard nylon tie as shown on FIGURE 5), there is a risk that the injector's hard fuel line be damaged by rubbing against the coolant line. The AHI's hard fuel line must be checked and if damaged, it must be replaced.

- 5) If the hard fuel line braided section shows evidence of rubbing and is damaged, then perform replacement as instructed in PART 2 of this document.

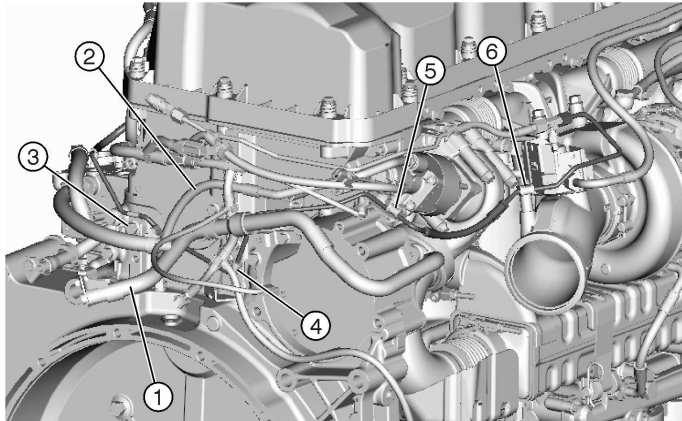
W2057937

1. Coolant Hard Pipe
  2. EGR Valve Oil Line
  3. M10 Screw (part number 946329), Air Line Bracket and M10 Clamp (part number 946219)
  4. Silicone Clamp (part number 20960413) at Bend of Line

5. Silicone Clamp (part number 20960413)
  6. Silicone Clamp (part number 20960413), Spacer (part number 847240) and M8 Screw (part number 948217)
- 16 Connect new hard fuel line to two-way check valve. Hand-tighten the fitting.

- 17 Connect the new hard fuel line to the flexible fuel line at the connector near the left rear of the engine.
- 18 Remove old M10 screw and install new screw through the air line bracket and M10 clamp. (Refer to item 3 in figure above)

- Note:** Install all clamps loosely. When all clamps are installed, tighten the fasteners.
- 19 Install silicone clamp on back of engine at the bend of the fuel line. (Refer to item 4 in figure above)

- 20 Install silicone clamp at right side of engine. Confirm that the bend in the fuel line is just outside the edge of the clamp and that the fuel line is not rubbing on the bracket. (Refer to item 5 in figure above)

- 21 Install silicone clamp with spacer and screw to turbocharger diffuser. (Refer to item 6 in figure above)

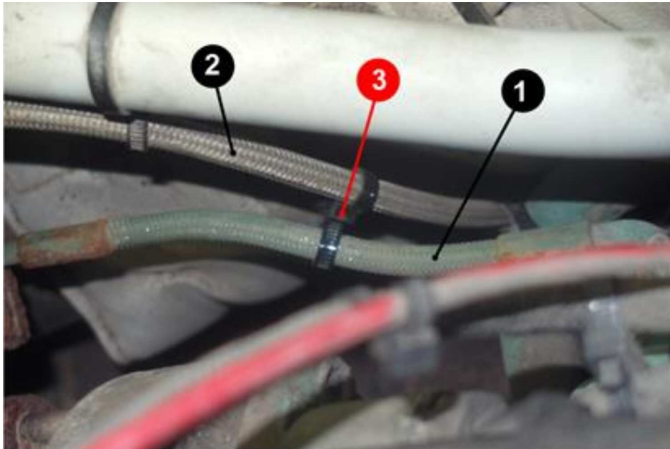
W2100336

- 22 If vehicle is equipped with Allison transmission, a double loop cable tie must be installed as shown to prevent rubbing between hard fuel line and nearby coolant line.

- 1. Hard Fuel Line
- 2. Coolant Line
- 3. Double Loop Cable Tie

Confirm that the line is not chafing anywhere before final tightening of the end fittings and fasteners. If the line is chafing anywhere, damage to the fuel line may result.
