<b>GROUP</b> <b>Safety Recall Campaign</b>	<b>MODEL</b> <b>2014~2015MY</b> <b>Soul (PS)</b> <b>2015MY</b> <b>Soul (PS EV)</b>
	<b>NUMBER</b> <b>SC 116</b>	<b>DATE</b> <b>March 2015</b>
<b>VOLUNTARY SAFETY RECALL CAMPAIGN</b>		
<b>SUBJECT: SOUL ACCELERATOR PEDAL (SC 116)</b>

This bulletin provides the procedure to install a rubber pad under the accelerator pedal of some Soul (PS) and Soul EV (PS EV) vehicles, produced from Job #1 through January 8, 2015. The accelerator pedal may fracture if the driver applies unanticipated excessive force on the pedal. Field information and testing indicates this can only occur when the vehicle is stationary. If the driver continues to operate the vehicle, this could impair acceleration on the road and increase the risk of a crash. To correct this concern, install the reinforcement rubber pad under the pedal by following the procedure outlined in this bulletin. Before conducting the procedure, verify the vehicle is included in the list of affected VINs.

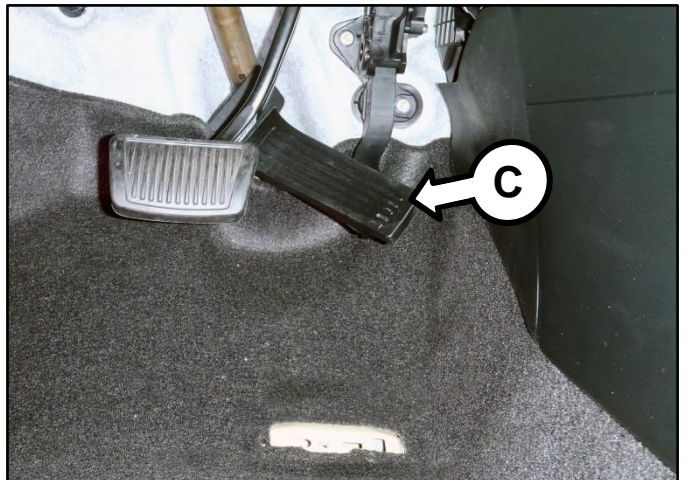
3. Gently rotate the accelerator pedal (C) to the left side, as shown.

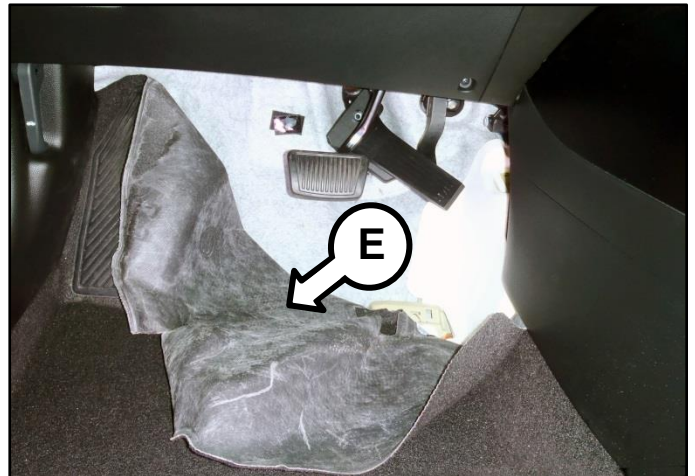
5. Remove the carpet (E) from the area under the pedals, as shown.

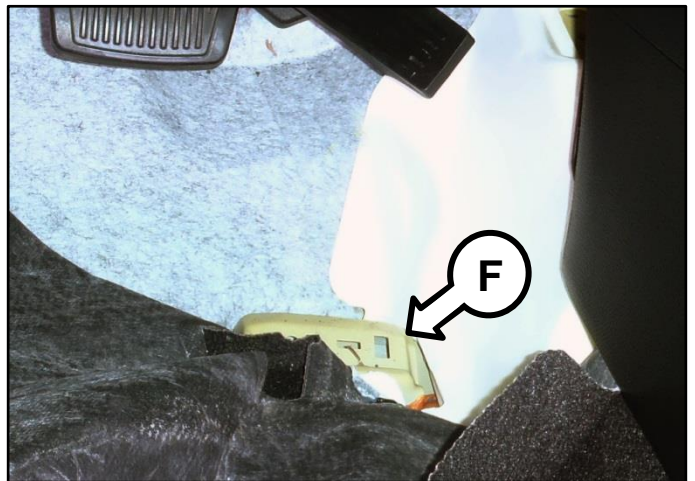
6. Locate the accelerator pedal mounting bracket (F) on the floor pan.

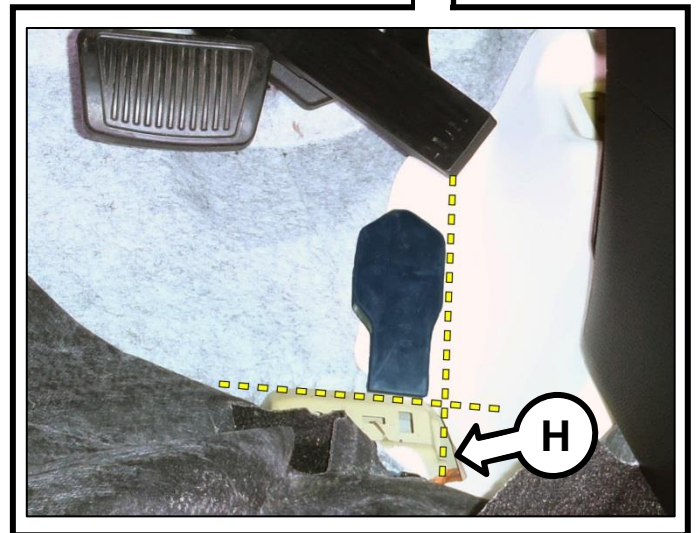
- 7. Align the rubber pad (G) with the right edge of the pedal mounting bracket (H), as shown.

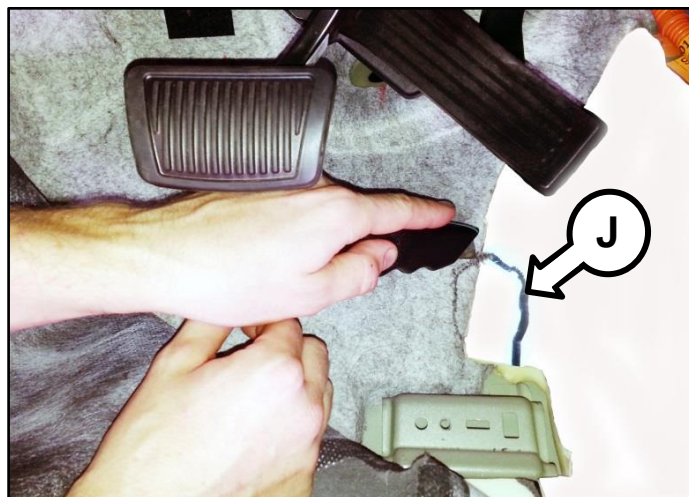
9. Use a sharp blade to cut the sound deadening material around the outline of the rubber pad (J), as shown.

Make sure to cut the outline as precisely as possible to ensure the rubber pad fits tightly in place.

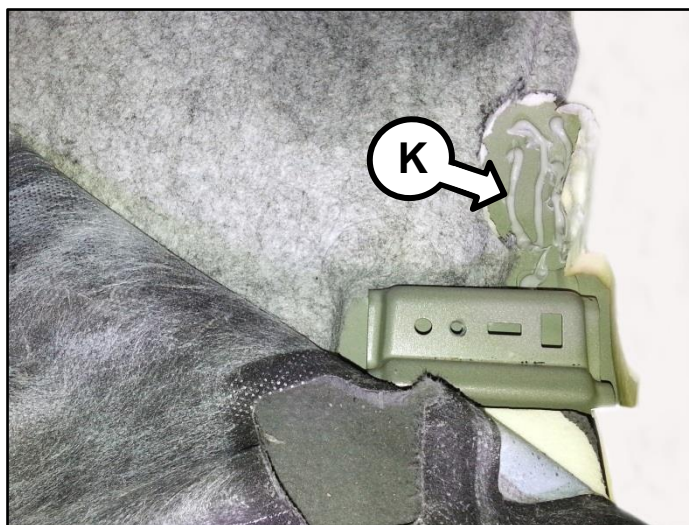
10. Apply several beads of Kia RTV Sealant (K), or equivalent, to the floor pan, as shown. **Note: One tube of RTV sealant should cover approximately ten (10) vehicles.**

Kia RTV Silicone Gasket Maker is recommended for this application.

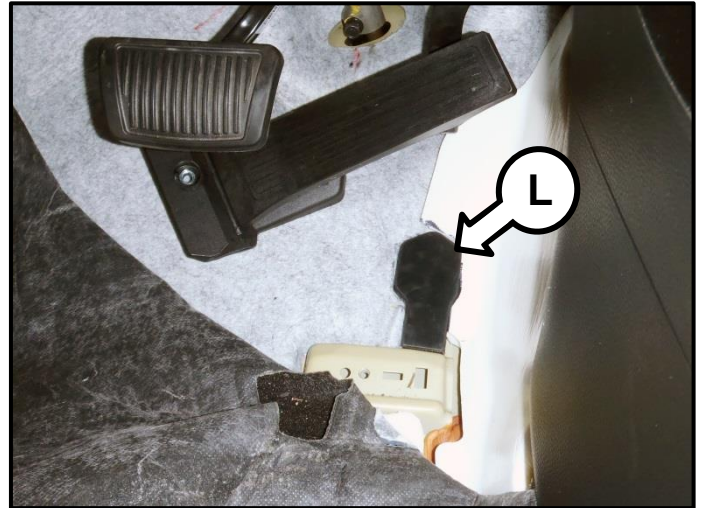
11. Install the rubber pad (L) into the cutout created in the sound deadening material, as shown.
