UPDATE! RECALL CAMPAIGN 15V-147: HEAD PROTECTION SYSTEM (RIGHT SIDE)

F15 (X5) produced from August 30, 2013 to February 18, 2015

BMW AG is conducting a voluntary Safety Recall involving the Head Protection System (HPS) on certain Model Year 2014 and 2015 X5 Sports Activity Vehicles (SAVs).

Due to a supplier production control error, the clamp which secures the HPS air bag to the gas generator is out of specification. As a result, it is possible that an insufficient inflation of the air bag could occur during activation of the HPS.

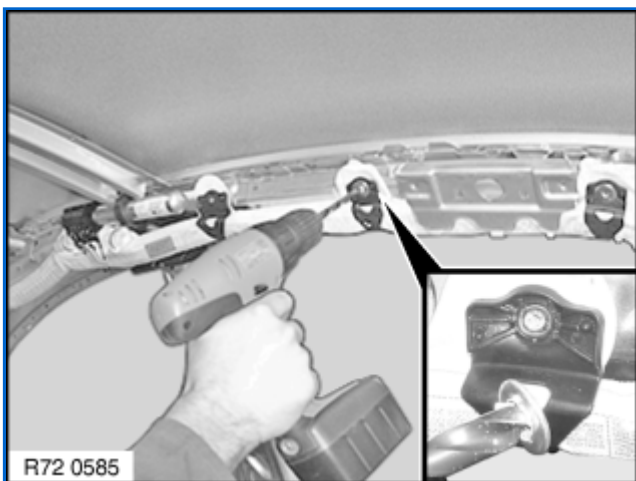
Schematic diagram of folding pack holder for head airbag:

Drill off rivet plate down to rivet shank with a 10 mm twist drill bit.

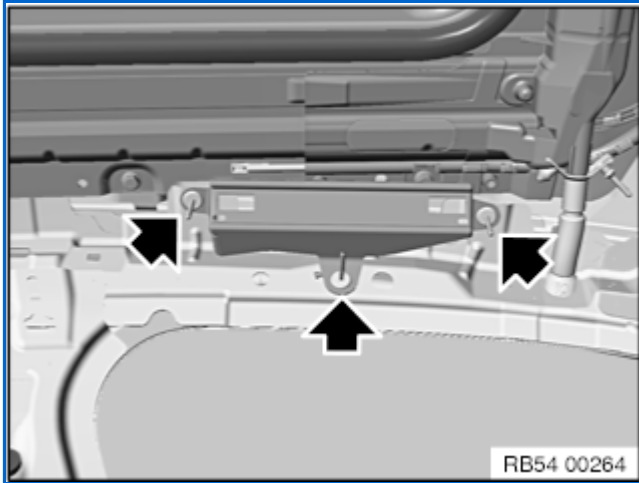
Described for grab handle holder:

Drill off rivet plate down to rivet shank with a 10 mm twist drill bit.

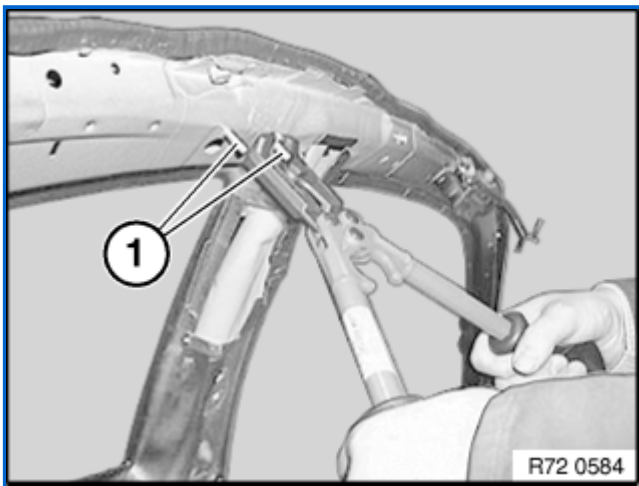
Cut off blind rivet shanks down to sheet metal as level as possible.

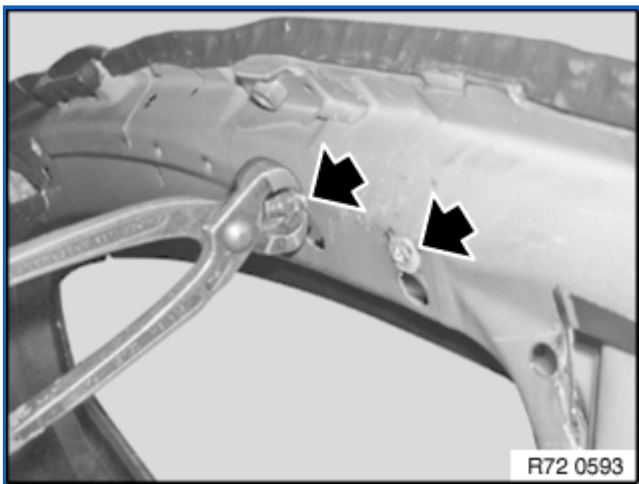
Deburr remaining rivets with nipper pliers.

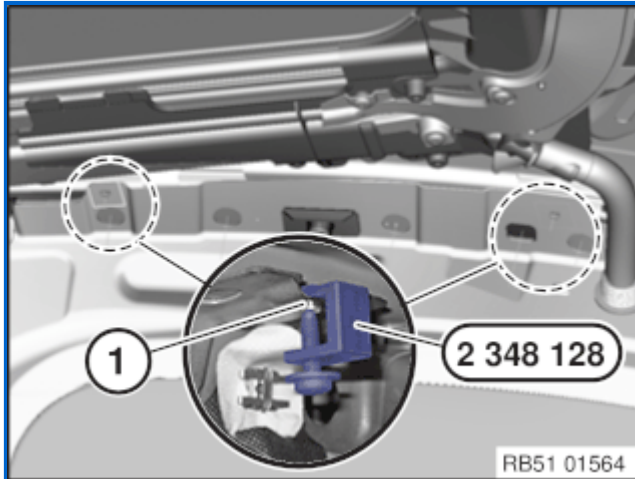
Press off rivet heads (1) using special tool 2 348 128 and remove.

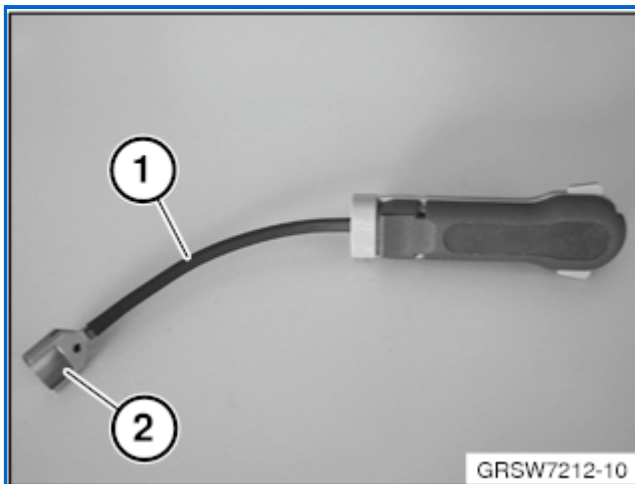
Special tool 72 1 210 for collecting rivet heads.

Shank (1) of special tool is flexible and can be adapted to the relevant body contours.

Insert butyl in the collecting tray (2) to secure rivet heads and prevent them from falling out.

Insert special tool 72 1 210 through bore hole in body next to attachment points.

Position special tool from rear on rivet head in cavity.

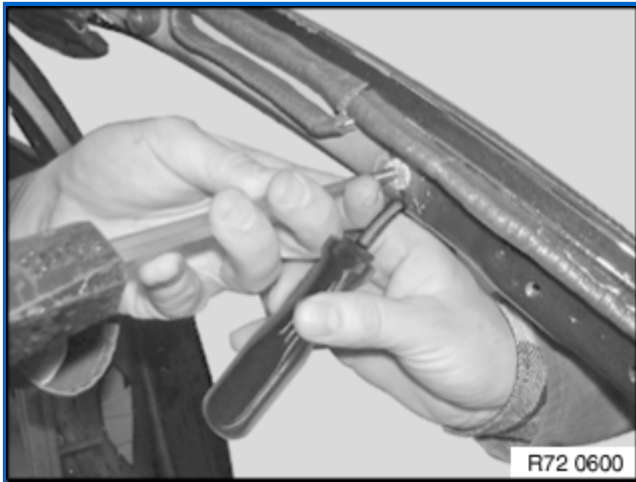
Drive out stem with hammer and 6 mm punch.

Carefully feed special tool out of body so that rivet head does not fall out of collecting tray.

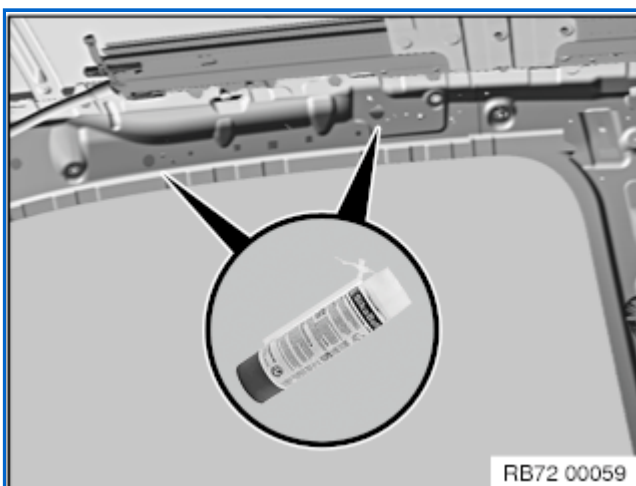
Fit tube to foam can.

Push the hose in through the pillar holes.

Fill cavity with a filling material.

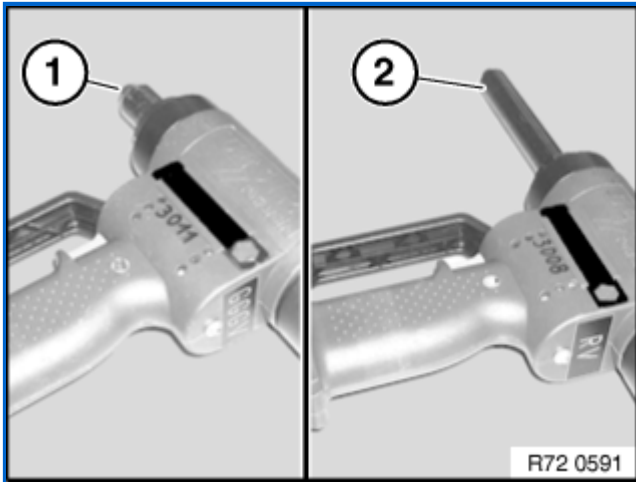
Overview of rivet gun:

Riveting of gas generator housing and holders for folding pack with rivet gun (refer to BMW Workshop Catalogue).

The interchangeable head is changed for the different work operations.

Riveting of gas generator housing with:

1.) 17/36 nosepiece and short shank

Riveting of holders for folding pack:

2.) 17/40 nosepiece and long shank

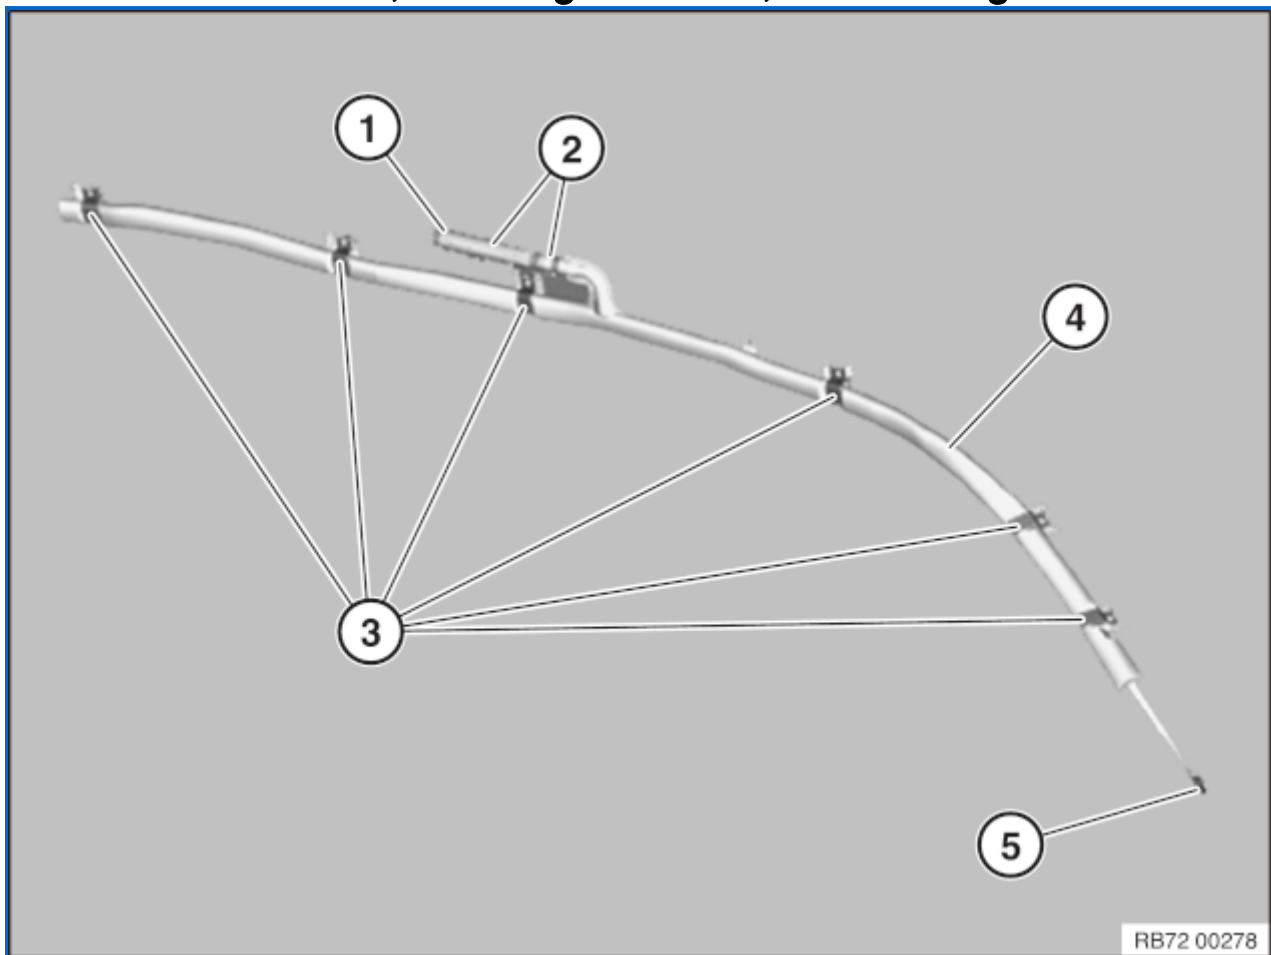
Installation overview, retaining elements, head airbag:

1 Gas generator

2 Rivets for gas generator

3 Retaining clips for folding pack

4 Folding pack, head airbag

5 Rivet for A-pillar end fitting retaining strap

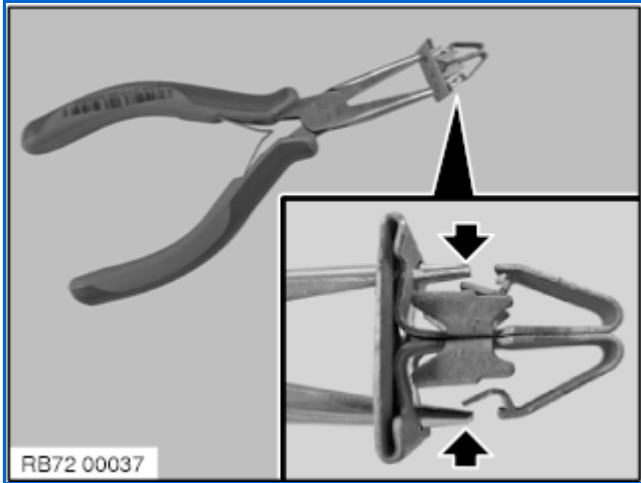
To detach the clamps, use special tool [72 0 020](#).

Push the left and right tabs together and pull clamp out.

Unlock and remove clamps (1) with flat-nose pliers.

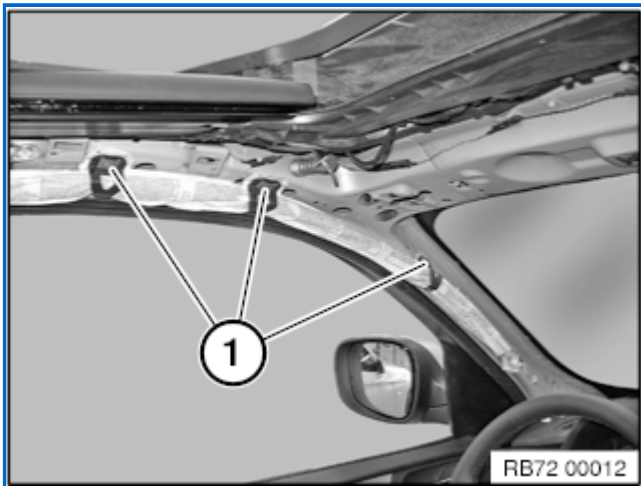
Unlock and remove clamps (1) with flat-nose pliers.

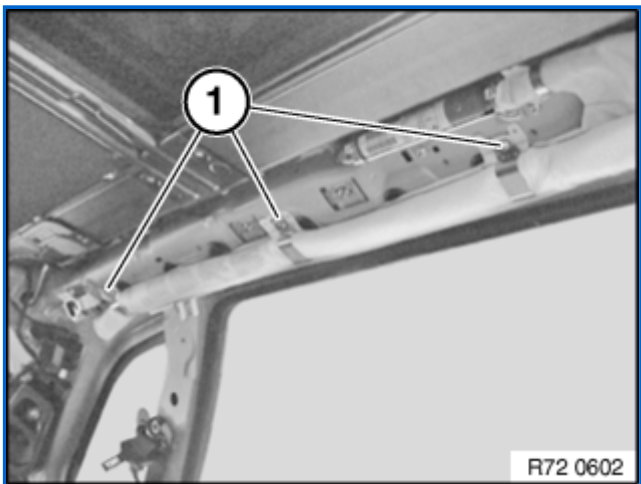
Drill out rivet head (1).

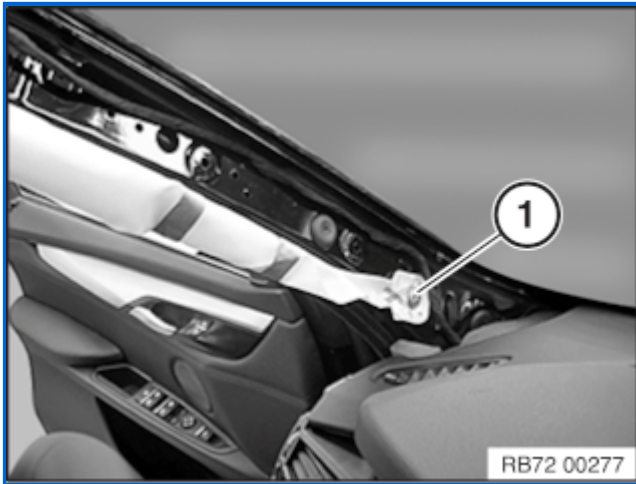
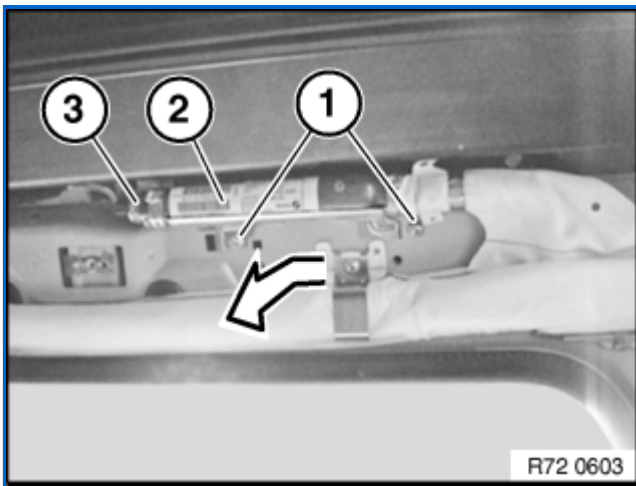
Unlock and disconnect the connector (3) for gas generator (2).

Drill out rivet heads (1).

Remove the gas generator (2) in direction of arrow.

Gas generator is coded against incorrect assembly.
