Bulletin No.: 15166A  
Date: March 2015

## F/CMVSS NONCOMPLIANCE RECALL

**SUBJECT:** Rim Size Missing on Certification Label

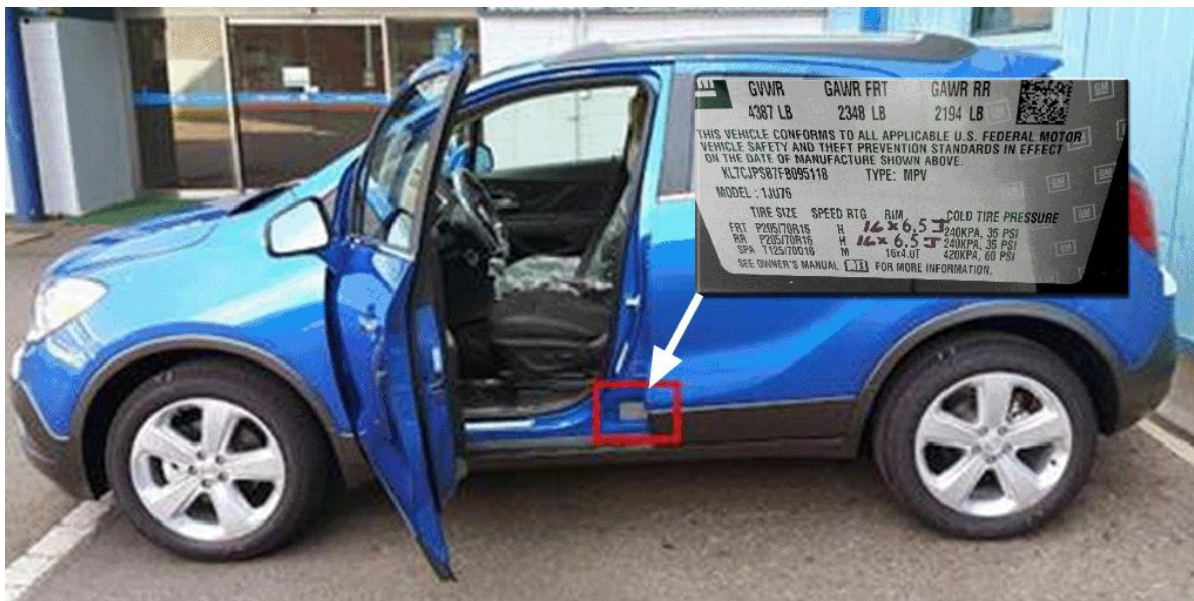
4122076

1. Locate Vehicle Certification Label on the lower section of the Driver Side B-Pillar.

2. Locate the blank RIM column on the label.
3. Clean the label (if required) and allow the surface to dry.
4. Using the chart below, locate the correct front (FRT) and rear (RR) wheel dimensions for the vehicle model you are working on.

5. Using a “Sharpie”® (or equivalent) Ultra Fine Point Black Permanent Marker write the vehicle RIM size as clearly and legibly as possible on the label as shown in the photograph.
