Safety Recall

Code: 20V5

Subject	Fuel Delivery Unit
Special Repair Notes	quattro vehicles (Criteria 04) REPAIR AVAILABLE Front-wheel drive vehicles (Criteria 03) REPAIR NOT YET AVAILABLE
Release Date	May 7, 2015
Affected Vehicles	U.S.A. & CANADA: 2015 MY Audi A3 with Gasoline Engine <i>Check Campaigns/Actions screen in Elsa on the day of repair to verify that a VIN qualifies for repair under this action. Elsa is the <u>only</u> valid campaign inquiry & verification source.</i> <ul style="list-style-type: none">ü Campaign status must show "open."ü If Elsa shows other open action(s), inform your customer so that the work can also be completed at the same time the vehicle is in the workshop for this campaign.
Problem Description	On some vehicles, contamination due to improper nickel plating of certain subcomponents within the fuel pump may cause excessive pump friction, potentially resulting in an inoperative fuel pump. If the fuel pump becomes inoperative due to this condition, it may result in a no-start condition or a stall while driving without warning, and without the ability to restart the vehicle. An engine stall without warning while driving can increase the risk of a crash.

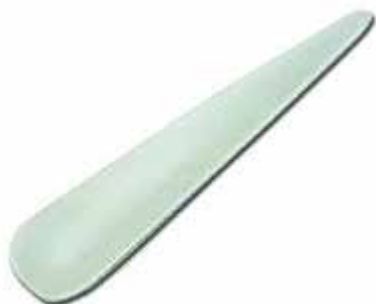
- Trim Removal Wedge - 3409

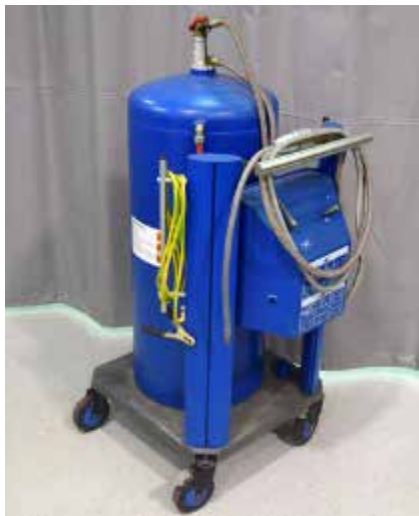
- Fuel Extracting Device – VAS5190
- OR**
- Fuel Extracting Device – VAS5190A (for vehicles filled with E85 fuel)

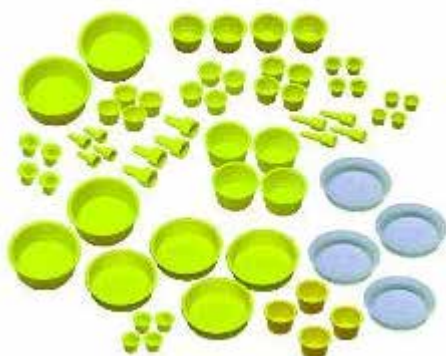
- Engine Bung Set – VAS6122

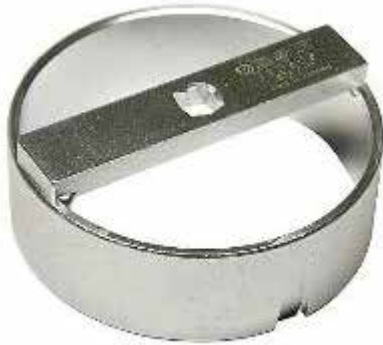
- Wrench – Fuel Sending Unit – T10202

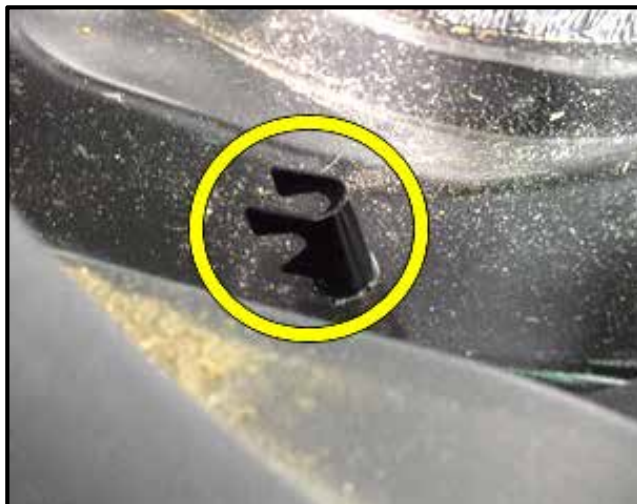
The rear frame of the seat bench engages locking fingers <circle> mounted to the vehicle body. During removal, it may be necessary to push the seat bench rearward slightly to disengage the locking fingers.

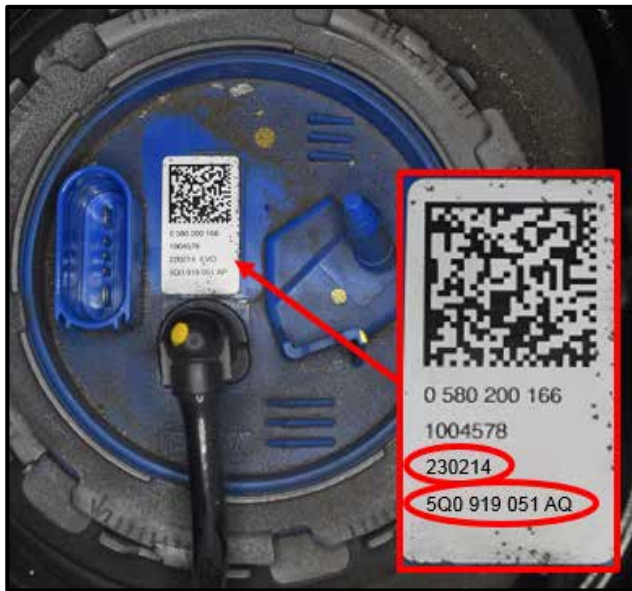
- Locate the label on top of the fuel delivery unit.
- Inspect the part number and build date of the fuel delivery unit <circles>.
- If the part number and build date are listed in the chart below, the fuel delivery unit **MUST** be replaced, **Proceed to Section C.**

NOTE
The electrical connector was removed in this step for picture clarity. It is **NOT** necessary to disconnect the wiring harness during this inspection step.

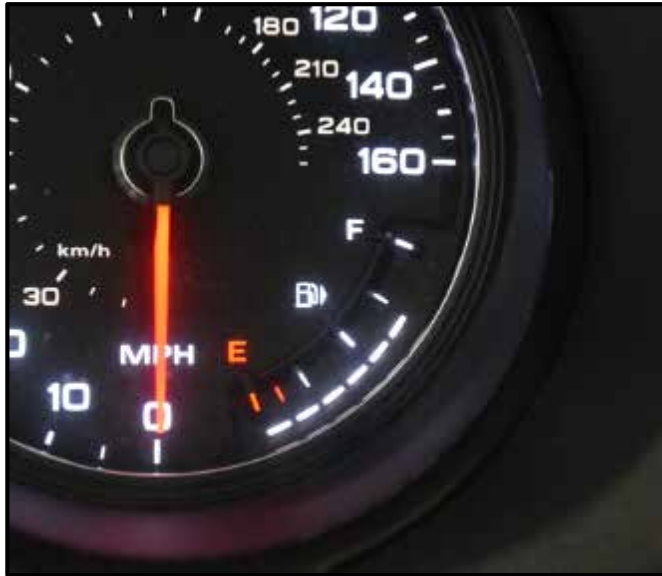
- Switch the ignition ON.
- Inspect the current fuel gauge reading.
- If the fuel gauge is **AT or ABOVE 3/4** <as shown>, the fuel tank must be partially drained prior to removing the fuel delivery unit, **Proceed with Section C.**
- If the fuel gauge is **BELOW 3/4**, the fuel delivery unit can be removed without performing this portion of the fuel draining procedure. **Proceed to Section D – Fuel Delivery Unit Replacement.**

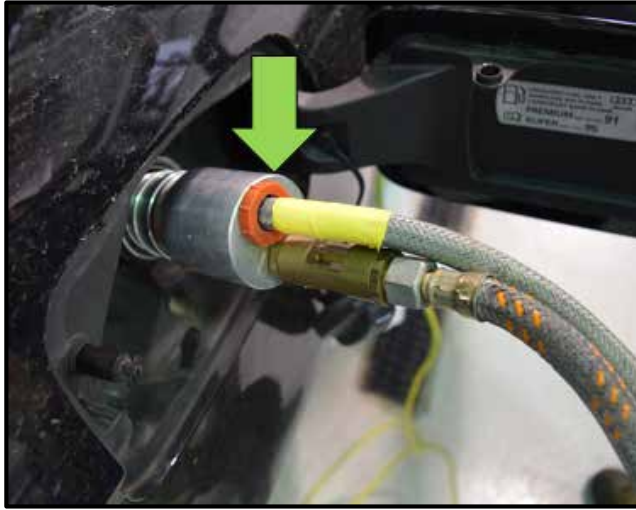
- Insert the extraction hose and fuel filler hose adapter on the VAS5190 into the fuel filler tube until the marking made previously <arrow> aligns with the fuel filler tube adapter as shown.
- Drain the fuel tank as much as possible through the fuel filler tube.

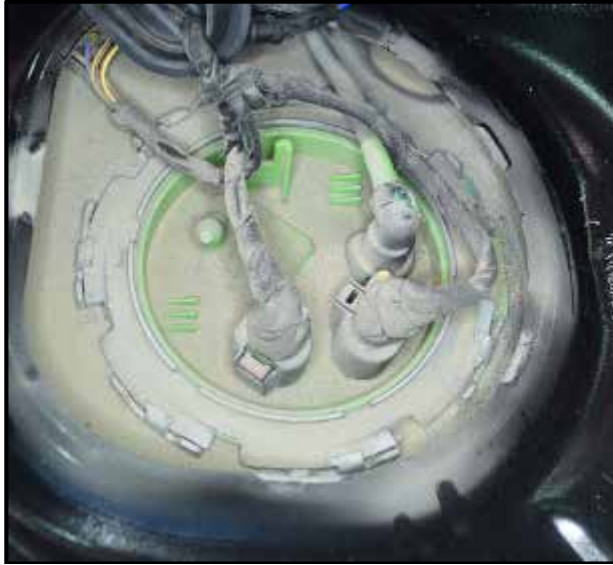
- Prior to disassembly, the fuel delivery unit **MUST** be clean. If excessive dirt or debris is present <as shown>, clean and dry the fuel delivery unit and surrounding areas as necessary.

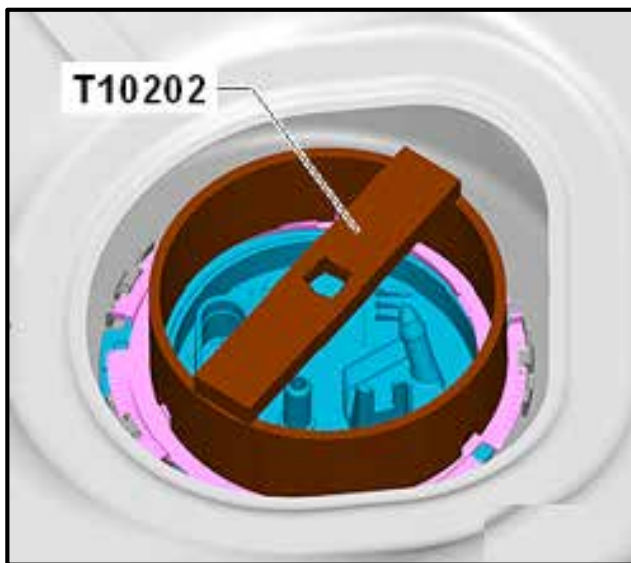
- Remove the locking ring using the Wrench – Fuel Sending Unit – T10202 <as shown>.

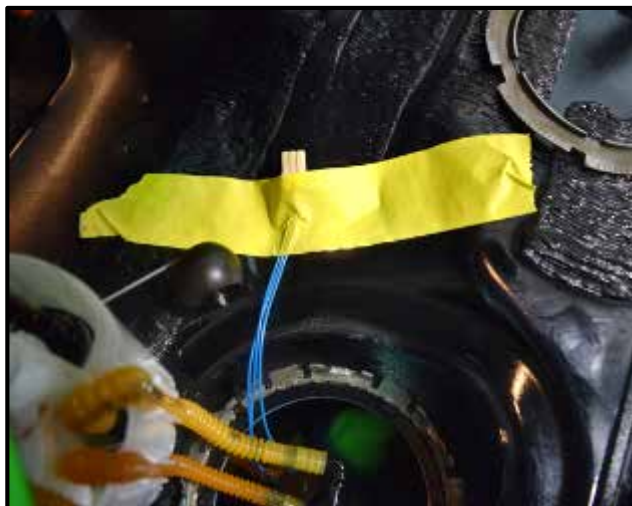
i TIP
 To avoid dropping the electrical connector and wiring harness into the fuel tank, the harness can be taped to the side <as shown>.

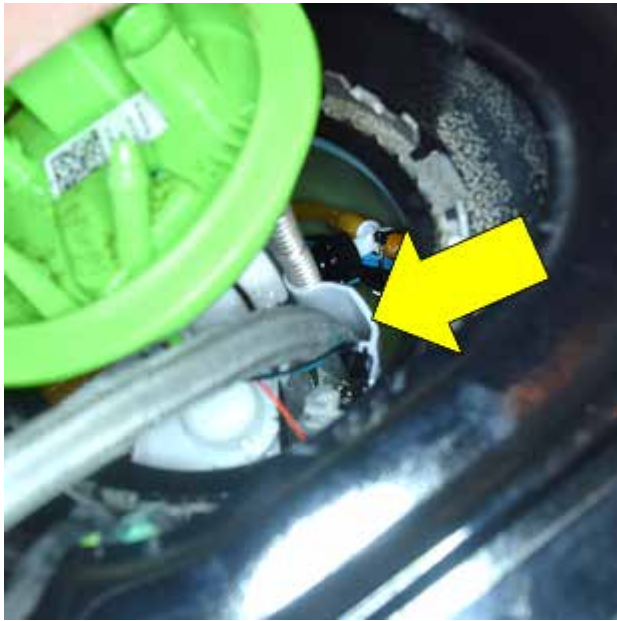
- Position the fuel delivery unit to the side.
- Insert the extraction hose from the VAS5190 into the fuel tank.
- Drain additional fuel out of the tank until the fuel level reaches approximately ¼ tank.
- Insert the extraction hose into the fuel delivery unit <arrow>.
- Drain as much fuel as possible from the fuel delivery unit itself.

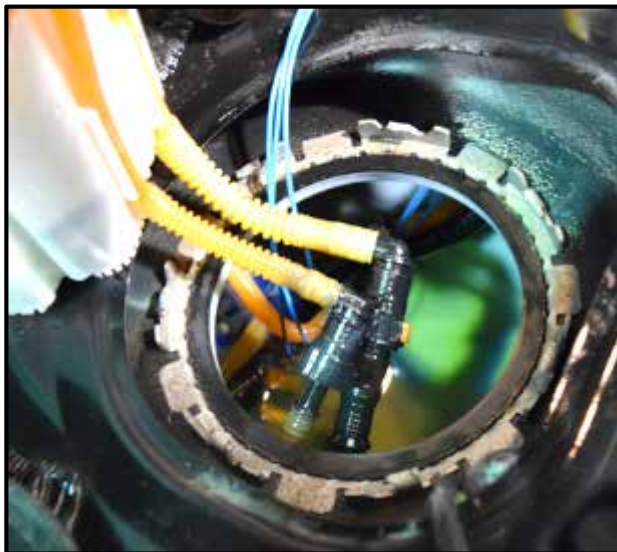
- Lay a cloth inside the vehicle to absorb any residual fuel.
- Turn and tilt the fuel delivery unit <1> with the fuel level sensor <2> as necessary to remove it through the opening in the fuel tank.

- The fuel delivery unit cannot be fully removed from the fuel tank at this point. Lift the fuel delivery unit high enough to access the lines from the suction jet pump as shown.
- Be careful when moving the fuel lines during this step. Fuel lines can be damaged with excessive force. Damage to the in-tank fuel lines is not covered under this action.

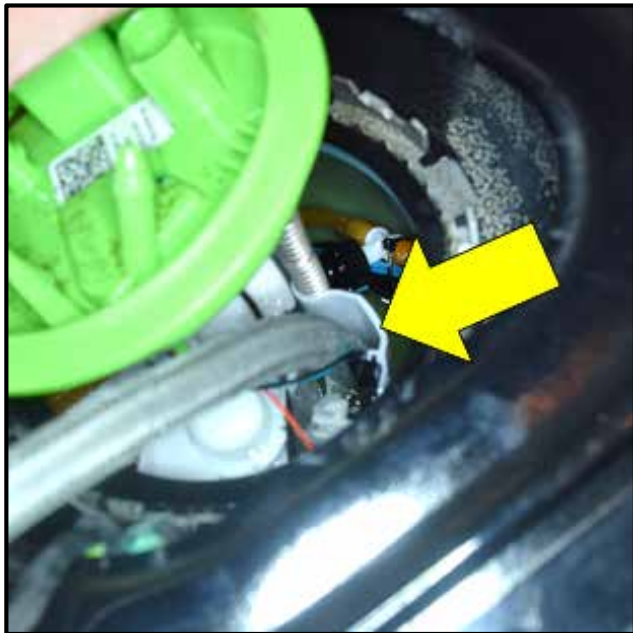
- Position the fuel delivery unit to the side.
- Insert the extraction hose from the VAS5190 into the fuel tank.
- Drain additional fuel out of the tank until the fuel level reaches approximately ½ tank.
- Insert the extraction hose into the fuel delivery unit <arrow>.
- Drain as much fuel as possible from the fuel delivery unit itself.

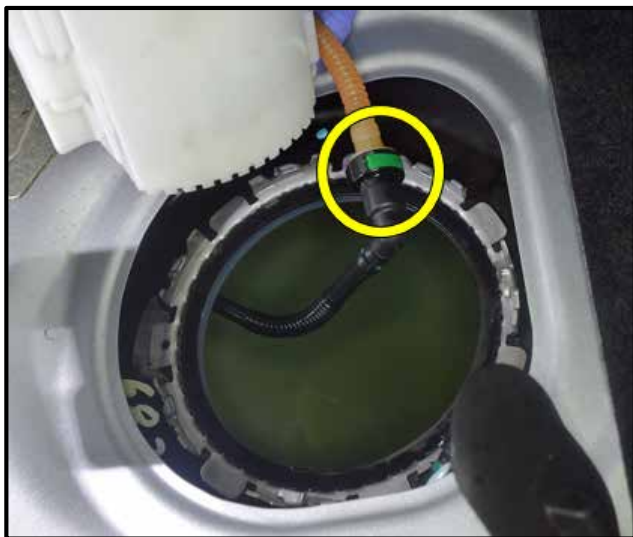
- Lay a cloth inside the vehicle to absorb any residual fuel.
- Carefully pull the fuel delivery unit with Fuel Level Sensor -G- out through the opening in the fuel tank.
- Turn and tilt the fuel delivery unit as needed.
- Disconnect the breather tube <circle> from the bottom of the fuel delivery unit.
- Remove the fuel delivery unit from the vehicle.

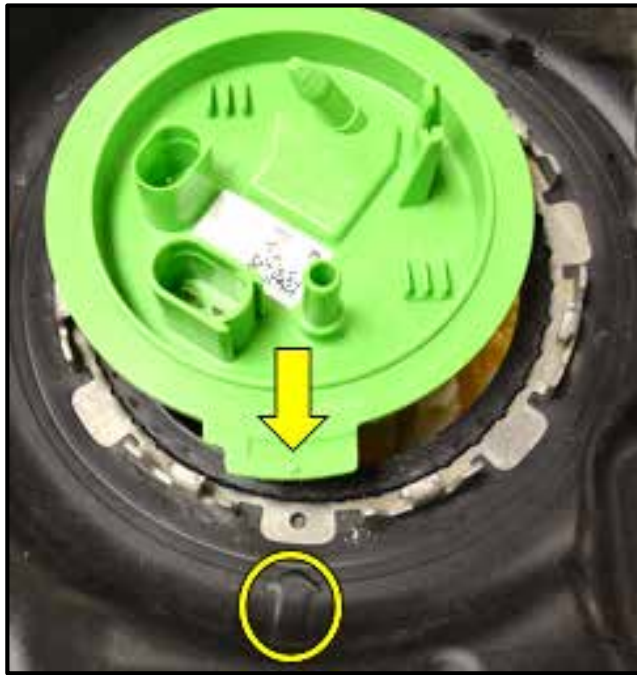
- Position the new fuel delivery unit, P/N: 5Q0919087R near the fuel tank opening.
- Reconnect the suction jet line <1> and the delivery line <2> to the fuel delivery unit fittings.
- Carefully insert the new fuel delivery unit into the fuel tank.

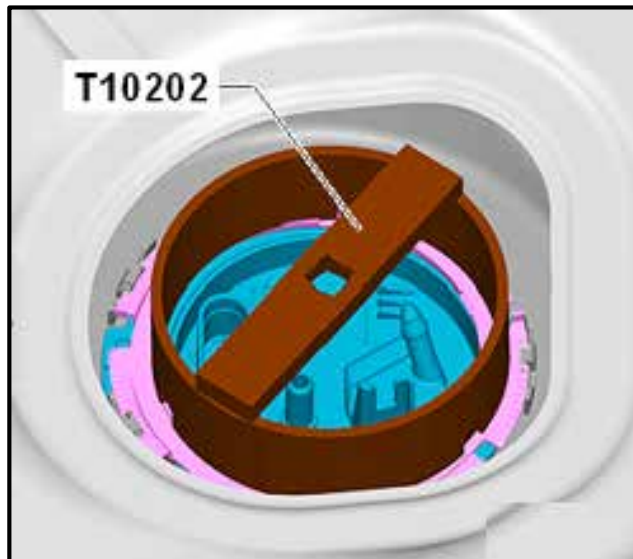
- Press the top of the fuel delivery unit down into the fuel tank opening.
- The arrow <3> on the fuel tank must point to the mark <2> on the locking flange <1>.

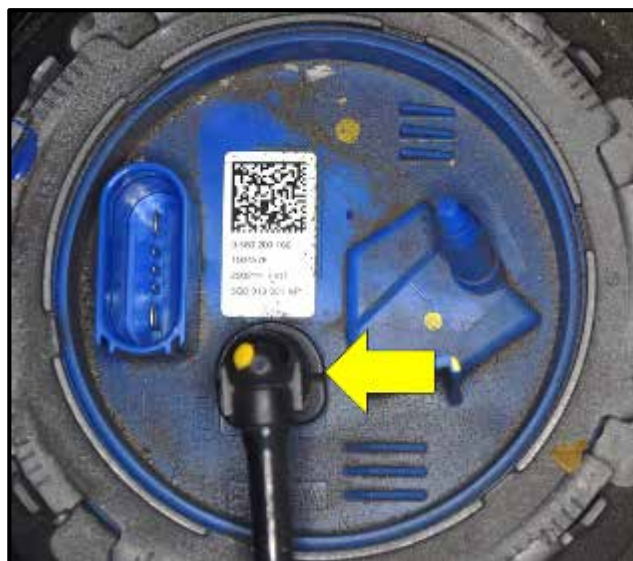
- Install the locking ring, and tighten using the Wrench – Fuel Sending Unit – T10202, and torque to 110Nm.
