Safety Recall

Code: 20W5

Subject	Fuel Delivery Unit
Release Date	June 16, 2015
Affected Vehicles	U.S.A. & CANADA: 2015 MY Golf/GTI with Gasoline Engine <i>Check Campaigns/Actions screen in Elsa on the day of repair to verify that a VIN qualifies for repair under this action. Elsa is the <u>only</u> valid campaign inquiry & verification source.</i> <ul style="list-style-type: none">✓ Campaign status must show "open."✓ If Elsa shows other open action(s), inform your customer so that the work can also be completed at the same time the vehicle is in the workshop for this campaign.
Problem Description	On some vehicles, contamination due to improper nickel plating of certain subcomponents within the fuel pump may cause excessive pump friction, potentially resulting in an inoperative fuel pump. If the fuel pump becomes inoperative due to this condition, it may result in a no-start condition or a stall while driving without warning, and without the ability to restart the vehicle. An engine stall without warning while driving can increase the risk of a crash.

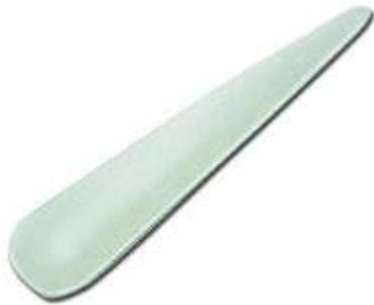
- Trim Removal Wedge - 3409

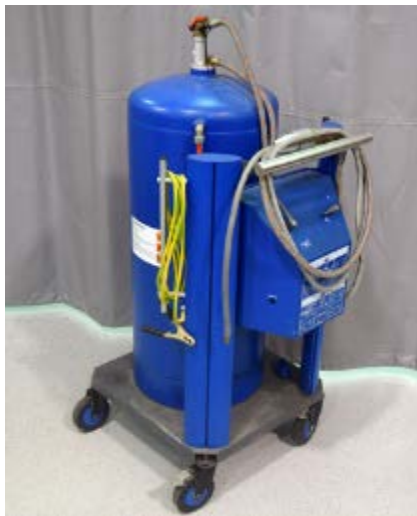
- Fuel Extracting Device – VAS5190
- OR**
- Fuel Extracting Device – VAS5190A (for vehicles filled with E85 fuel)

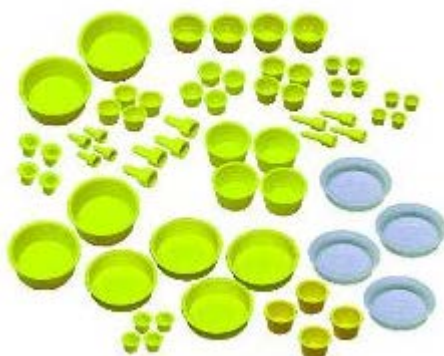
- Engine Bung Set – VAS6122

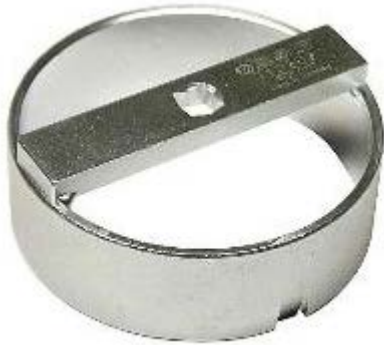
- Wrench – Fuel Sending Unit – T10202

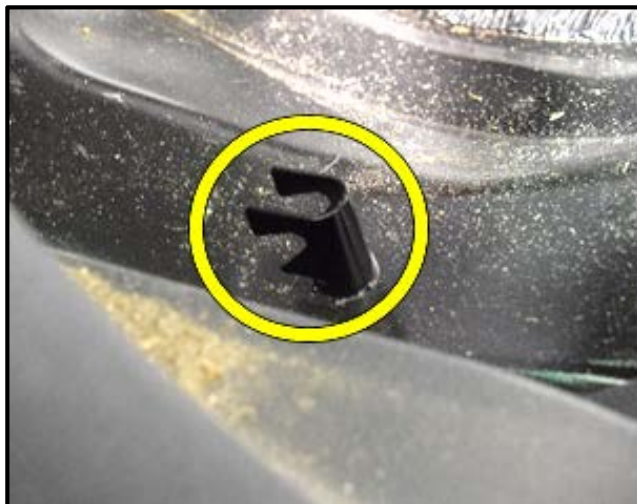
The rear frame of the seat bench engages locking fingers <circle> mounted to the vehicle body. During removal, it may be necessary to push the seat bench rearward slightly to disengage the locking fingers.

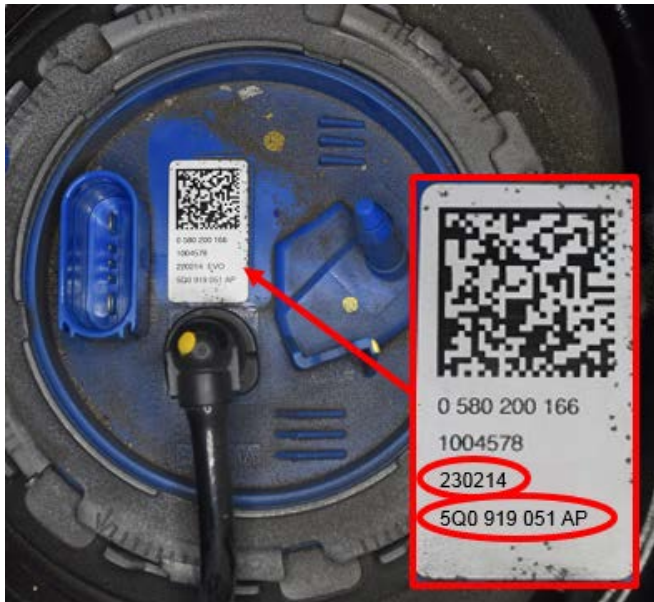
- Locate the label on top of the fuel delivery unit.
- Inspect the part number and build date of the fuel delivery unit <circles>.
- Reference the chart below using the part number and build date of the fuel delivery unit.
- If the part number and build date are listed in the chart below, the fuel delivery unit **MUST** be replaced, **Proceed to Section C**.
- If the part number and build date are **NOT** listed in the chart below, no further work is required, reassemble the vehicle and **Proceed to Section D**.

Part Number	Production Date – Replace fuel delivery unit ONLY if the production date matches one of the numbers below:		
5Q0 919 051 AP (FWD)	010314	040314	240214
	020114	050114	250214
	020314	060114	260214
	030114	070114	270214
	030314	101213	280214
	040114	230214

NOTE
Fuel delivery unit P/N: 5Q0 919 051 BK may also be installed in the vehicle. If the “BK” suffix part number is present on the label, the fuel delivery unit does **NOT** need to be replaced.

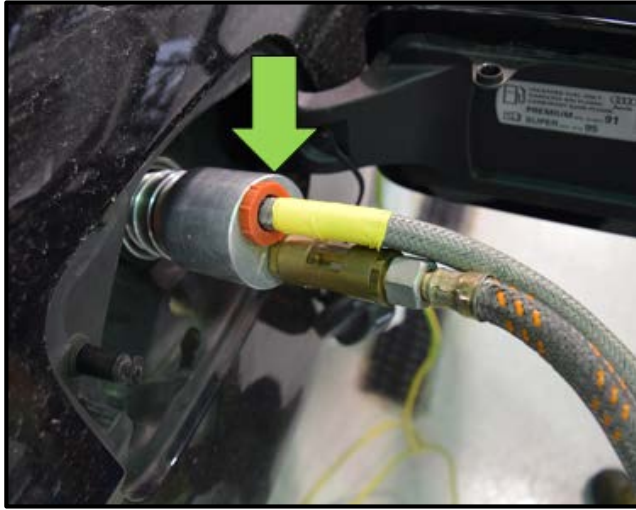
- Insert the extraction hose and fuel filler hose adapter of the VAS5190 into the fuel filler tube until the marking made previously <arrow> aligns with the fuel filler tube adapter as shown.
- Drain the fuel tank as much as possible through the fuel filler tube.

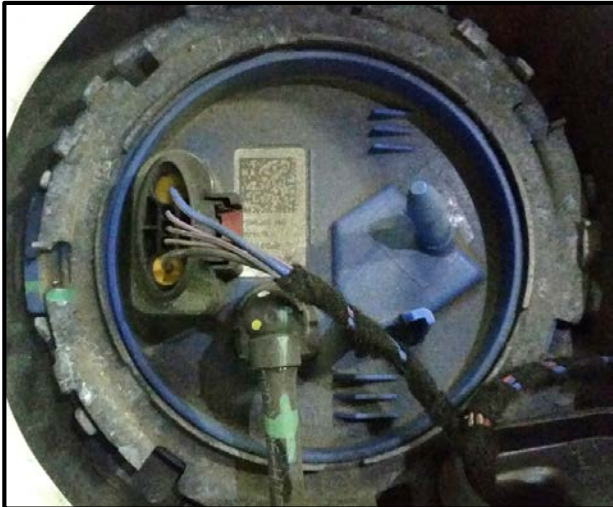
- Prior to disassembly, the fuel delivery unit **MUST** be clean. If excessive dirt or debris is present <as shown>, clean and dry the fuel delivery unit and surrounding areas as necessary.

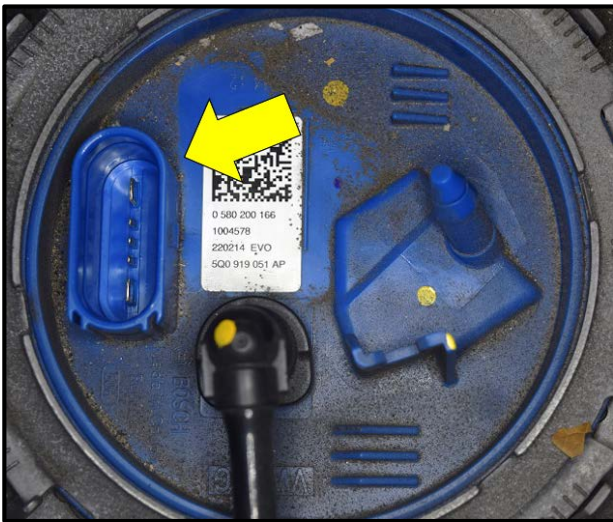
- At the fuel delivery unit, unlock and disconnect the connector <arrow> from the locking flange.

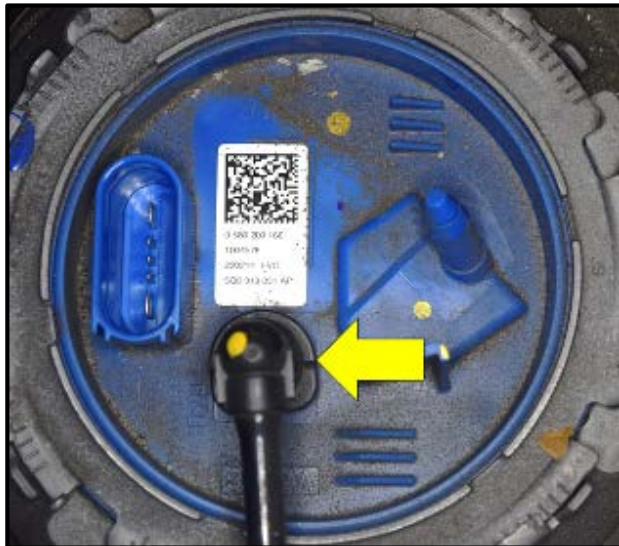
- Disconnect the fuel line <arrow> from the locking flange.

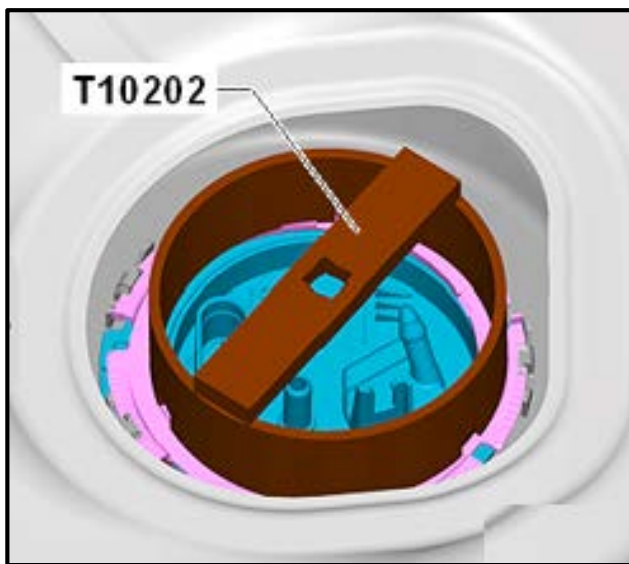
- Remove the locking ring using the Wrench – Fuel Sending Unit – T10202 <as shown>.

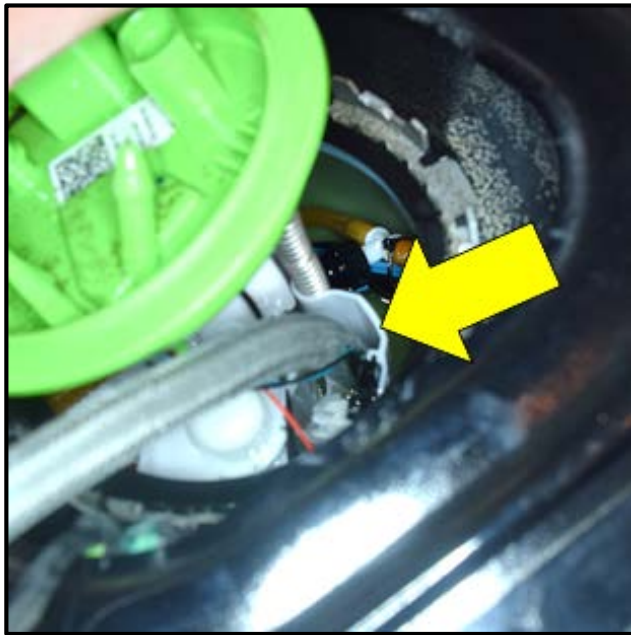
- Position the fuel delivery unit to the side.
- Insert the extraction hose from the VAS5190 into the fuel tank.
- Drain additional fuel out of the tank until the fuel level reaches approximately $1/2$ tank.
- Insert the extraction hose into the fuel delivery unit <arrow>.
- Drain as much fuel as possible from the fuel delivery unit itself.

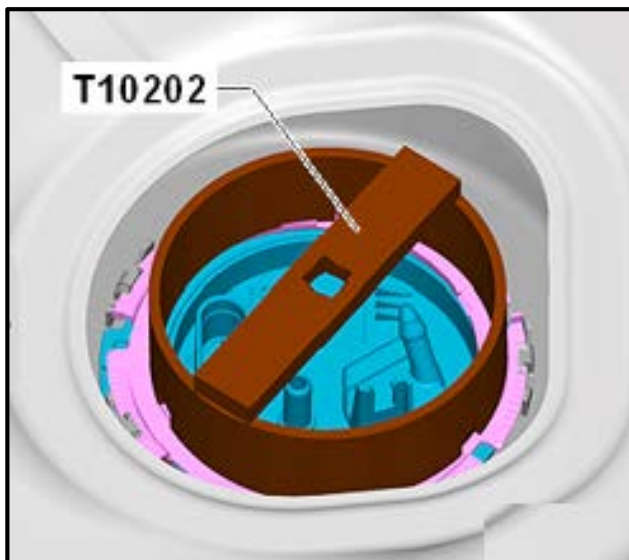
- Install the locking ring, and tighten using the Wrench – Fuel Sending Unit – T10202, and torque to 110Nm.

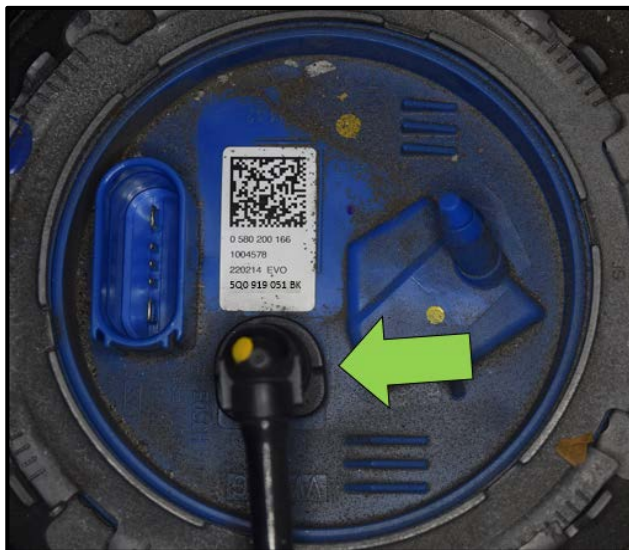
- Attach the fuel line <1> to the locking flange until it clicks into place.

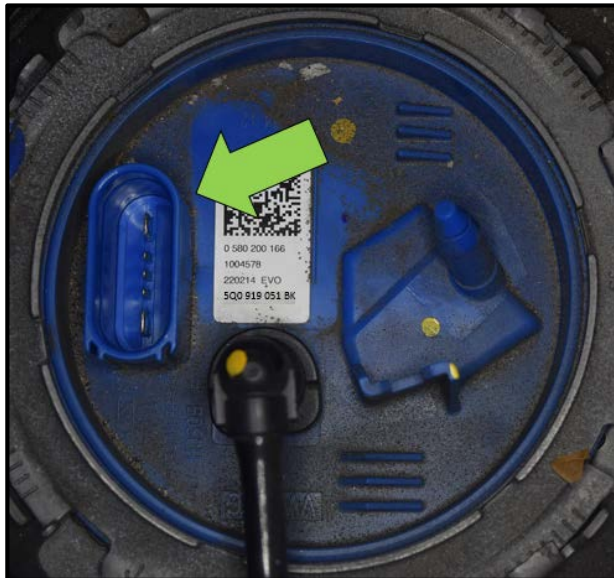
- Securely refasten the connector <arrow>.
- Reinstall the fuel pump control module.
- Reinstall the fuel delivery unit access cover.
- Refasten the wiring harness grommet into the cover.
- Reinstall the rear bench seat.
- Reinstall the child seat anchor covers.
- Reconnect the vehicle battery.
- Switch the ignition ON.
- Attach an appropriate VAS tester to the vehicle.
- Clear all DTCs.
- Reset customer convenience basic settings (i.e. one touch windows, instrument cluster clock, etc.).
- Refill the fuel tank with any fuel that was extracted previously.
