# Safety Recall

## Code: 20V5

Audi

<b>Subject</b>	<b>Fuel Delivery Unit</b>
<b>Release Date</b>	June 16, 2015
<b>Revision Summary</b>	Repair is now available for front wheel drive vehicles (criteria 03).
<b>Affected Vehicles</b>	<b>U.S.A. &amp; CANADA: 2015 MY Audi A3 with Gasoline Engine</b> <i>Check Campaigns/Actions screen in Elsa on the day of repair to verify that a VIN qualifies for repair under this action. Elsa is the <u>only</u> valid campaign inquiry &amp; verification source.</i> <ul style="list-style-type: none"><li>✓ Campaign status must show "open."</li><li>✓ If Elsa shows other open action(s), inform your customer so that the work can also be completed at the same time the vehicle is in the workshop for this campaign.</li></ul>
<b>Problem Description</b>	On some vehicles, contamination due to improper nickel plating of certain subcomponents within the fuel pump may cause excessive pump friction, potentially resulting in an inoperative fuel pump. If the fuel pump becomes inoperative due to this condition, it may result in a no-start condition or a stall while driving without warning, and without the ability to restart the vehicle. An engine stall without warning wh

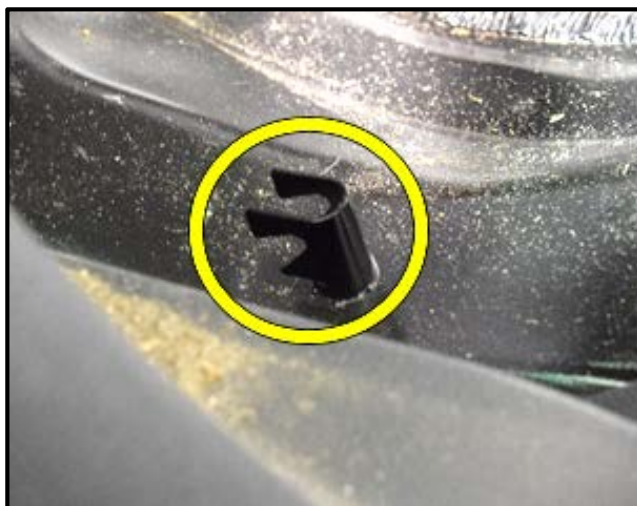
The rear frame of the seat bench engages locking fingers <circle> mounted to the vehicle body. During removal, it may be necessary to push the seat bench rearward slightly to disengage the locking fingers.

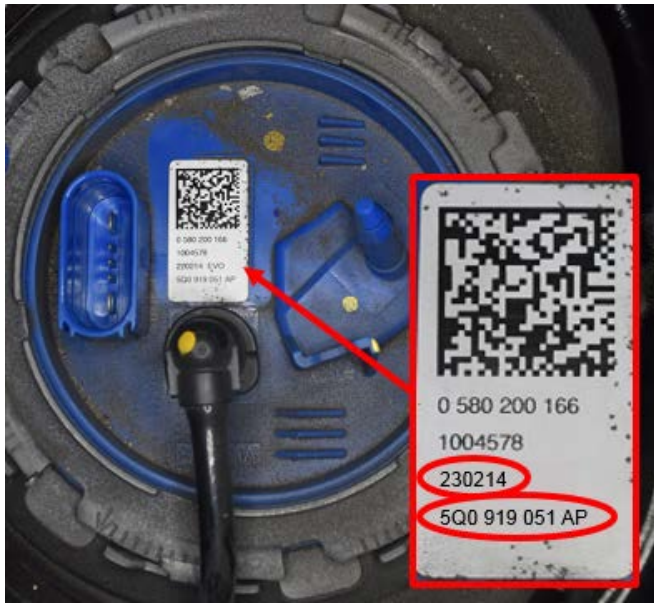
- Locate the label on top of the fuel delivery unit.
- Inspect the part number and build date of the fuel delivery unit <circles>.
- Reference the chart below using the part number and build date of the fuel delivery unit.
- If the part number and build date are listed in the chart below, the fuel delivery unit **MUST** be replaced, **Proceed to Section C**.
- If the part number and build date are **NOT** listed in the chart below, no further work is required, reassemble the vehicle and **Proceed to Section E**.

Part Number	Production Date – Replace fuel delivery unit <b>ONLY</b> if the production date matches one of the numbers below:		
5Q0 919 051 AP (FWD)	010314	040314	240214
	020114	050114	250214
	020314	060114	260214
	030114	070114	270214
	030314	101213	280214
	040114	230214

**NOTE**  
Fuel delivery unit P/N: 5Q0 919 051 BK may also be installed in the vehicle. If the “BK” suffix part number is present on the label, the fuel delivery unit does **NOT** need to be replaced.

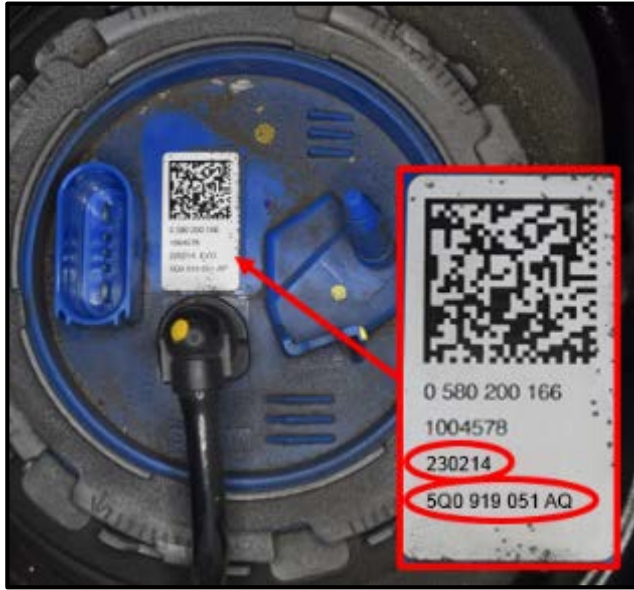
- Locate the label on top of the fuel delivery unit.
- Inspect the part number and build date of the fuel delivery unit <circles>.
- Reference the chart below using the part number and build date of the fuel delivery unit.
- If the part number and build date are listed in the chart below, the fuel delivery unit **MUST** be replaced, **Proceed to Section C.**

**NOTE**  
The electrical connector was removed in this step for picture clarity. It is **NOT** necessary to disconnect the wiring harness during this inspection step.

5Q0 919 051 AQ (Quattro)	010314	050114	080314
	020314	050314	090314
	030114	060114	100314
	030314	060314	101213
	040114	070114	270214
	040314	070314	280214

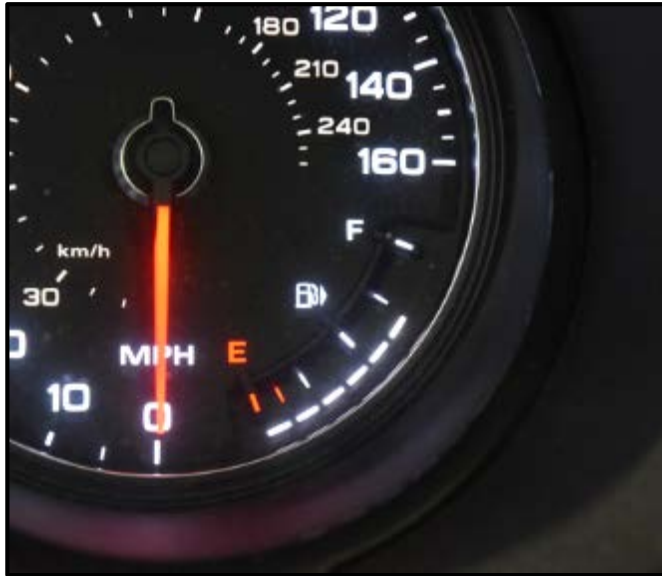
- Switch the ignition ON.
- Inspect the current fuel gauge reading.
- If the fuel gauge is **AT or ABOVE 3/4** <as shown>, the fuel tank must be partially drained prior to removing the fuel delivery unit, **continue with this section**.
- If the fuel gauge is **BELOW 3/4**, the fuel delivery unit can be removed without performing this portion of the fuel draining procedure. **Proceed to Section D**

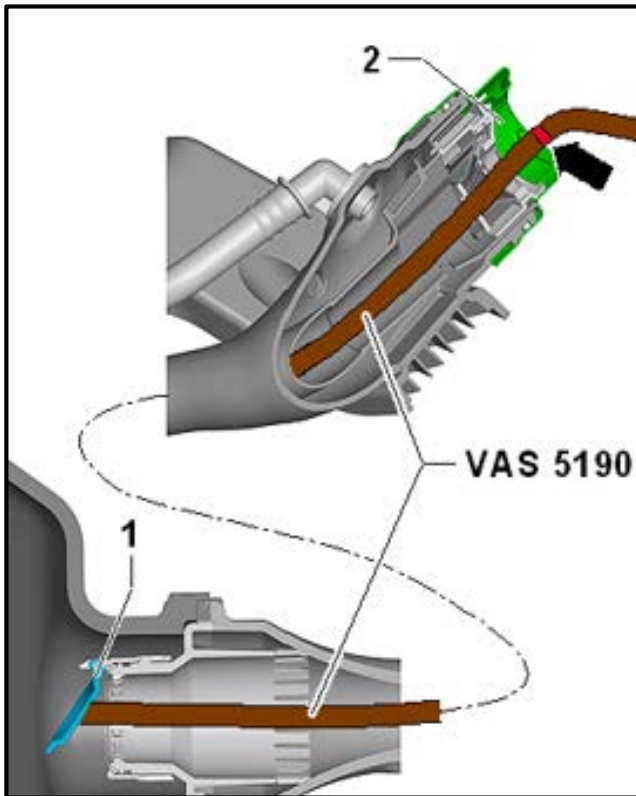
- A flap <1> is located in the fuel tank on the lower end of the fuel filler tube. It must not be damaged by the extraction hose. Only slide the hose into the fuel filler tube until the tape mark lines up with the top of the fuel filler tube <arrow>.
- Do not use force to pull the extraction hose if it gets stuck on the check valve.
- If the extraction hose becomes lodged in the check valve, remove the fuel delivery unit manually and hold the check valve open.

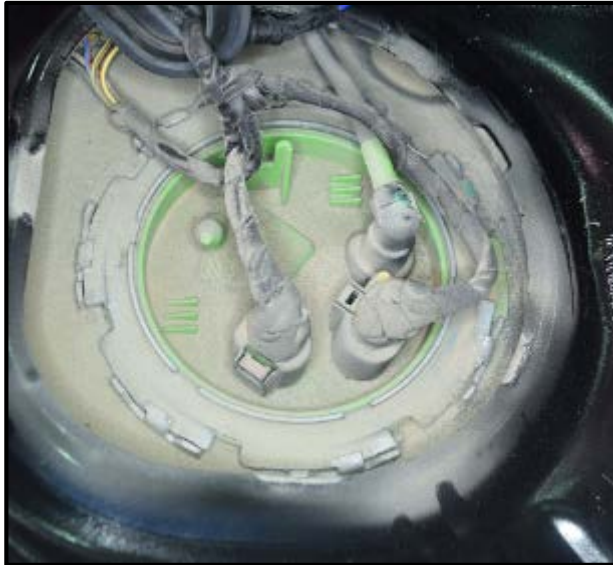
- Prior to disassembly, the fuel delivery unit **MUST** be clean. If excessive dirt or debris is present <as shown>, clean and dry the fuel delivery unit and surrounding areas as necessary.

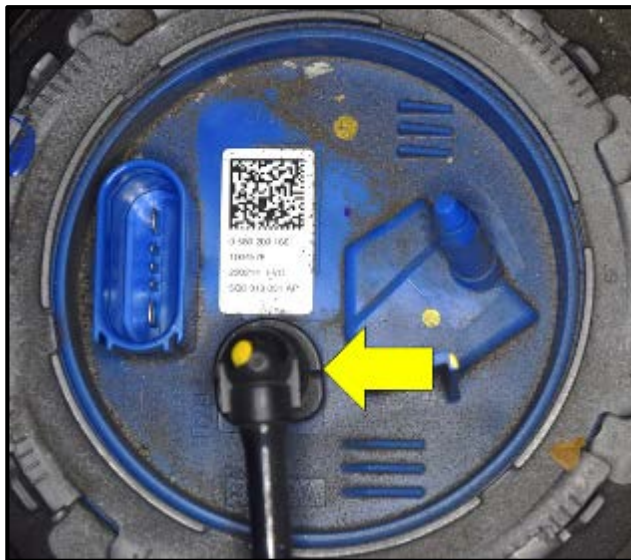
- Disconnect the fuel line <arrow> from the locking flange.

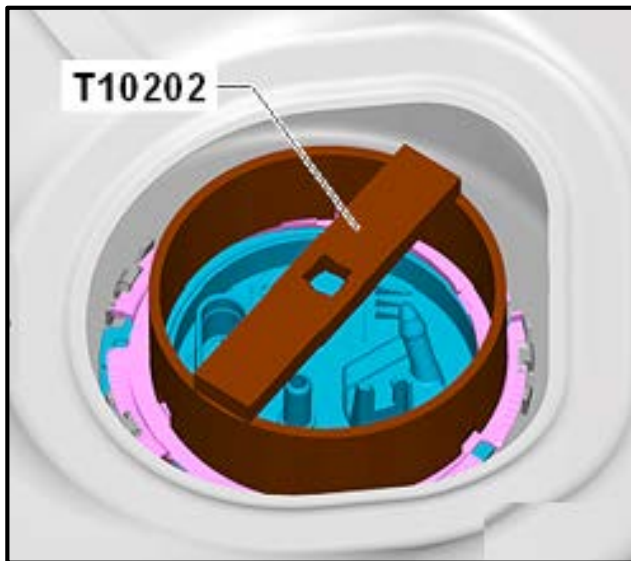
- Remove the locking ring using the Wrench – Fuel Sending Unit – T10202 <as shown>.

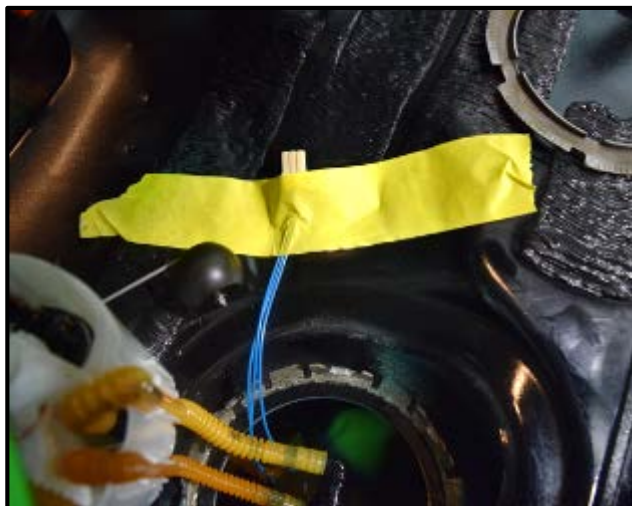
**TIP**  
 To avoid dropping the electrical connector and wiring harness into the fuel tank, the harness can be taped to the side <as shown>.

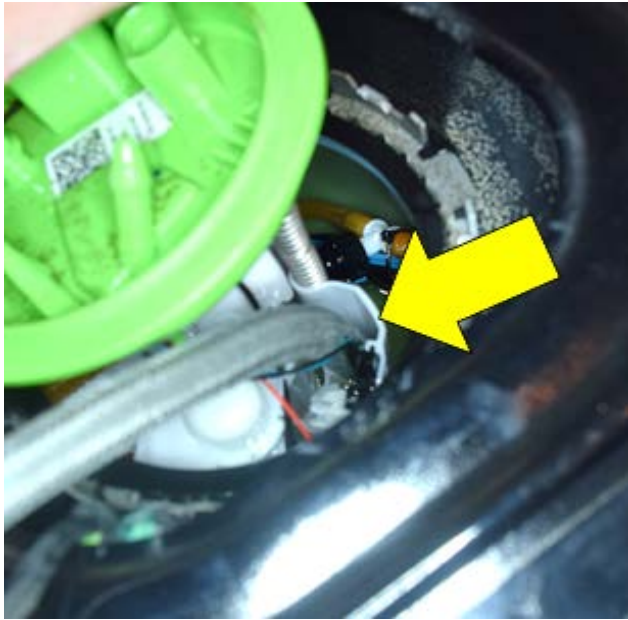
- Position the fuel delivery unit to the side.
- Insert the extraction hose from the VAS5190 into the fuel tank.
- Drain additional fuel out of the tank until the fuel level reaches approximately  $\frac{1}{4}$  tank.
- Insert the extraction hose into the fuel delivery unit <arrow>.
- Drain as much fuel as possible from the fuel delivery unit itself.

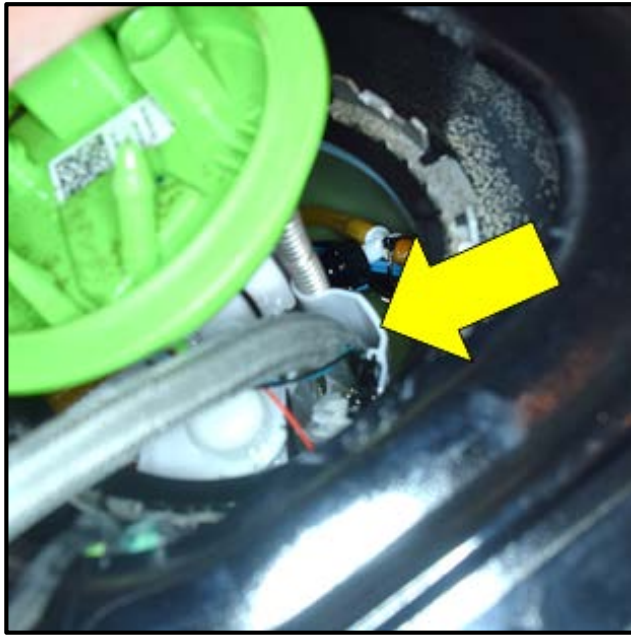
- Position the fuel delivery unit to the side.
- Insert the extraction hose from the VAS5190 into the fuel tank.
- Drain additional fuel out of the tank until the fuel level reaches approximately  $\frac{1}{2}$  tank.
- Insert the extraction hose into the fuel delivery unit <arrow>.
- Drain as much fuel as possible from the fuel delivery unit itself.

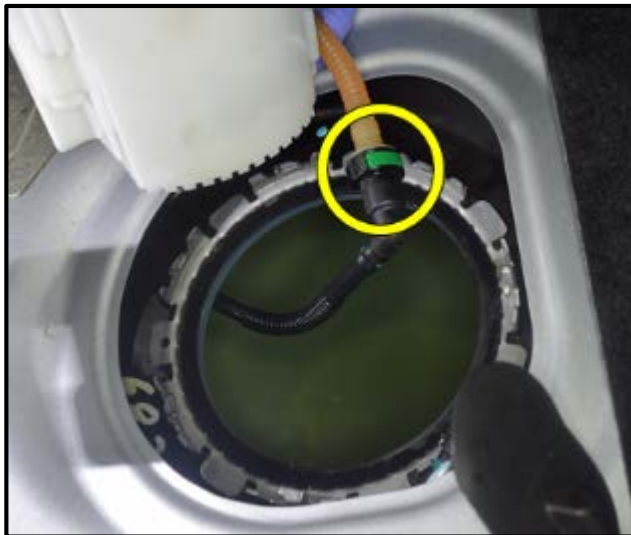
- Lay a cloth inside the vehicle to absorb any residual fuel.
- Carefully turn and tilt the fuel delivery unit as needed and remove it through the opening in the fuel tank.
- Disconnect the breather tube <circle> from the bottom of the fuel delivery unit.
- Remove the fuel delivery unit from the vehicle.

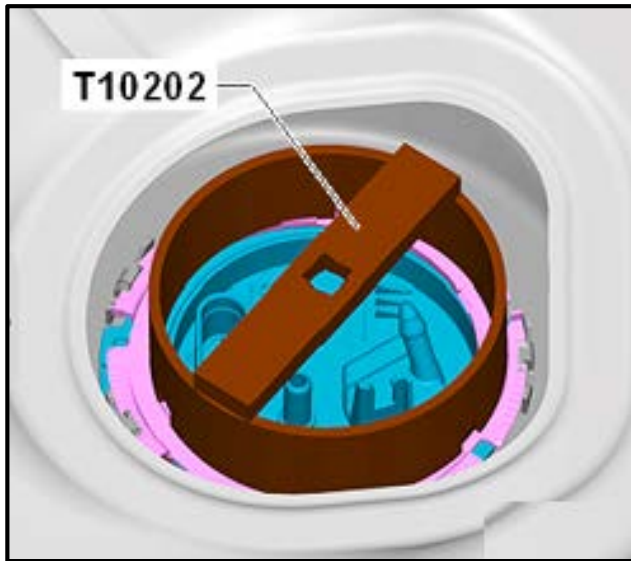
- Install the locking ring, and tighten using the Wrench – Fuel Sending Unit – T10202, and torque to 110Nm.

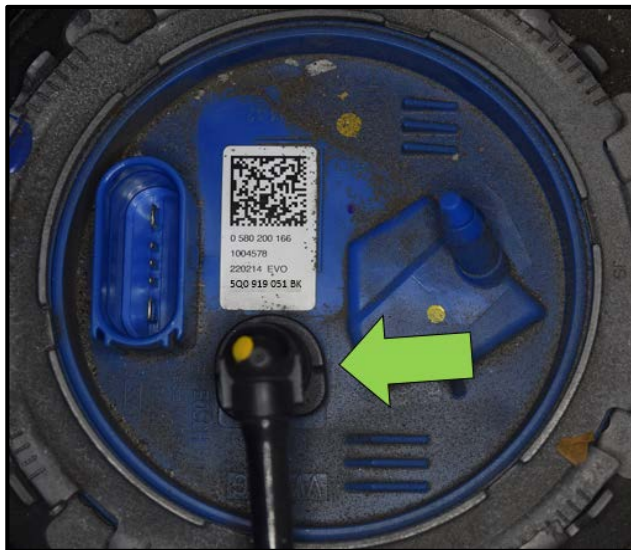
- Attach the fuel line <1> to the locking flange until it clicks into place.
