# Recall Bulletin

**SUBJECT:** Front Seat Hooks Not Installed Into Underbody

**MODELS:** 2015 Chevrolet Colorado  
2015 GMC Canyon

GM Recall #15150

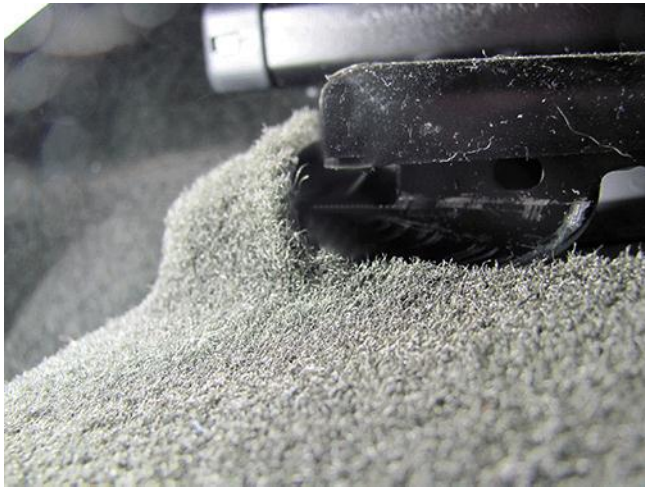
4178493

#### **Examples of Improperly Installed Seat Hooks:**

**Driver Seat Inboard**

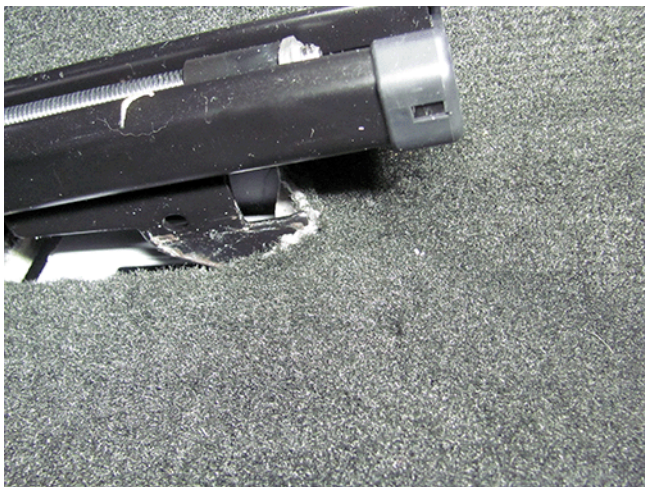
4178498

**Passenger Seat Inboard**

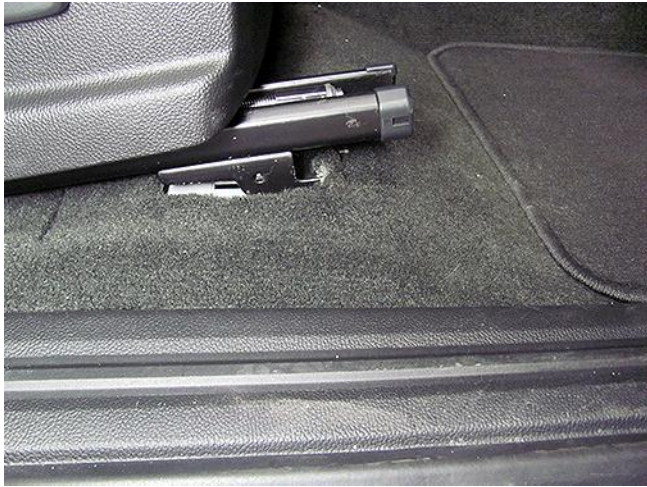
4178505

**Driver/Passenger Seat Outboard**

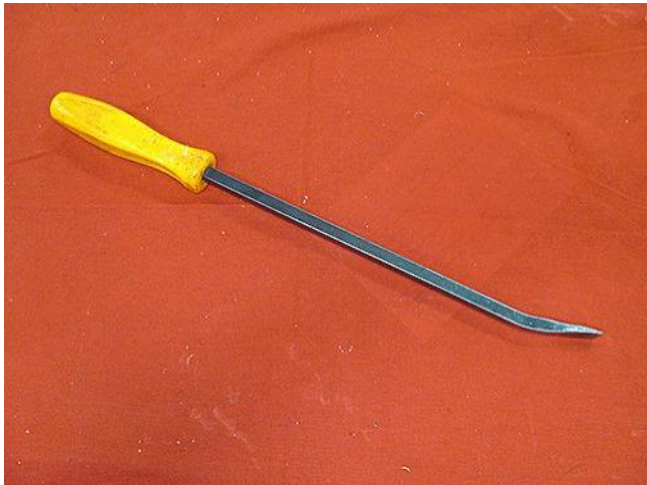
4178508

**Note:** Move both front seats to the furthest rearward position for the inspection steps.

Using a medium size pry bar, check the four front seat hooks (two on each front bucket seat) for proper engagement. Use care not to mar the door sill trim.

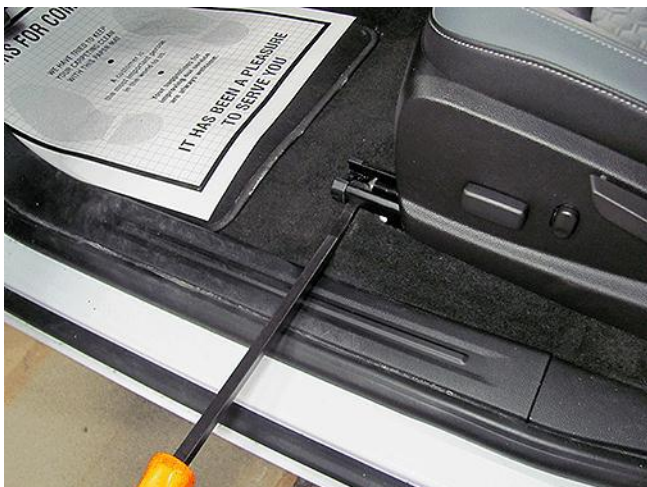
4178512

1. On the driver and passenger outboard seat tracks, position the pry bar as shown. Pry the seat track in an upward direction using moderate force. The seat track should not move away from the floor. **If the seat track does move**, proceed to the repair procedure below.

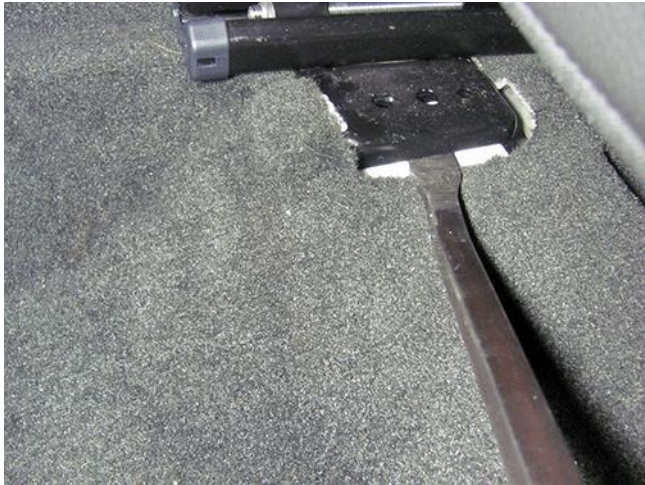
4178515

2. On the driver seat inboard track, position the pry bar as shown. Pry the seat track in an upward direction using moderate force. The seat track should not move away from the floor. **If the seat track does move**, proceed to the repair procedure below.

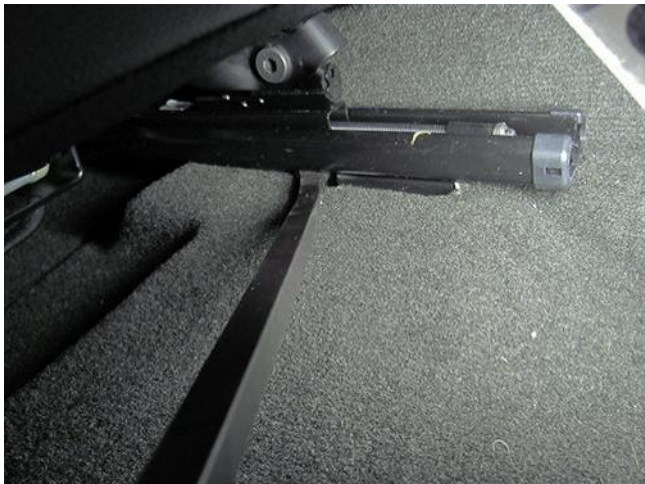
4178527

3. On the passenger seat inboard track, position the pry bar as shown. Pry the seat track in an upward direction using moderate force. The seat track should not move away from the floor. **If the seat track does move**, proceed to the repair procedure below.
