### SAFETY RECALL DSF and E04

### FRONT PASSENGER AIRBAG “MODULE” REPLACEMENT ONLY

### CERTAIN 2003 – 2008 MODEL YEAR MATRIX

**Note: This TI is for front passenger airbag “Module” replacement only. If replacing the “Inflator”, refer to the DSF/E04 Matrix Inflator TI located on TIS.**

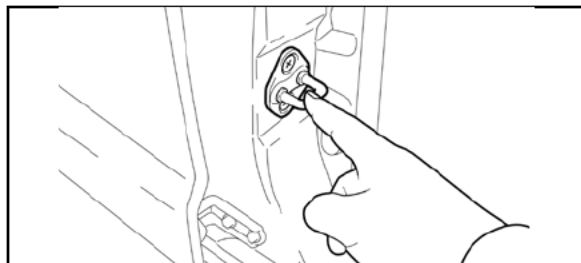
#### 1. ELIMINATE STATIC ELECTRICITY

- a) Before starting work and periodically while working on the vehicle, touch a metallic part of the vehicle to discharge static electricity in the body.

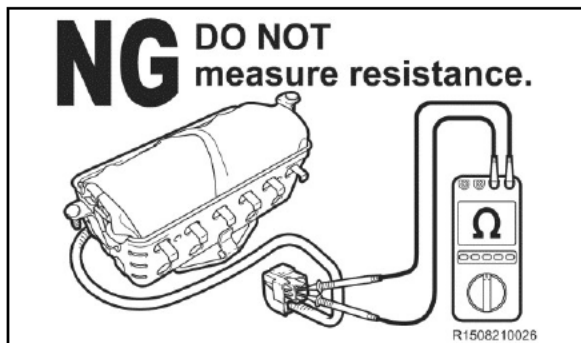
#### 2. DO NOT MEASURE RESISTANCE

- a) **DO NOT** measure resistance of airbag components, this may cause accidental activation.

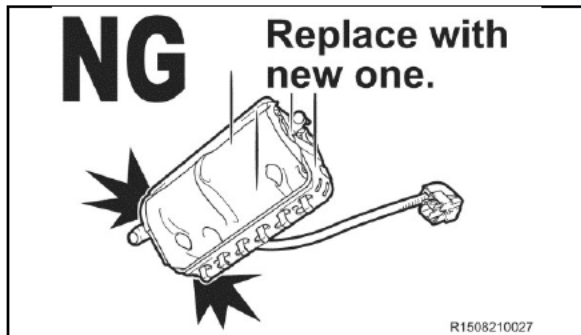
#### 3. HANDLE THE AIRBAG CAREFULLY

- a) If an inflator is dropped, replace it with a **NEW** inflator.

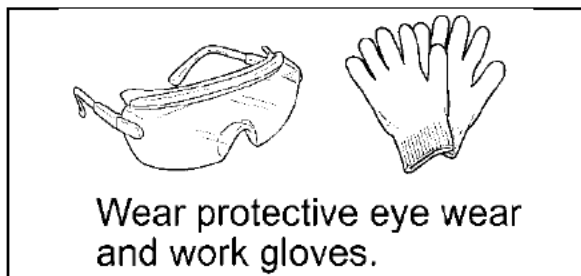
#### 4. WEAR PROTECTIVE EQUIPMENT

- a) Always wear appropriate protective equipment when working on the SRS.

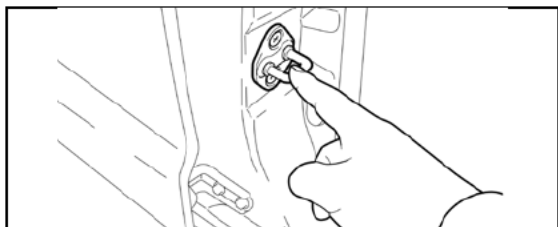
The anti-static mat set that is an essential SST may be available at your dealership and is optional to use during inflator replacement. If the anti-static kit is not available, before starting work and periodically while working on the vehicle, touch a metallic part of the vehicle to discharge static electricity in the body.

If the anti-static kit is not available, before starting work and periodically while working on the vehicle, touch a metallic part of the vehicle to discharge static electricity in the body.

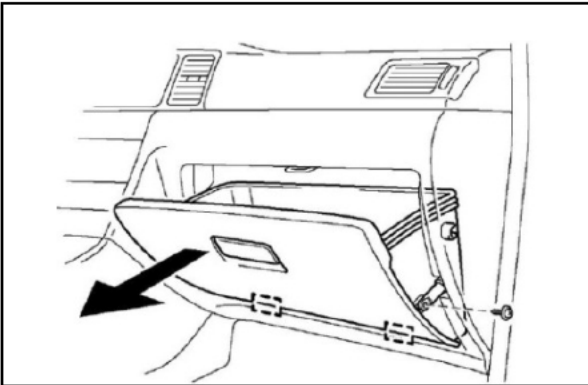
## 2. REMOVE THE GLOVE BOX

- Open the glove box door.
- Press in on both sides of the door and swing it down to remove it from the vehicle.

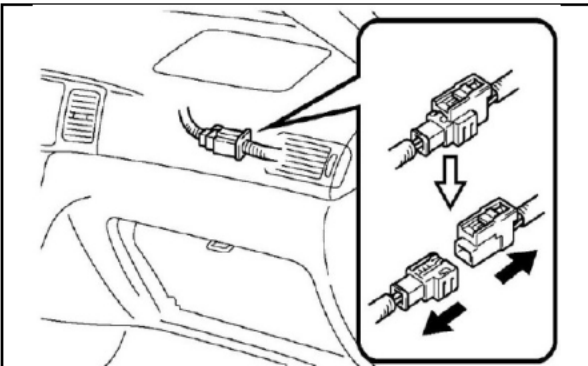
## 3. REMOVE THE AIRBAG ASSEMBLY

- Disconnect the negative battery cable.

- Wait at least 90 seconds after disconnecting the cable from the negative battery terminal to prevent airbag and seat belt pre-tensioner deployment.
- Follow all precautions as outlined on TIS before servicing the SRS system.

- Disconnect the airbag connector.

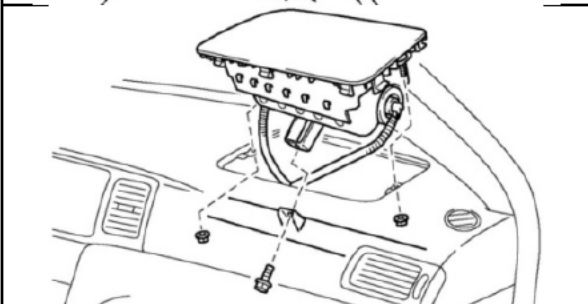
## 4. REMOVE THE FRONT PASSENGER AIRBAG

- Remove the 2 nuts and release the 6 clips.
- Remove the airbag assembly.

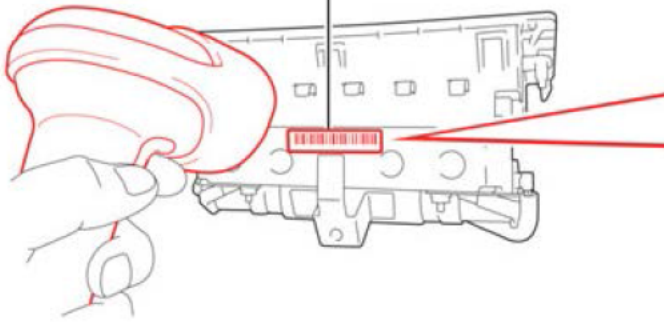
#### Airbag Serial Number Label Example

- The airbag serial number is **ALWAYS** the 12 **DIGITS** located between the asterisks.
- The 3 digits before the asterisk **ARE NOT** part of the serial number, and **SHOULD NOT** be entered or an inaccurate response may be returned.

The **AIRBAG ASSEMBLY** serial number **MUST** be recorded prior to replacement.

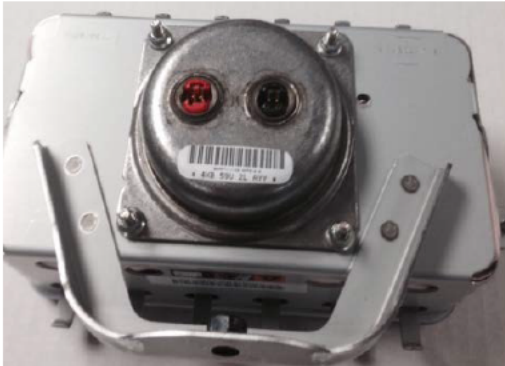
**CRITICAL INFORMATION – READ THOROUGHLY**

- Because this new part is a complete airbag assembly with a different style inflator installed, **you do not need to record the old or new inflator serial numbers.**

Note: The old tube style inflator may still be available. If you have that part you need to refer to the old set of instructions which will require the old and new inflators to be recorded.

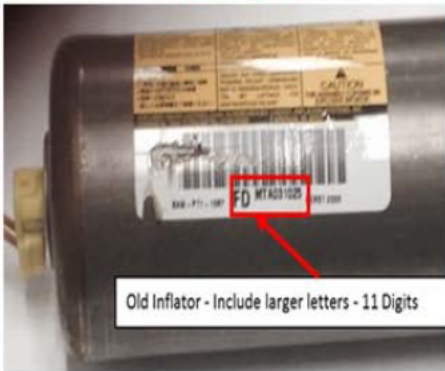
#### Original Inflator

Old Inflator - Include larger letters - 11 Digits

The first two characters of the **Original Inflator Serial code** will be from [AA, AB, AJ, FD or JD].

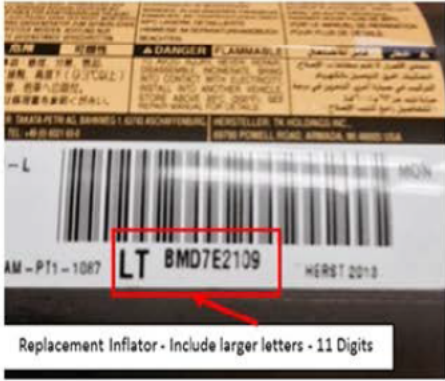
#### Replacement Inflator

Replacement Inflator - Include larger letters - 11 Digits

The first two characters of the **Replacement Inflator Serial code** will be either 'LT' or 'LR'.

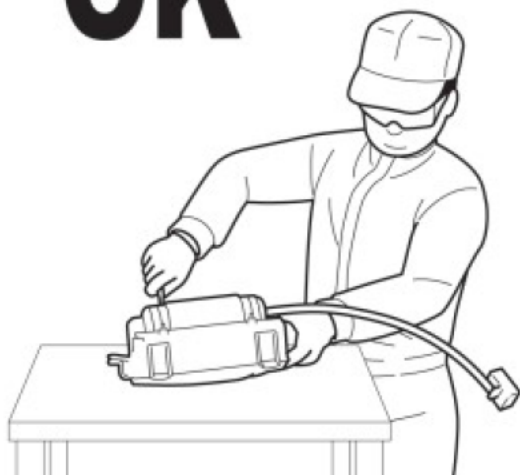
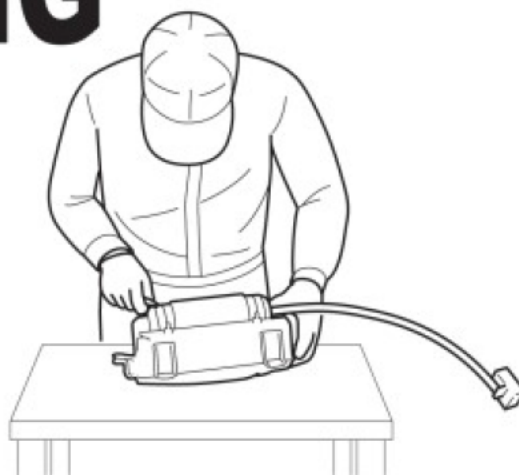
- Carefully place the airbag on the bench inflator side up.

- Avoid standing directly over the inflator.

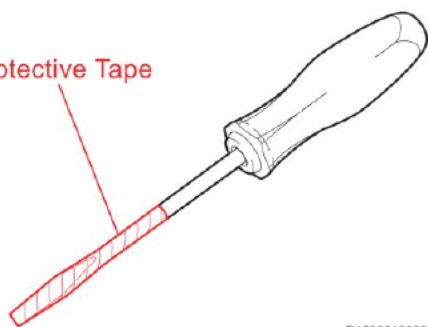
Protective Tape

### 2. TOOL PREPARATION

- Wrap a screwdriver with tape.

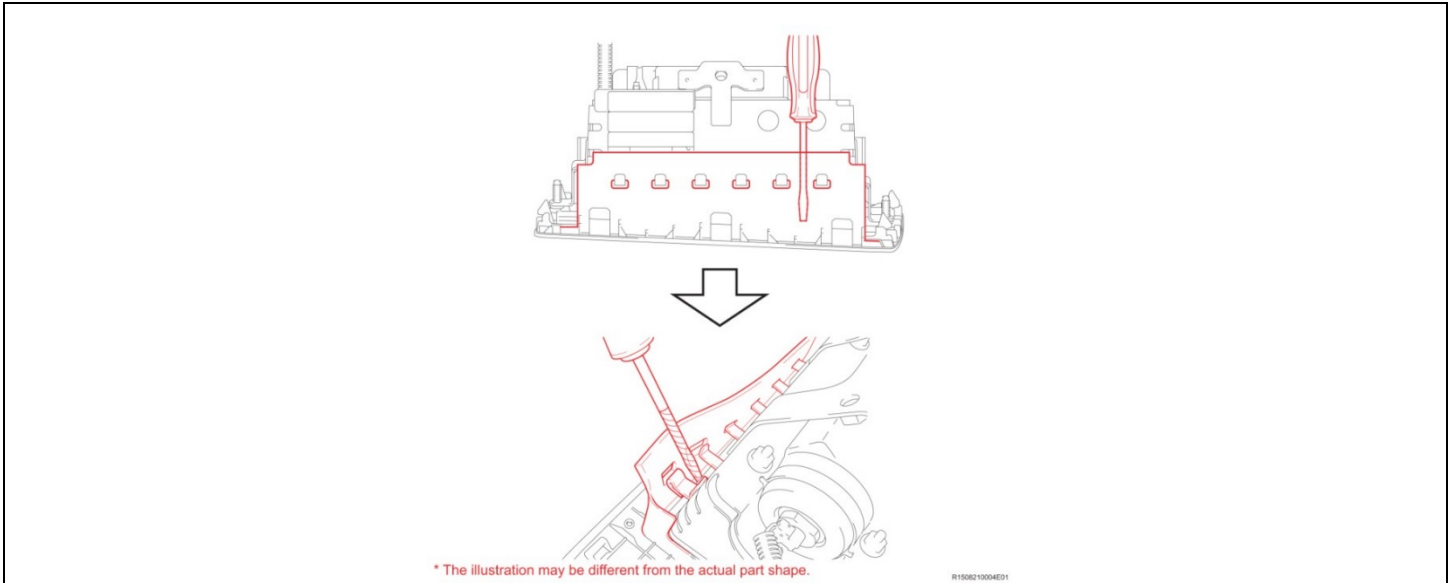
- a) Gently insert the screwdriver between the airbag door and module and disengage the claws holding the door to the module. Please refer to the video below.

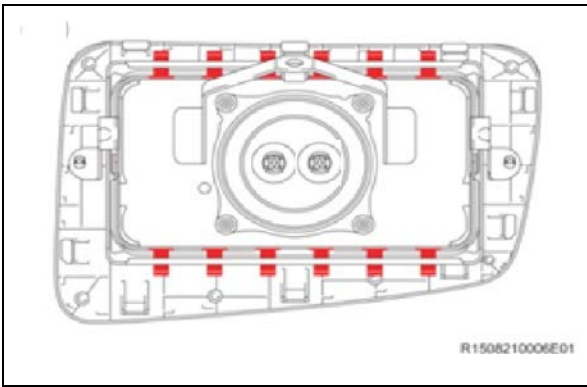
- a) Carefully slide the new module into the airbag door.

**NOTE: Mounting direction.**
