### SAFETY RECALL DSF and E04

### FRONT PASSENGER AIRBAG “MODULE” REPLACEMENT ONLY

### CERTAIN 2003 – 2008 MODEL YEAR MATRIX

**Updated 04-18-18**

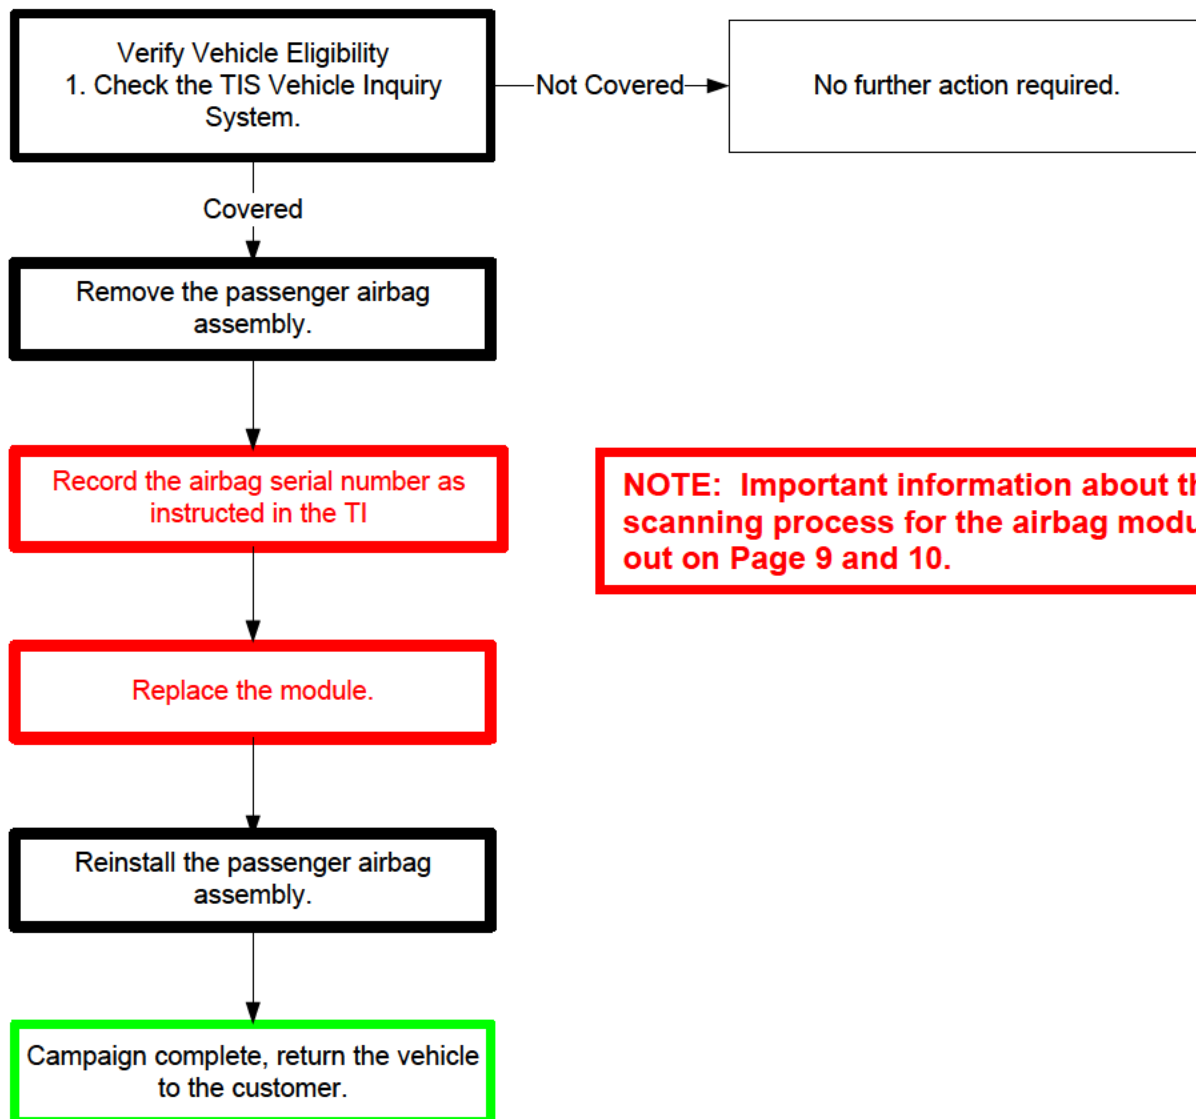
## I. OPERATION FLOW CHART

The flow chart is for reference only. **DO NOT** use it in place of the full technical instructions. Follow **ALL** steps as outlined in the full technical instructions to confirm the campaign is completed correctly.

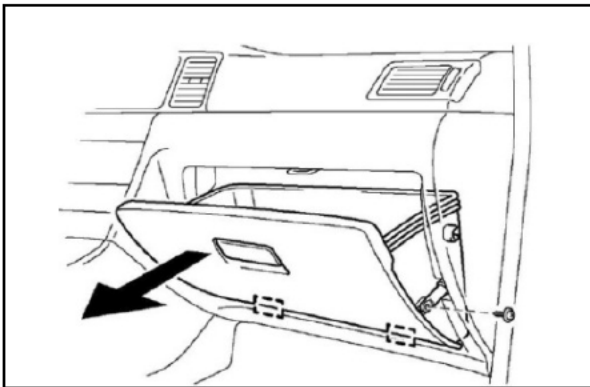
## 2. REMOVE THE GLOVE BOX

- Open the glove box door.
- Press in on both sides of the door and swing it down to remove it from the vehicle.

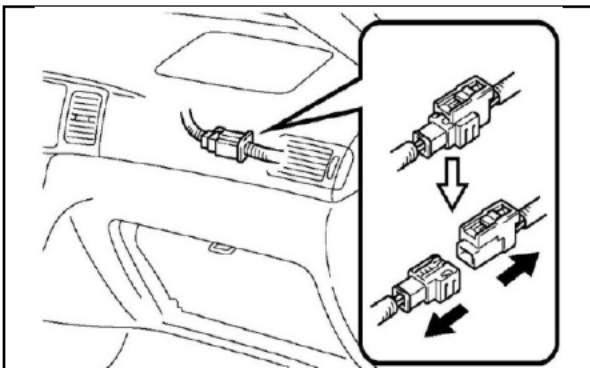
## 3. REMOVE THE AIRBAG ASSEMBLY

- Disconnect the negative battery cable.

- Wait at least 90 seconds after disconnecting the cable from the negative battery terminal to prevent airbag and seat belt pre-tensioner deployment.
- Follow all precautions as outlined on TIS before servicing the SRS system.

- Disconnect the airbag connector.

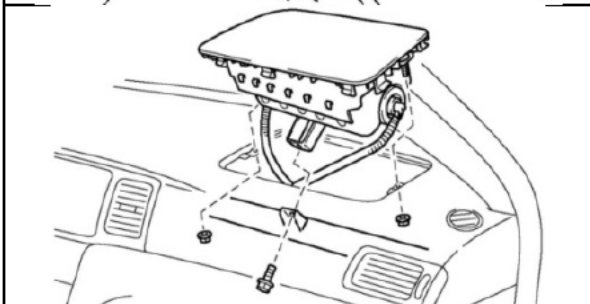
## 4. REMOVE THE FRONT PASSENGER AIRBAG

- Remove the 2 nuts and release the 6 clips.
- Remove the airbag assembly.

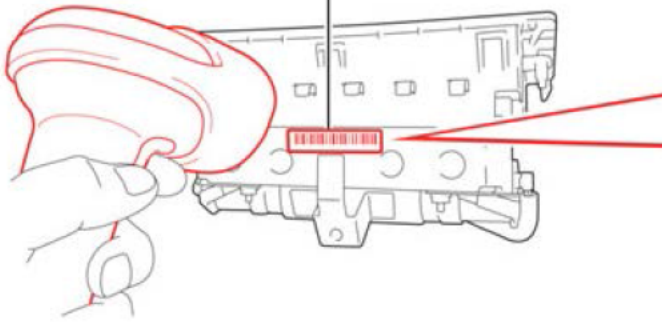
#### Airbag Serial Number Label Example

- The airbag serial number is **ALWAYS** the 12 **DIGITS** located between the asterisks.
- The 3 digits before the asterisk **ARE NOT** part of the serial number, and **SHOULD NOT** be entered or an inaccurate response may be returned.

The **AIRBAG ASSEMBLY** serial number **MUST** be recorded prior to replacement.

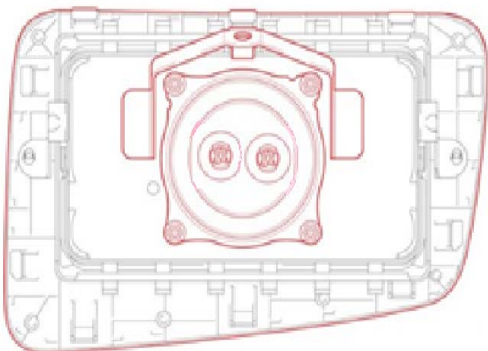
- b) After all the claws have been disengaged separate the module from the door.
- c) Mark the old module so it is not reused.
- d) Inspect the door for damage to the mounting slots.

**Take care not to mistake the mounting direction.**
