SAFETY RECALL DSF and E04

FRONT PASSENGER AIRBAG “MODULE” REPLACEMENT ONLY

CERTAIN 2003 – 2004 MODEL YEAR MATRIX

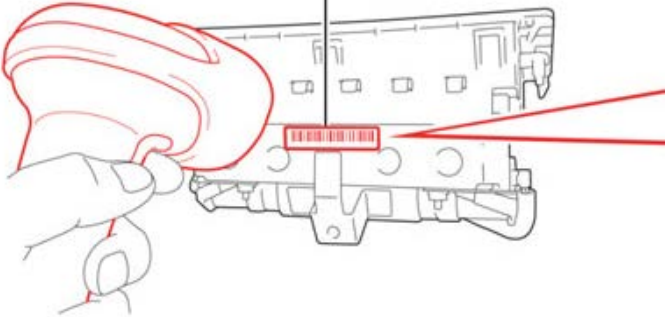
Airbag Serial Number Label Example

AIRBAG SERIAL NUMBER IDENTIFICATION

- The airbag serial number is **ALWAYS** the 12 **DIGIT** located between the asterisks.
- The 3 digits before the asterisk **ARE NOT** part of the serial number, and **SHOULD NOT** be entered or an inaccurate response may be returned.

Serial Number

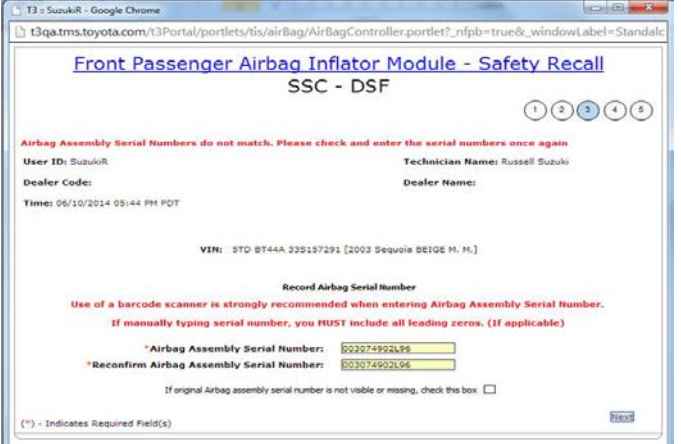
Front Passenger Airbag Inflator Module - Safety Recall
SSC - DSF

Airbag Assembly Serial Numbers do not match. Please check and enter the serial numbers once again

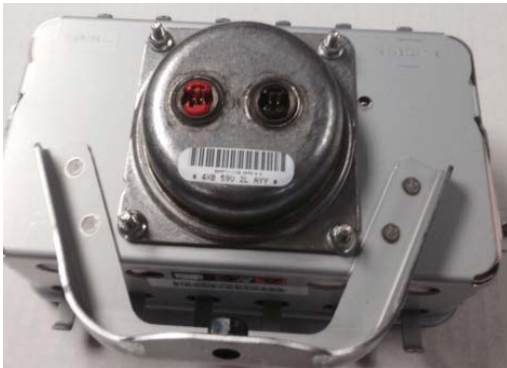
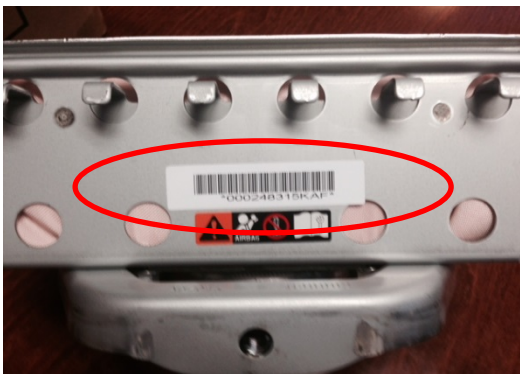
- Because this new part is a complete airbag assembly with a different style inflator installed, you do not need to record the old or new inflator serial numbers.

Note: The old tube style inflator may still be available. If you have that part you need to refer to the old set of instructions which will require the old and new inflators to be recorded.

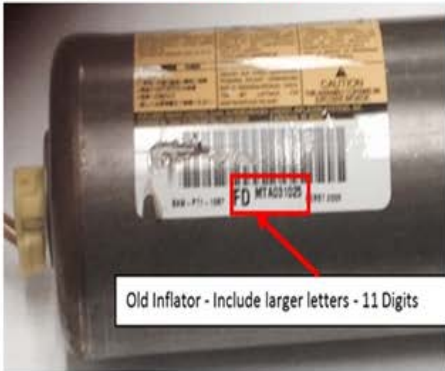
Old Inflator - Include larger letters - 11 Digits

How to Identify the Inflator serial code on the Original and Replacement Inflator can?
The Inflator serial code is an 11 digit code on the Inflator can. It can be found with a bar code on removing the Inflator can from the Airbag Assembly unit.
The first two characters of the Original Inflator Serial code will be from [AA, AB, AJ, FD or JD].
The first two characters of the Replacement Inflator Serial code will be either 'LT' or 'LR'.

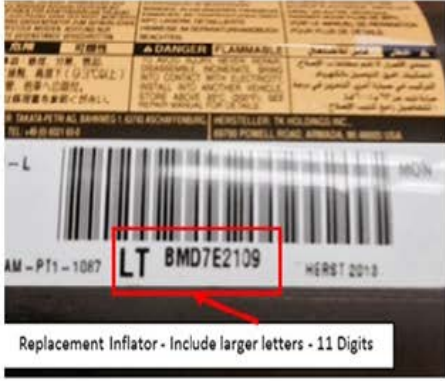
Replacement Inflator - Include larger letters - 11 Digits
