SAFETY RECALL DSF and E04

FRONT PASSENGER AIRBAG “MODULE” REPLACEMENT ONLY

CERTAIN 2003 – 2008 MODEL YEAR MATRIX

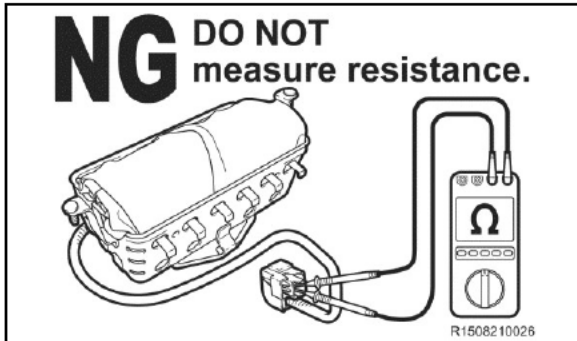
2. DO NOT MEASURE RESISTANCE

- a) **DO NOT** measure resistance of airbag components, this may cause accidental activation.

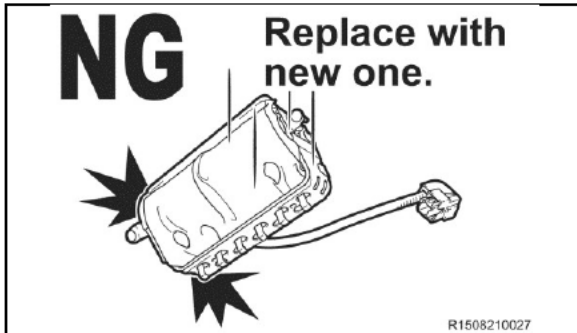
3. HANDLE THE AIRBAG CAREFULLY

- a) If an inflator is dropped, replace it with a **NEW** inflator.

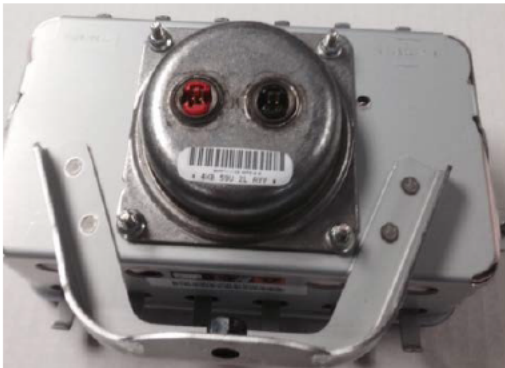
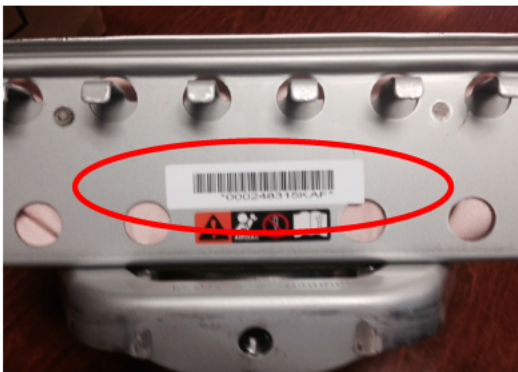
- Because this new part is a complete airbag assembly with a different style inflator installed, **you do not need to record the old or new inflator serial numbers.**

Note: The old tube style inflator may still be available. If you have that part you need to refer to the old set of instructions which will require the old and new inflators to be recorded.

- The New 12 digit Airbag Serial number on the side of the assembly will need to be recorded
- To record the new Airbag Serial number, in the scanning application you will need to **check the box indicating the old Inflator serial number is not readable or missing.** This will take you to the screen that allows you to enter the new airbag serial number.
Go to step C on page 10

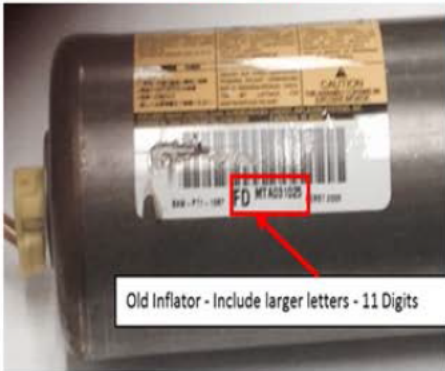
Old Inflator - Include larger letters - 11 Digits

How to Identify the Inflator serial code on the Original and Replacement Inflator can?
The Inflator serial code is an 11 digit code on the Inflator can. It can be found with a bar code on removing the Inflator can from the Airbag Assembly unit.
The first two characters of the Original Inflator Serial code will be from [AA, AB, AJ, FD or JD].
The first two characters of the Replacement Inflator Serial code will be either 'LT' or 'LR'.

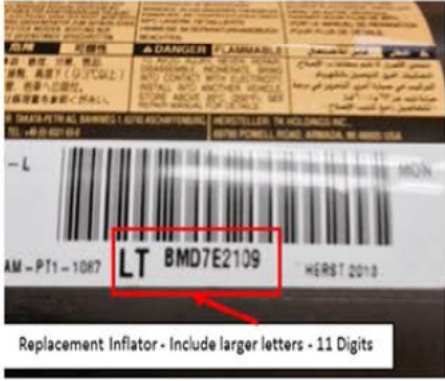
Replacement Inflator - Include larger letters - 11 Digits

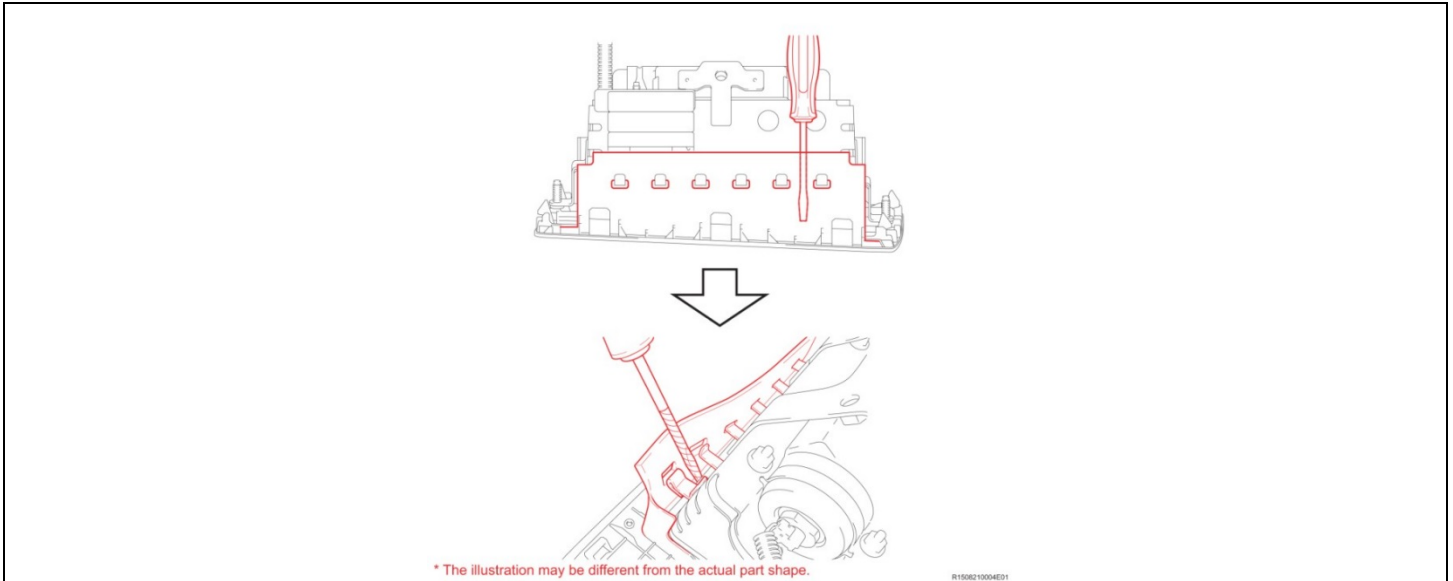
3. REMOVE THE COVER

- a) Gently insert the screwdriver between the airbag door and module and disengage the claws holding the door to the module. Please refer to the video below.

- b) After all the claws have been disengaged separate the module from the door.
- c) Mark the old module so it is not reused.
- d) Inspect the door for damage to the mounting slots.
