March 2016

Dealer Service Instructions for:

# **Safety Recall R26 / NHTSA 15V-312 Passenger Airbag Inflator**

**2003 (DR) Dodge RAM 1500/2500/3500 Pickup**

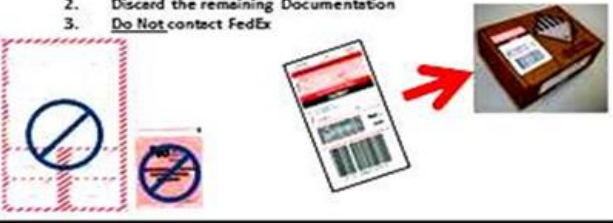
1. Peel off the backing of the FedEx Ground PRP Shipping label and affix to top of box to left of the Class 9 label.
- Use the scribe line on the box as a guide
- The FedEx Ground PRP Shipping label must not touch any portion of the printing to the right of the scribe line.
2. Discard the remaining Documentation
3. **Do Not** contact FedEx

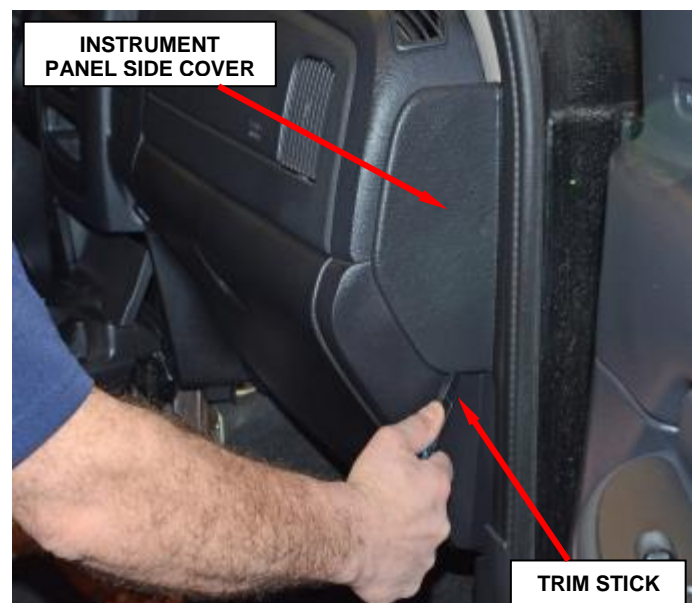
**Figure 1 – Instrument Panel Side Cover**

2. Using a trim stick, from the notch on the bottom, remove the right instrument panel side cover (Figure 1).

35. Install the steering column opening cover (Figure 4).
36. Install the glove box (Figure 3).
37. Install the right side scuff panel (Figure 2).
38. Install the right instrument panel side cover (Figure 1).

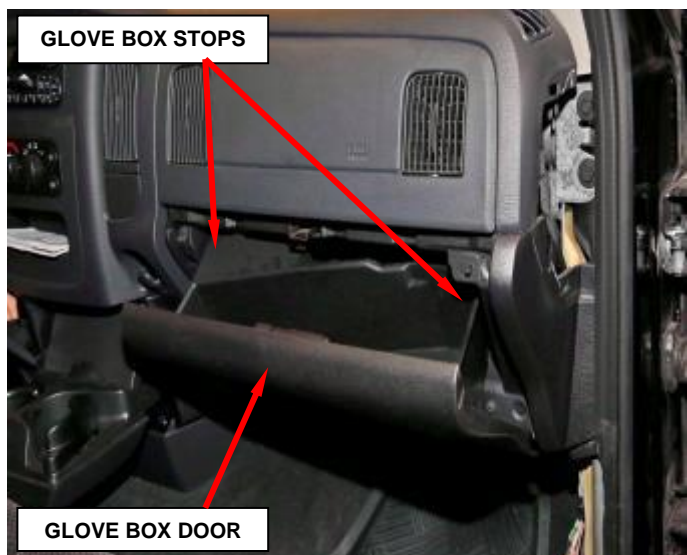
**Figure 3 – Glove Box**

- 4. Use the following steps to remove the glove box:
  - a. Remove and save the glove box contents.
  - b. Release the two glove box stops and lower the glove box downward past the stops (Figure 3).
  - c. Disengage the glove box hinges from the instrument panel and remove the glove box.

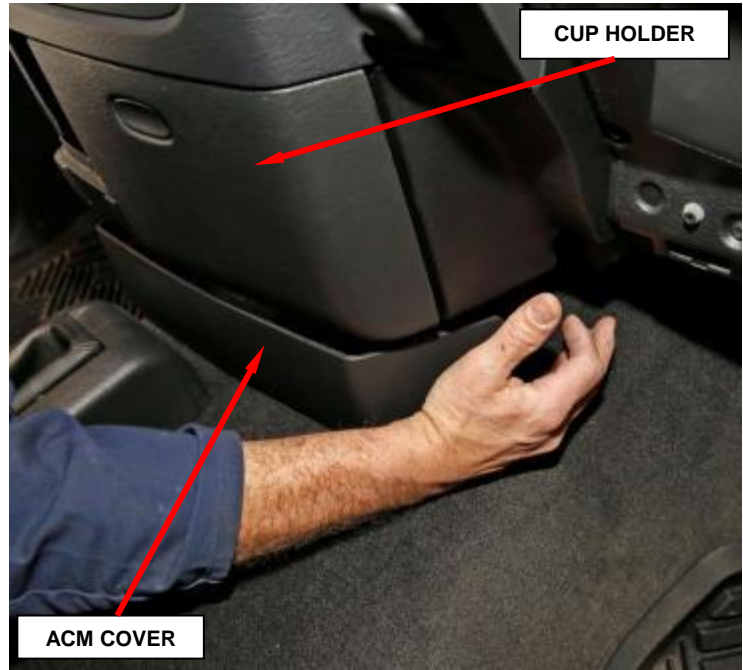
Figure 7 – Airbag Control Module (ACM) Cover

- 6. Use the following steps to remove the cup holder, if equipped:
  - a. Remove the Airbag Control Module (ACM) cover using a trim stick or another suitable wide flat-bladed tool. Gently pry each side of the ACM cover away from the instrument panel at each side of the center bracket on the floor panel transmission tunnel far enough to disengage the two snap clip retainers from the instrument panel receptacles (Figure 7).

- b. Position and gently clip into place.
  - c. Install one screw on right side (Figure 5).
33. Install the ACM cover (Figure 7).
34. Install the ash receiver.

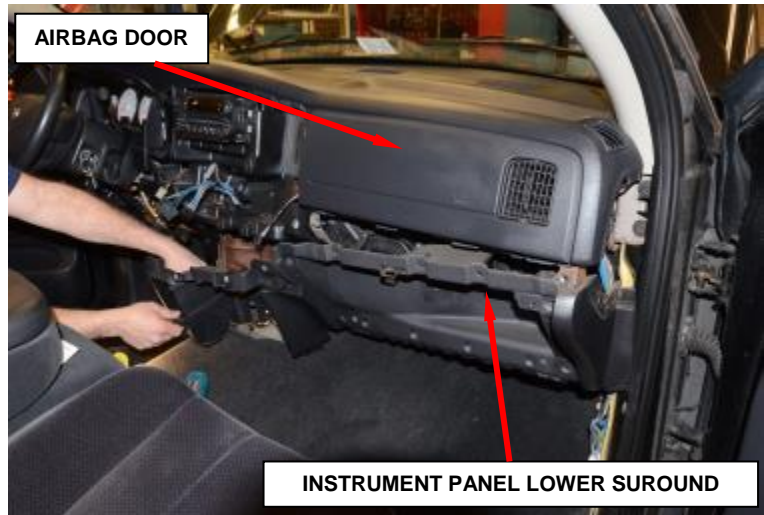
**Figure 11 – Instrument Panel Lower Surround**

- 8. Use the following steps to remove the ash receiver:
  - a. Open the ash receiver and apply force in a downward motion to disengage the locking tabs from the instrument panel.
  - b. Roll the ash receiver further downward and remove it from the instrument panel.

- 9. Remove and save the twenty one screws that secure the instrument panel lower surround to the instrument panel and support (Figure 11 and 12).

30. Install the instrument panel lower surround onto the instrument panel and install the twenty one screws. Tighten the screws to 20 in. lbs. (2 N·m) (Figures 11 and 12).

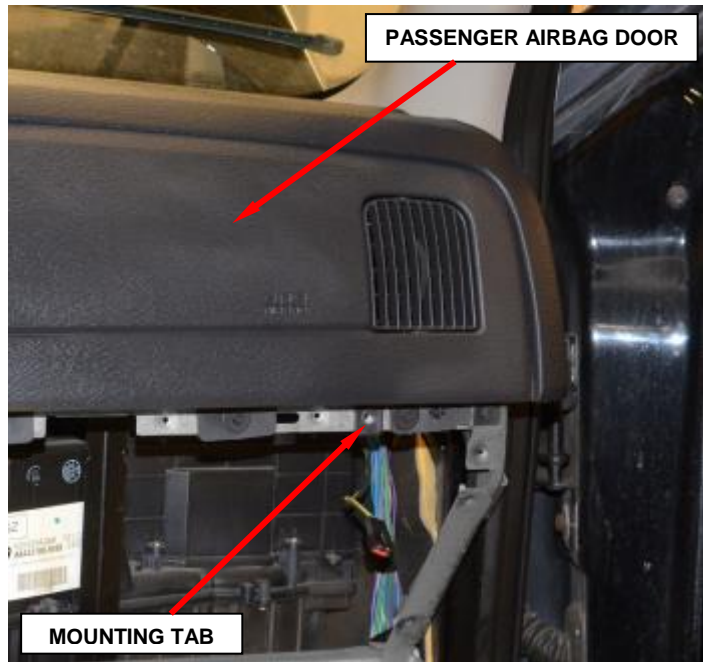
Figure 13 – Panel Outlet Housing Mounting Tab

10. Disconnect the wire harness connectors for the 12V power outlet and the glove box switch then remove the instrument panel lower surround.
11. Remove and save the screw that secures the mounting tab of the panel outlet housing to the upper glove box opening reinforcement (Figure 13).
12. Remove and save the six mounting screws that secure the inboard and lower flanges of the passenger airbag door to the instrument panel (Figure 14).

28. Install the screw that secures the mounting tab of the panel outlet housing to the upper glove box opening reinforcement. Tighten the screw to 20 in. lbs. (2 N·m) (Figure 13).

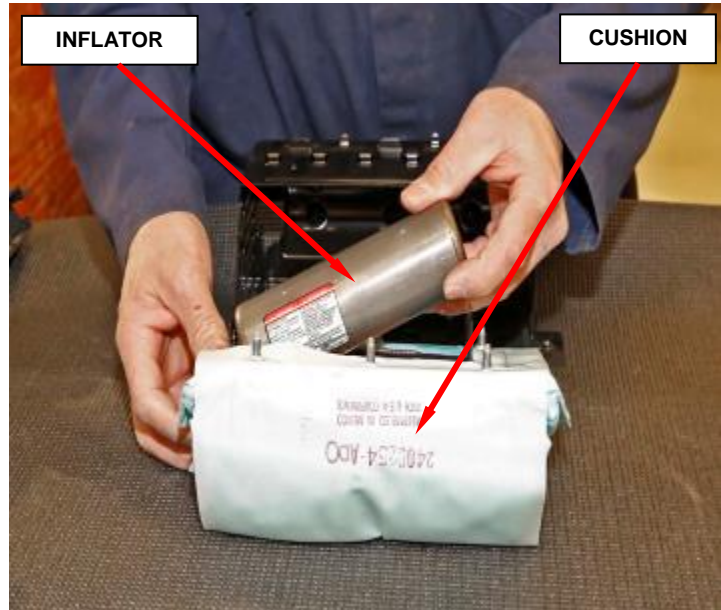
**Figure 22 – Inflator and Cushion**

- f. Remove the inflator from the cushion (Figure 22).
- g. Install the new inflator to the cushion, keyed end first (Figure 23).

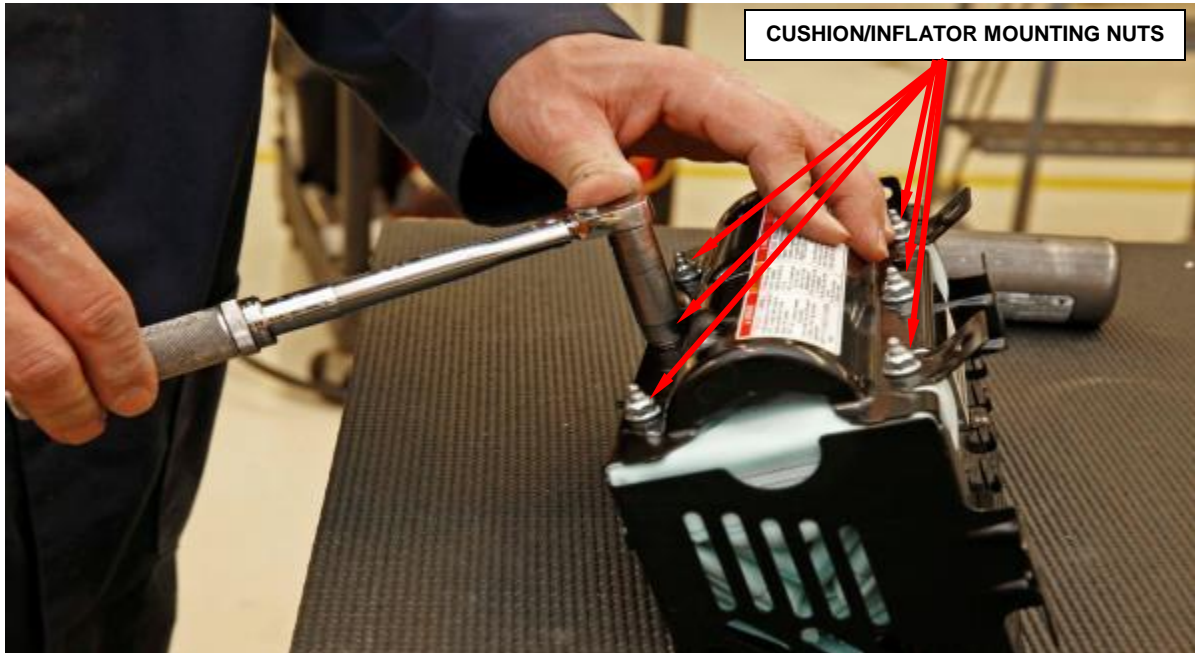
**Figure 25 – Cushion/Inflator Assembly Mounting Nuts**

- j. Install the six new cushion/inflator mounting nuts and tighten to 88 in. lbs. (10 N·m) (Figure 25).
