Dealer Service Instructions for:

Safety Recall R26 / NHTSA 15V-312

Passenger Airbag Inflator

2003 (DR) Dodge RAM 1500/2500/3500 Pickup

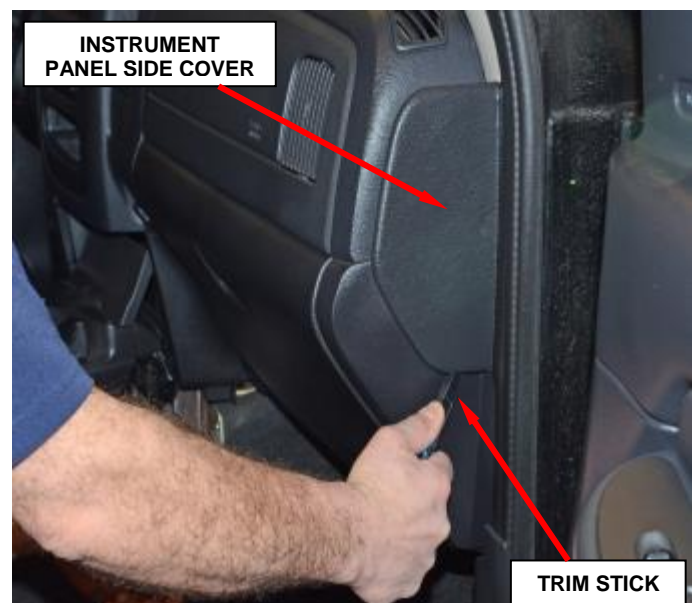
Figure 1 – Instrument Panel Side Cover

2. Using a trim stick, from the notch on the bottom, remove the right instrument panel side cover (Figure 1).

35. Install the steering column opening cover (Figure 4).
36. Install the glove box (Figure 3).
37. Install the right side scuff panel (Figure 2).
38. Install the right instrument panel side cover (Figure 1).

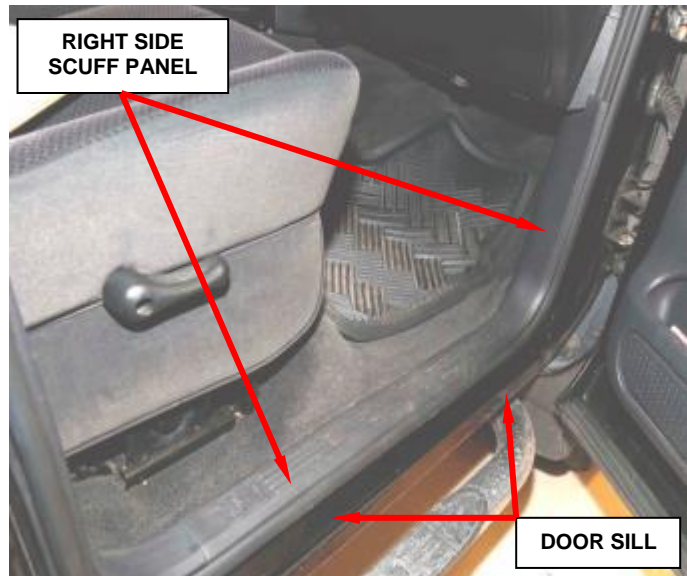
Figure 2 – Right Side Scuff Panel

3. Use the following steps to remove the right side cowl trim panel.
 - a. Using a trim stick, disengage the retaining tabs of the cowl trim panel from the retainer clips in the door sill (Figure 2).
 - b. Pull the scuff panel rearward and remove it from the vehicle.

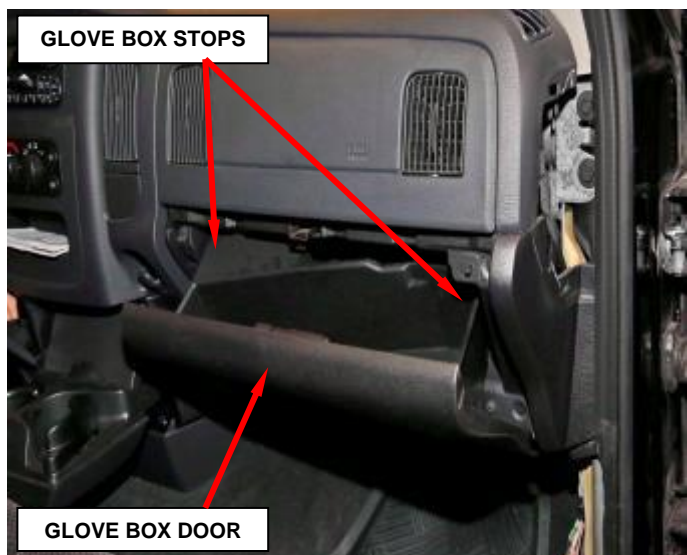
Figure 3 – Glove Box

4. Use the following steps to remove the glove box:
 - a. Remove and save the glove box contents.
 - b. Release the two glove box stops and lower the glove box downward past the stops (Figure 3).
 - c. Disengage the glove box hinges from the instrument panel and remove the glove box.

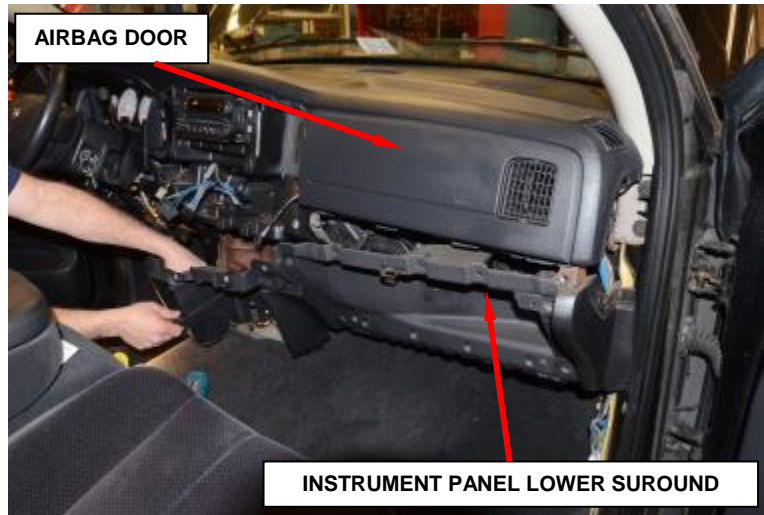
Figure 11 – Instrument Panel Lower Surround

- 9. Remove and save the twenty one screws that secure the instrument panel lower surround to the instrument panel and support (Figure 11 and 12).

30. Install the instrument panel lower surround onto the instrument panel and install the twenty one screws. Tighten the screws to 20 in. lbs. (2 N·m) (Figures 11 and 12).

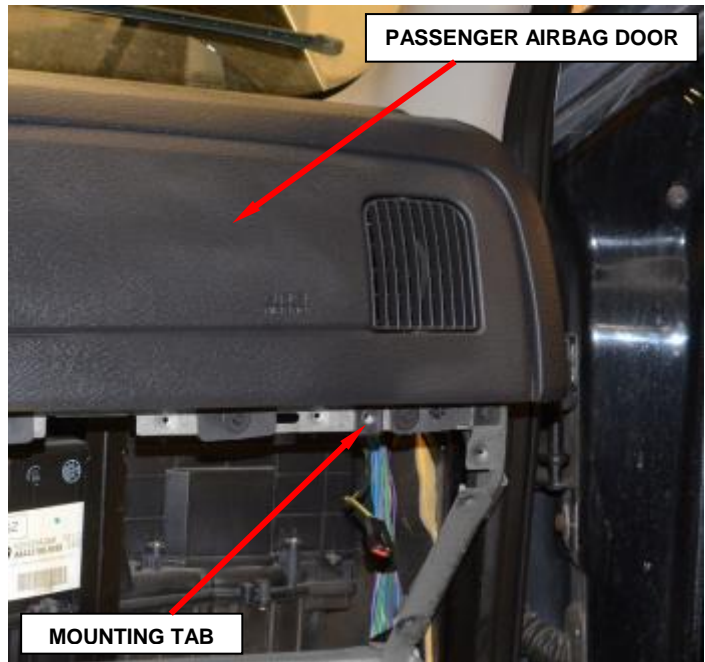
Figure 13 – Panel Outlet Housing Mounting Tab

10. Disconnect the wire harness connectors for the 12V power outlet and the glove box switch then remove the instrument panel lower surround.
11. Remove and save the screw that secures the mounting tab of the panel outlet housing to the upper glove box opening reinforcement (Figure 13).
12. Remove and save the six mounting screws that secure the inboard and lower flanges of the passenger airbag door to the instrument panel (Figure 14).

28. Install the screw that secures the mounting tab of the panel outlet housing to the upper glove box opening reinforcement. Tighten the screw to 20 in. lbs. (2 N·m) (Figure 13).

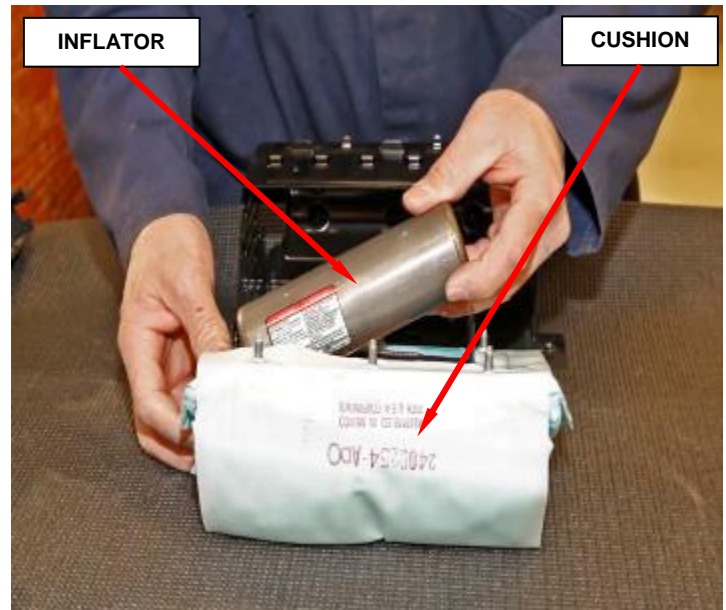
Figure 22 – Inflator and Cushion

- f. Remove the inflator from the cushion (Figure 22).
- g. Install the new inflator to the cushion, keyed end first (Figure 23).
