Dealer Service Instructions for:

Safety Recall R25 / NHTSA 15V-313 Driver Airbag Inflator

The driver airbag inflator housing on about 4,060,000 of the above vehicles may rupture, due to excessive internal pressure, during normal airbag deployment events. This condition is more likely to occur if the vehicle has been exposed to high levels of absolute humidity for extended periods of time. An inflator rupture, during airbag deployment events, could result in metal fragment(s) striking and potentially seriously injuring the vehicle occupant(s).

Service Procedure Continued**B. Replace Driver Airbag Inflator - DR, DH, D1, DC, HB, HG, ND**

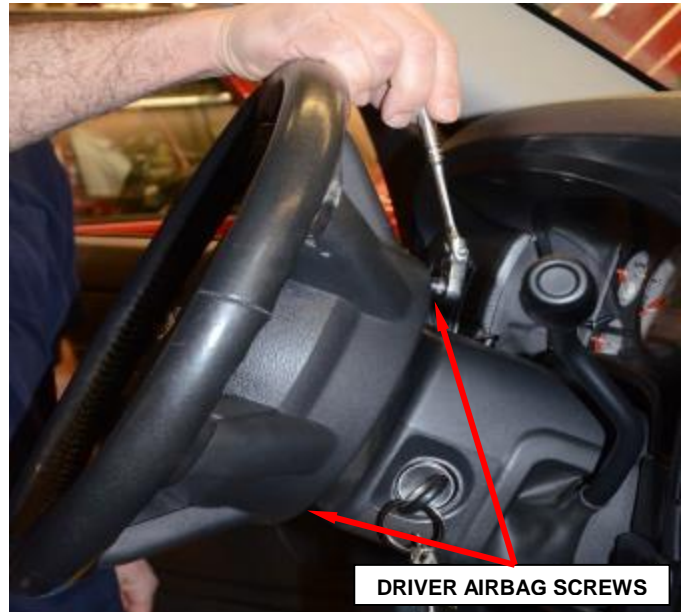
Figure 1 - Driver Airbag Screw Location

1. Use this procedure to replace the driver airbag inflator.
 - **For LX, L2 and LE model vehicles**, continue with **Section C. Replace Driver Airbag Inflator – LX, L2 and LE.**
 - **For all other models**, continue with **Step 2.**
2. Disconnect and isolate the negative battery cable. Wait two minutes for the system capacitor to discharge before further service.
3. Remove and save the two driver airbag screws that secure the driver airbag to the steering wheel armature from the underside of the steering wheel (Figure 1).

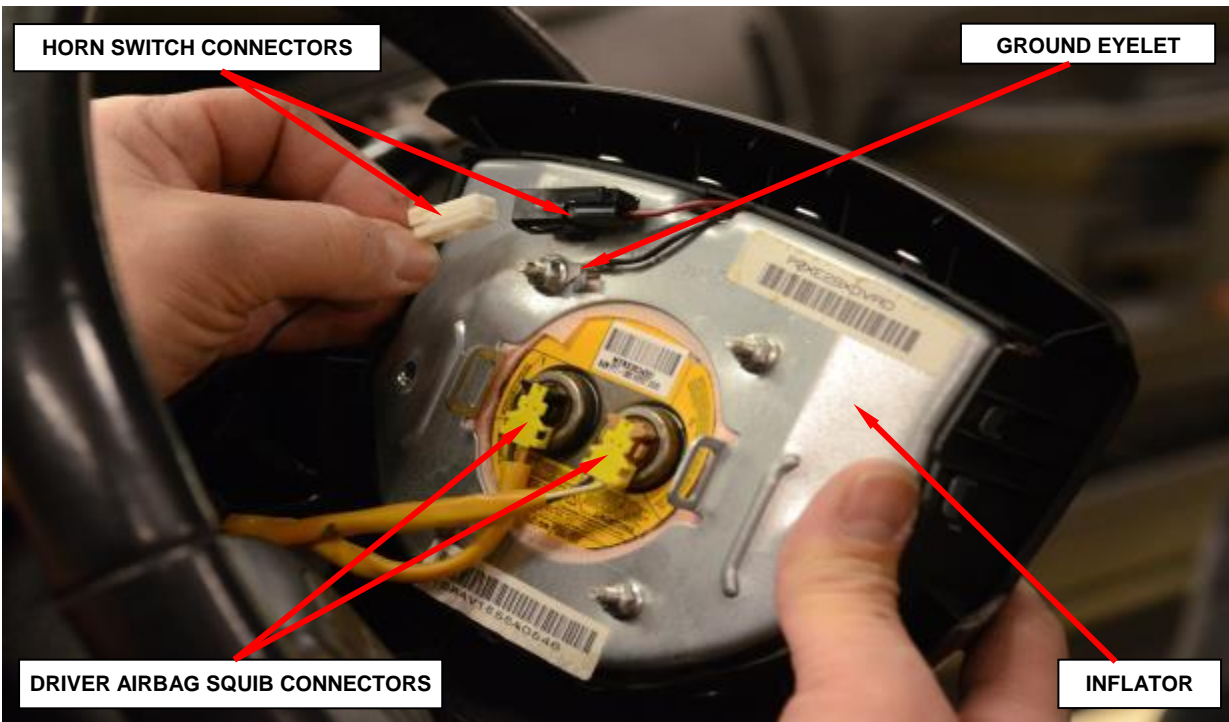
Figure 2 – Driver Airbag Electrical Connections

4. Pull the driver airbag away from the steering wheel far enough to access the three electrical connections on the back of the driver airbag housing (Figure 2).
5. Disconnect the horn switch connector, which is located on the back of the driver airbag housing (Figure 2).

25. Connect the steering wheel wire harness connector for the horn switch to the horn switch connector which is located on the back of the inflator assembly (Figure 2).

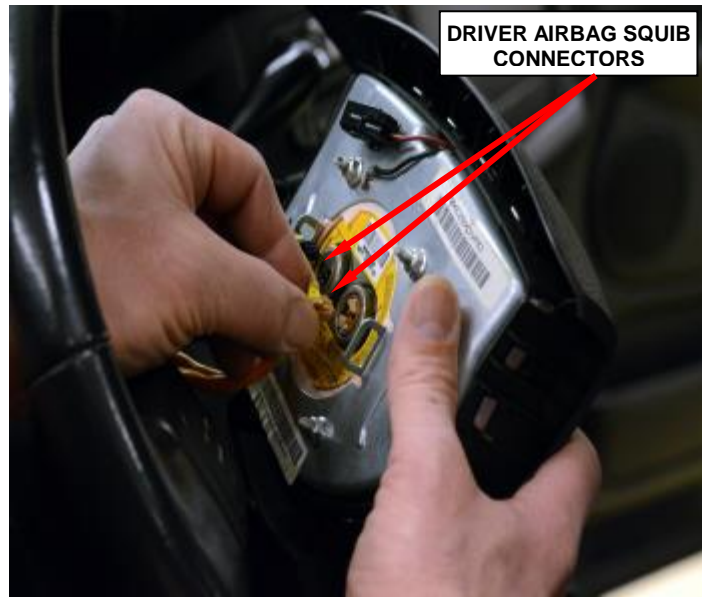
Figure 3 – Driver Airbag Squib Connectors

6. Disconnect the two driver airbag squib connectors. Depress the latches on each side of the connector insulator and pull the insulators straight out from the driver airbag inflator to disconnect them from the connector receptacles (Figure 3).

23. Position the driver airbag to the steering wheel to connect the three electrical connections on the back of the driver airbag housing (Figure 3).

24. Connect the two driver airbag squib connectors to the driver airbag inflator assembly connector receptacles by pressing straight in on the connector. Be certain to engage each keyed and color-coded connector to the matching connector receptacle (**See figure 14 and note on page 15**). Be certain that each connector is fully engaged in its receptacle by listening carefully for a distinct, audible click as the connector latches snap into place (Figure 3).

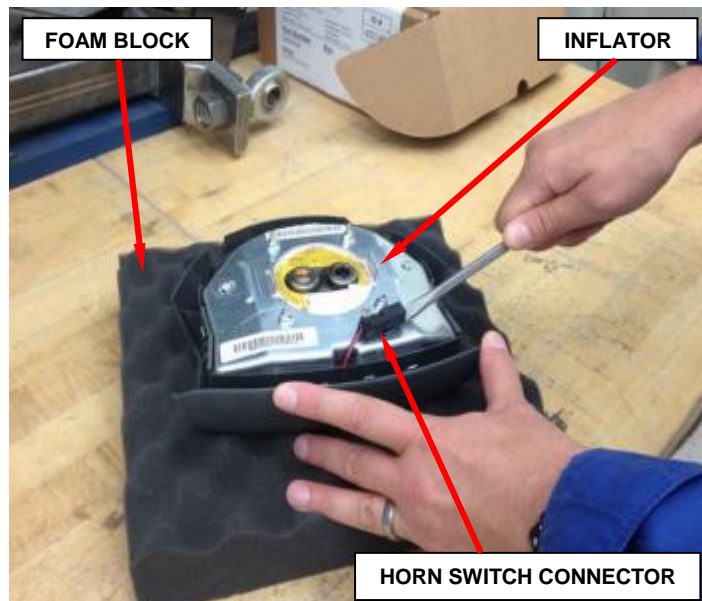
Figure 4 – Horn Switch Connector

7. Remove the driver airbag from the steering wheel.
8. Place the driver airbag on a soft surface to prevent damage using the foam block provided with the inflator kit (Figure 4).
9. Remove the horn switch connector from the inflator assembly using a flat head screwdriver (Figure 4).

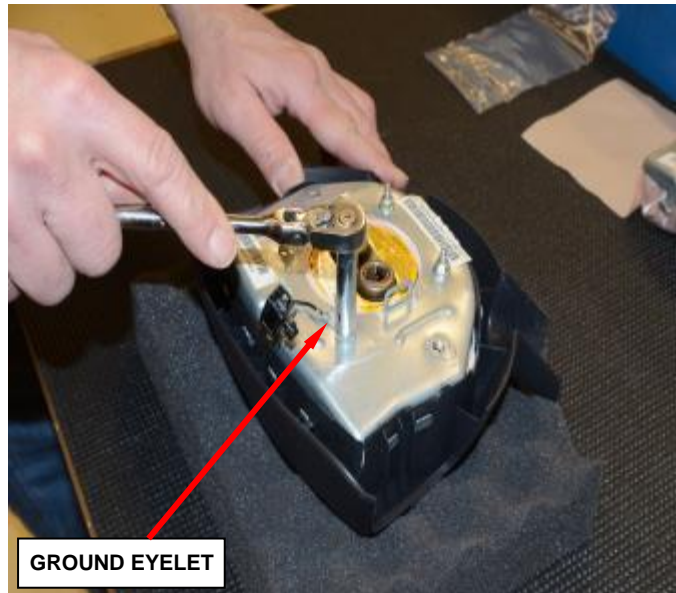
Figure 5 – Ground Eyelet

10. Remove and discard the nut holding the ground eyelet to the inflator assembly and remove the ground eyelet from the stud (Figure 5).

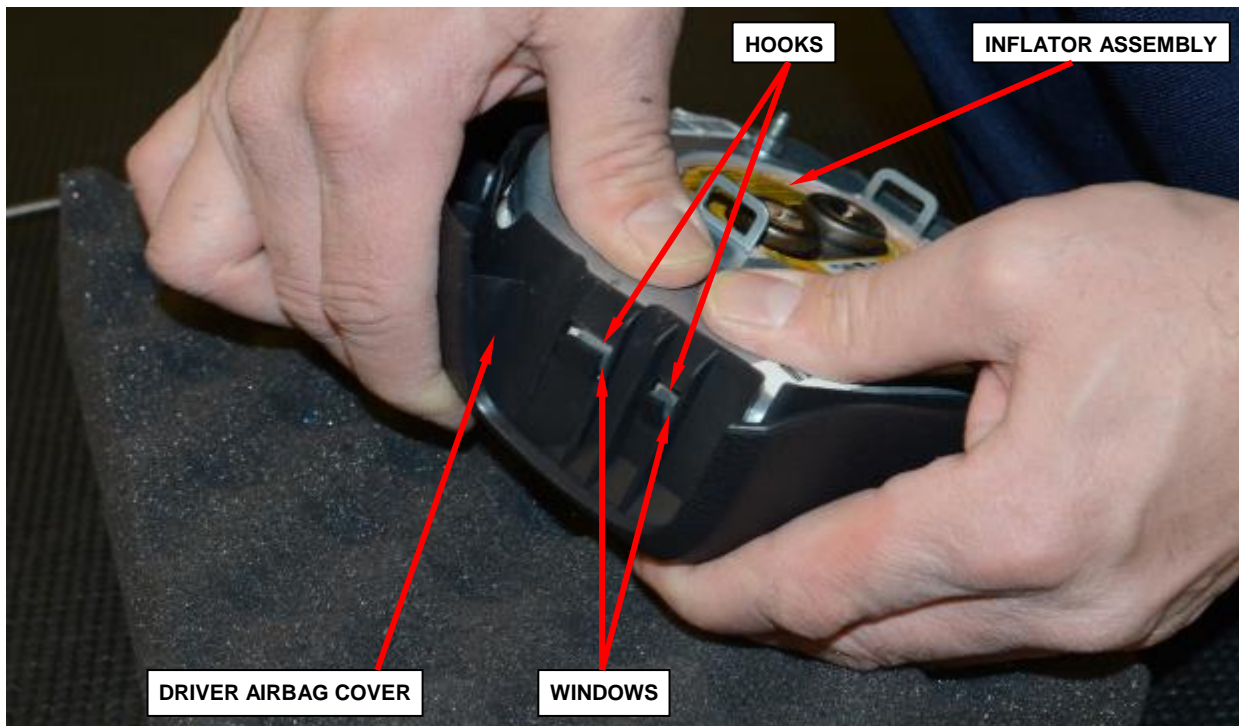
Figure 6 – Left Side Driver Airbag Cover to Inflator Assembly Hooks

11. Remove the driver airbag cover starting with the left side by pressing down on the inflator assembly until the hooks unsnap from the windows (Figure 6).

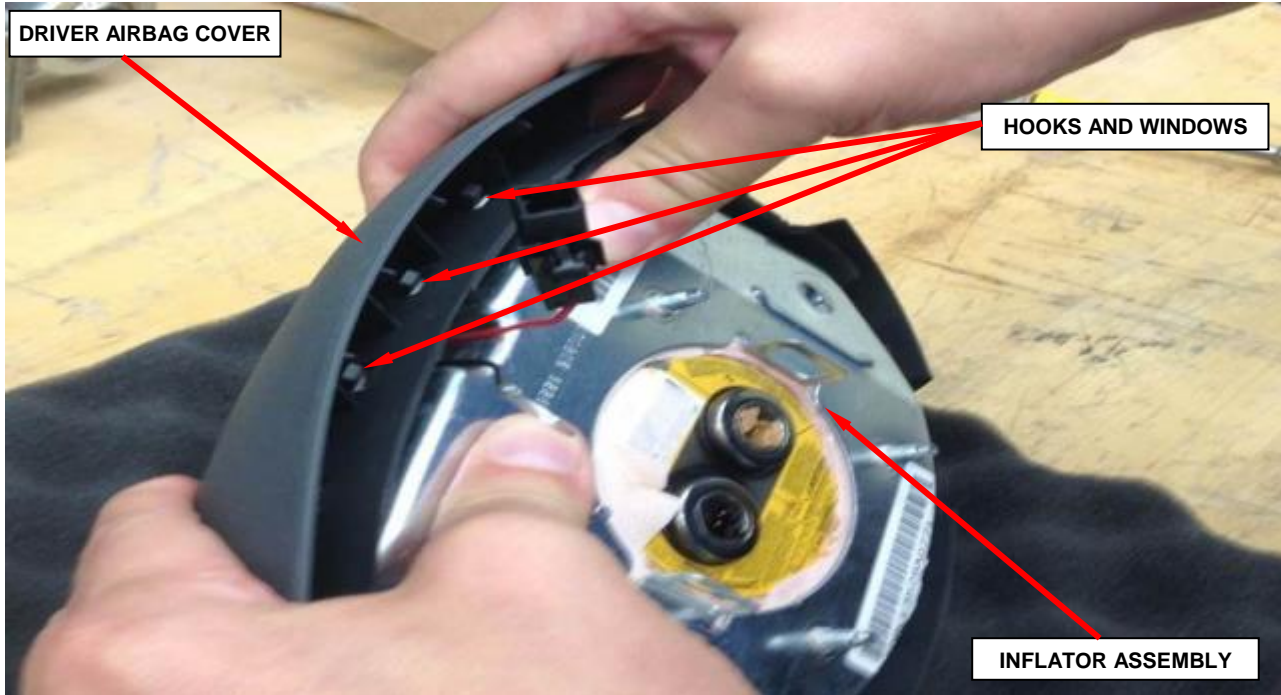
Figure 7 - Top Driver Airbag Cover to Inflator Assembly Hooks

12. Unsnap the top hooks by pressing down on the inflator assembly until the hooks unsnap from the airbag cover windows (Figure 7).
13. Unsnap the right side hooks by pressing down on the inflator until the hooks unsnap from the driver airbag cover.
14. Gently pull the inflator assembly up slowly making sure that the hooks are clear from the windows on all sides (Figure 8).

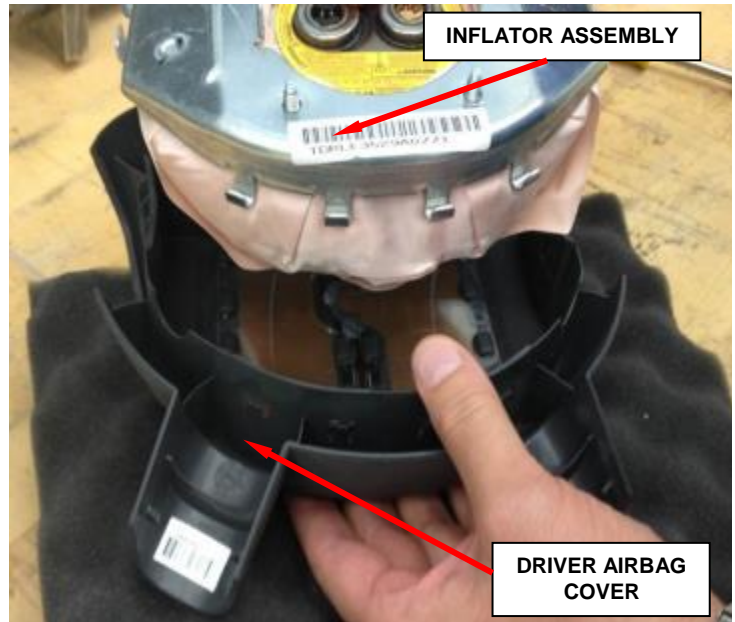
Figure 9 - Inflator Assembly to Driver Airbag Cover

- 15. Disengage the inflator assembly from the driver airbag cover and set aside for shipping (Figure 9).

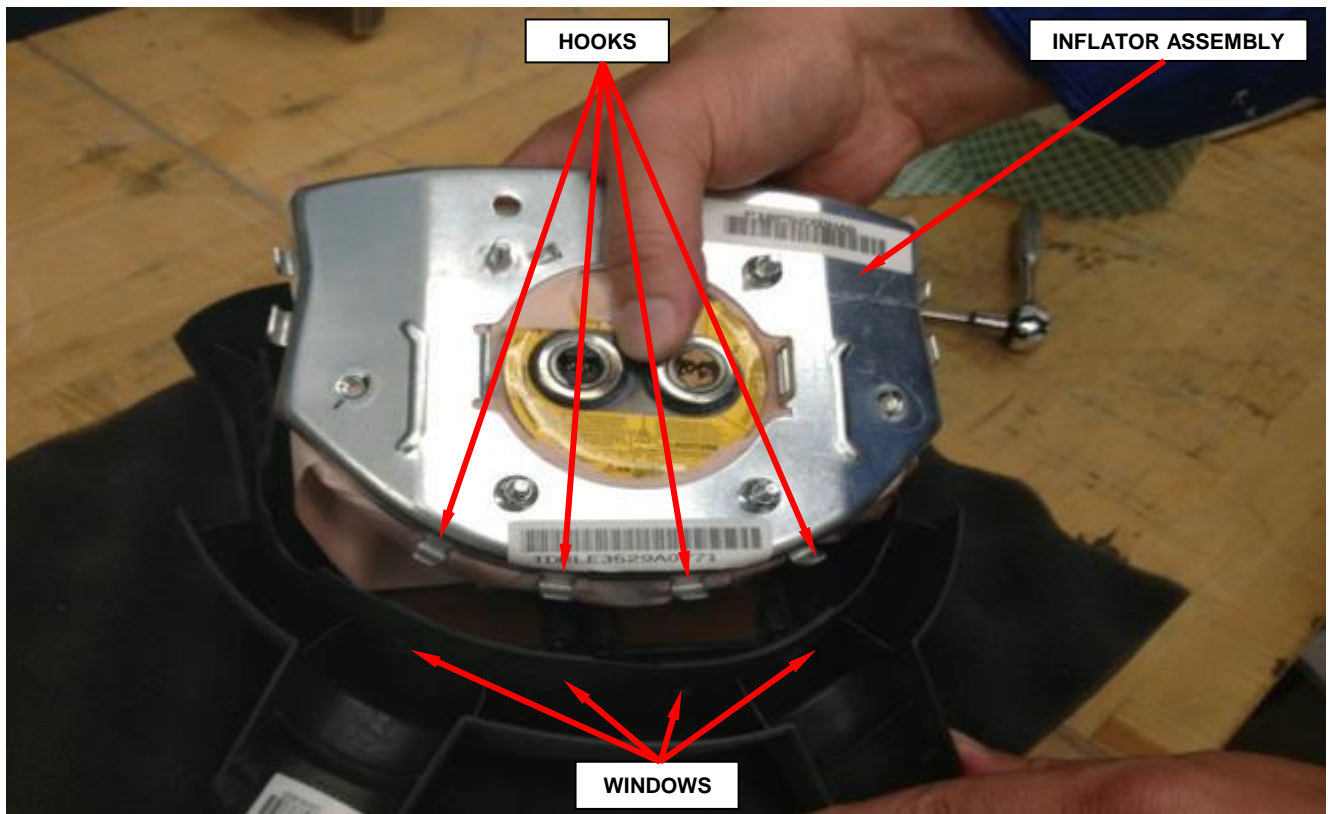
Figure 10 - Inflator Assembly to Driver Airbag Cover Hooks

- 16. Install the new inflator assembly to the original driver airbag cover by first inserting the bottom hooks into the windows (Figure 10).

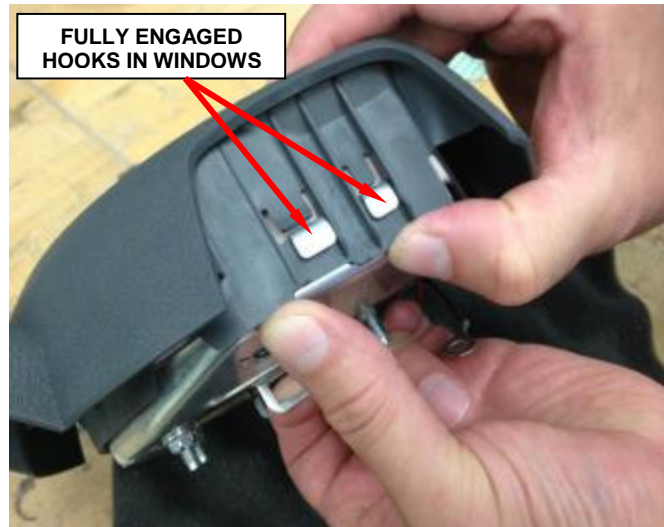
Figure 11 – Inflator Assembly Hooks

17. Snap the remaining hooks on all sides into place.
18. Pull on the inflator assembly to fully engage the windows and hooks on all sides (Figure 11).

NOTE: Visually inspect and verify that all the hooks are fully engaged with the windows on all sides.

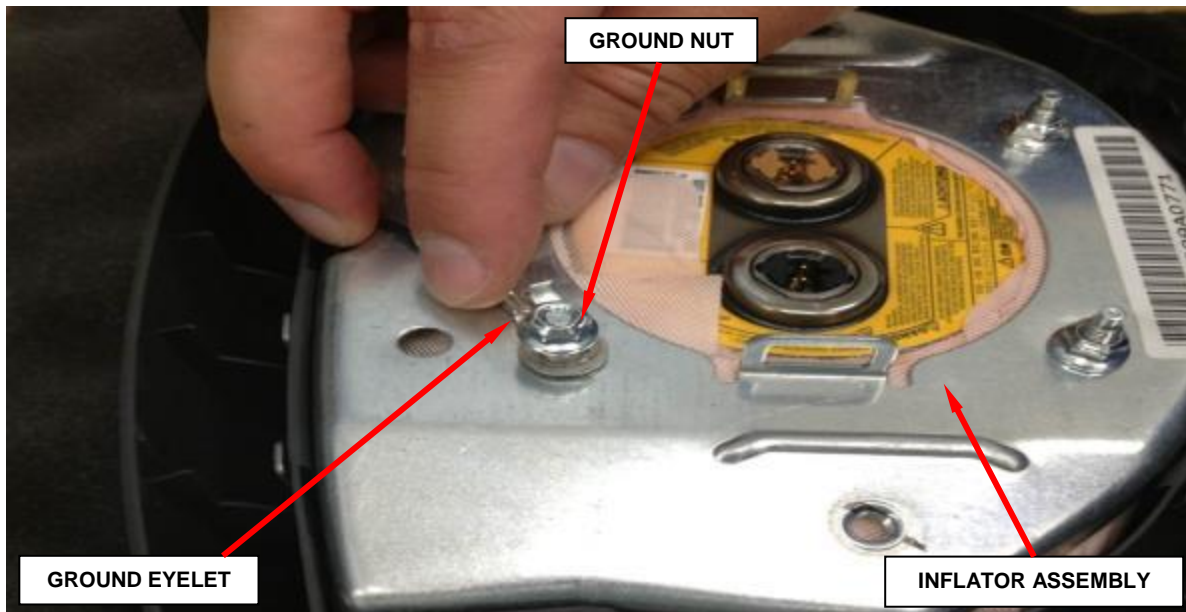
Figure 12 – Ground Eyelet to Inflator Assembly

19. Install the ground eyelet on the upper left stud (Figure 12).
20. Install the new ground nut and tighten to 26 in. lbs. (3 N·m).

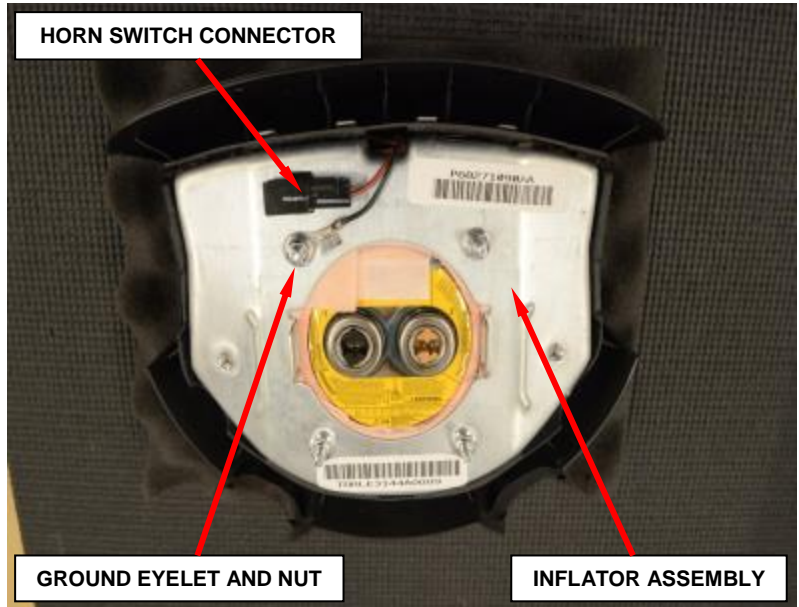
Figure 13 – Driver Airbag Assembly

21. Clip the horn switch connector to the inflator assembly (Figure 13).

22. Driver airbag retrofit is complete (Figure 13).

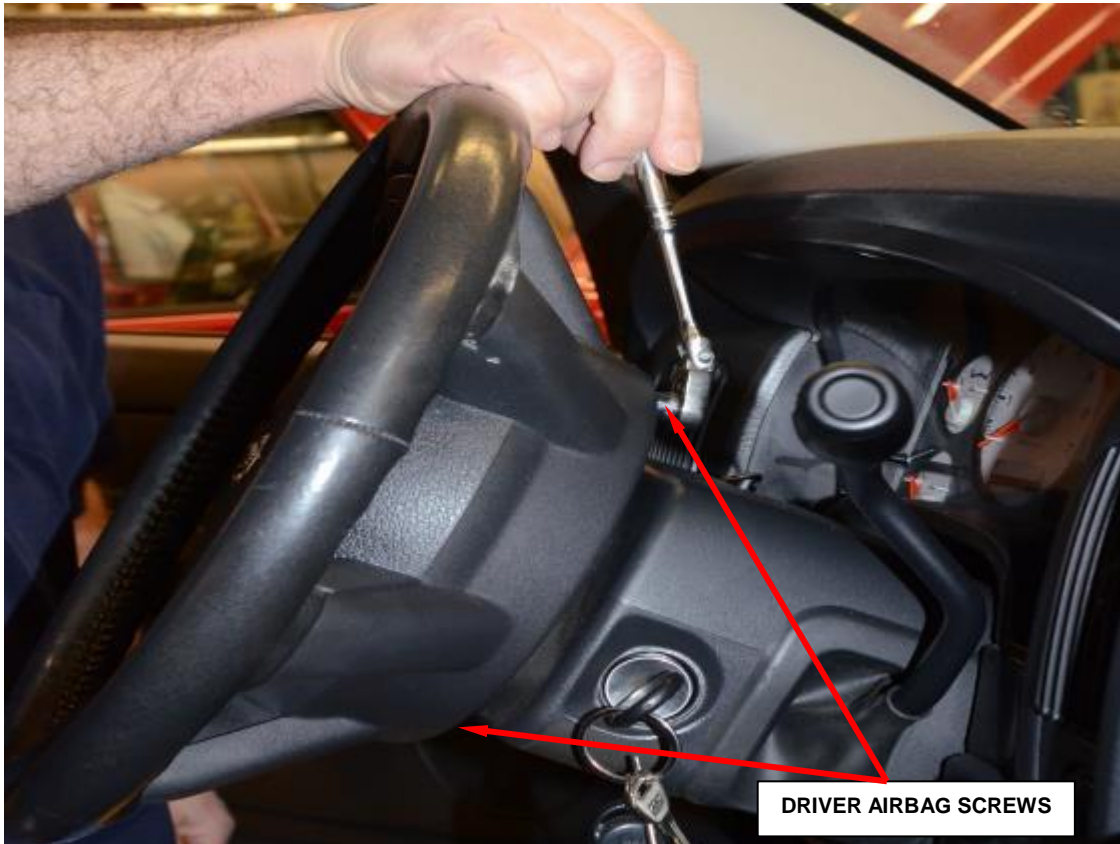
Figure 15 – Typical Driver Airbag Screw Locations

1. Use this procedure to replace the driver airbag inflator.
2. Disconnect and isolate the negative battery cable. Wait two minutes for the system capacitor to discharge before further service.
3. Remove and save the two screws that secure the driver airbag assembly to the steering wheel armature from the underside of the steering wheel (Figure 15).

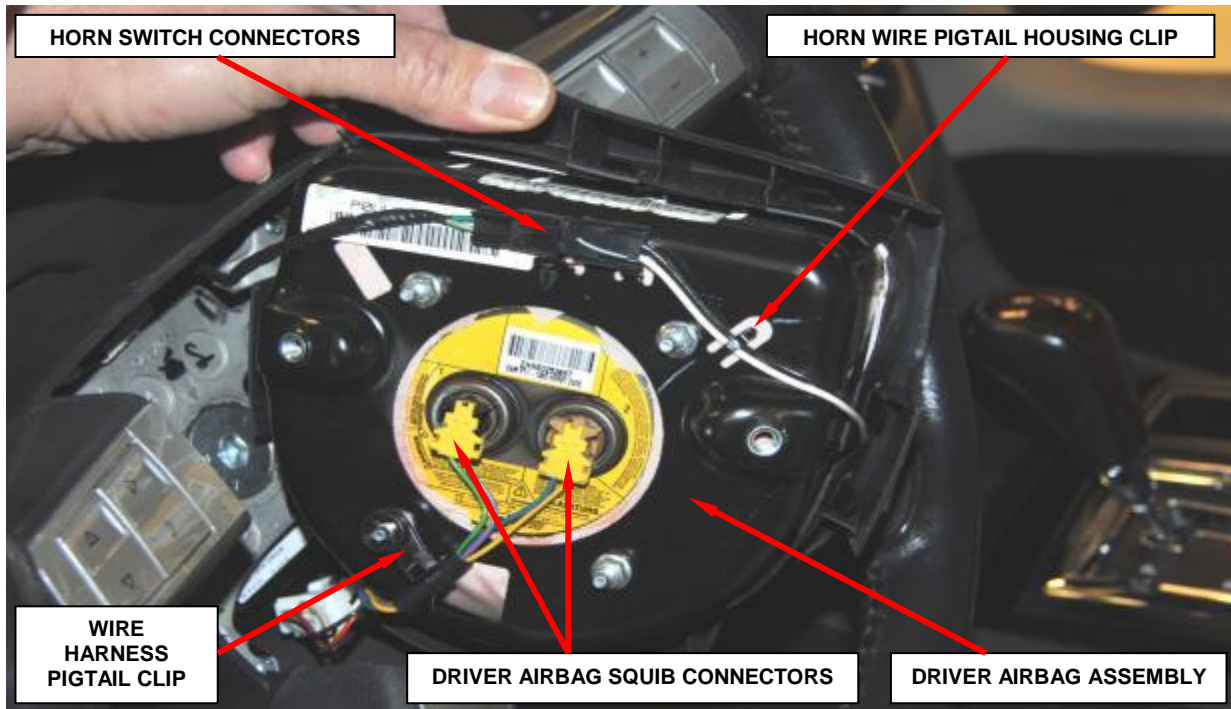
**Figure 16 – Electrical Connectors**

4. Pull the driver airbag assembly away from the steering wheel far enough to access the three electrical connections on the back of the airbag housing (Figure 16).
5. Disconnect the steering wheel wire harness connector for the horn switch from the horn switch feed pigtail wire connector, which is located on the back of the driver airbag housing (Figure 16).

23. Position the driver airbag to the steering wheel to connect the three electrical connections on the back of the airbag housing.
24. Connect the two driver airbag squib connectors to the airbag inflator connector receptacles by pressing straight in on the connector. Be certain to engage each keyed and color-coded connector to the matching connector receptacle. Be certain that each connector is fully engaged in its receptacle by listening carefully for a distinct, audible click as the connector latches snap into place (Figure 16).

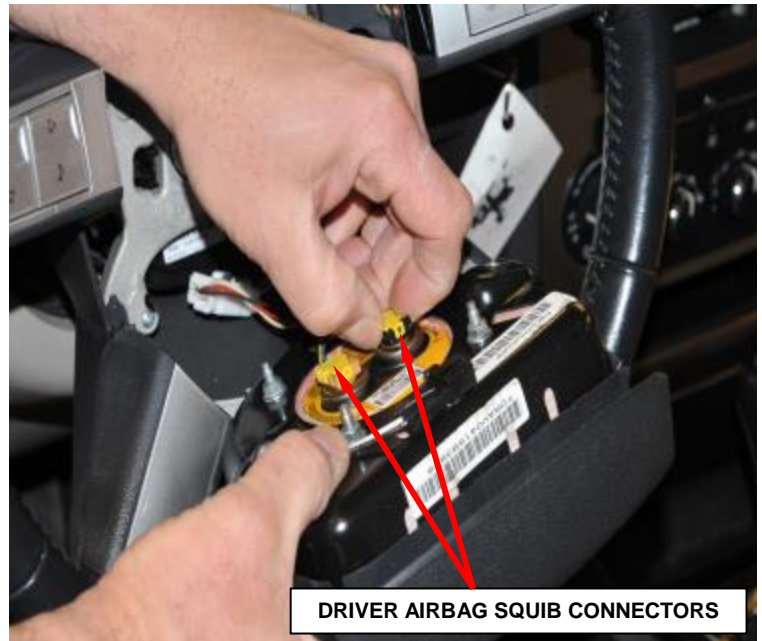
Figure 17 – Airbag Squib Connectors

6. Disconnect the driver airbag squib connectors. Depress the latches on each side of the connector insulator and pull the insulators straight out from the airbag inflator to disconnect them from the connector receptacles (Figure 17).
7. Disengage the wire harness pigtail clip from the housing (Figure 18).
8. Remove the driver airbag assembly from the steering wheel.

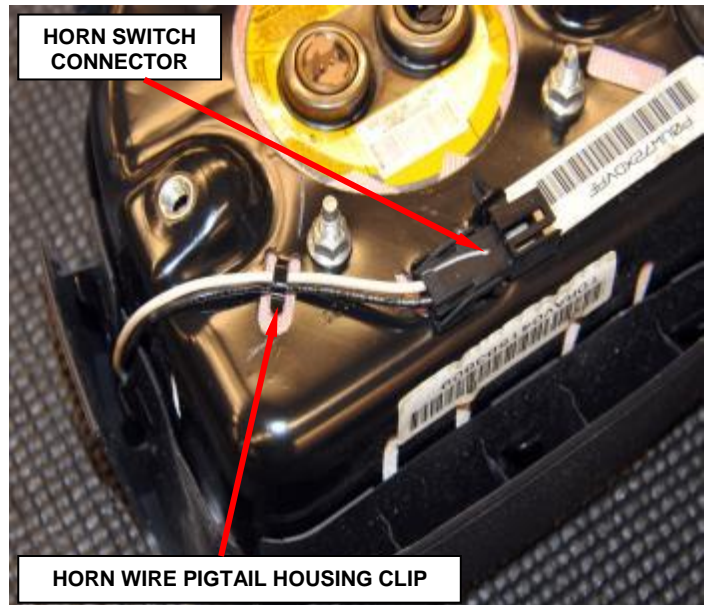
Figure 19 – Horn Connector

9. Place the driver airbag on a soft surface to prevent damage using the foam block provided with the inflator kit.
10. Remove the horn switch connector from the housing (Figure 19).
11. Remove the horn wire pigtail from the housing clip (Figure 19).
12. Remove the driver airbag cover starting with the left side by pressing down on the driver airbag housing until the hooks unsnap from the windows (Figure 20).

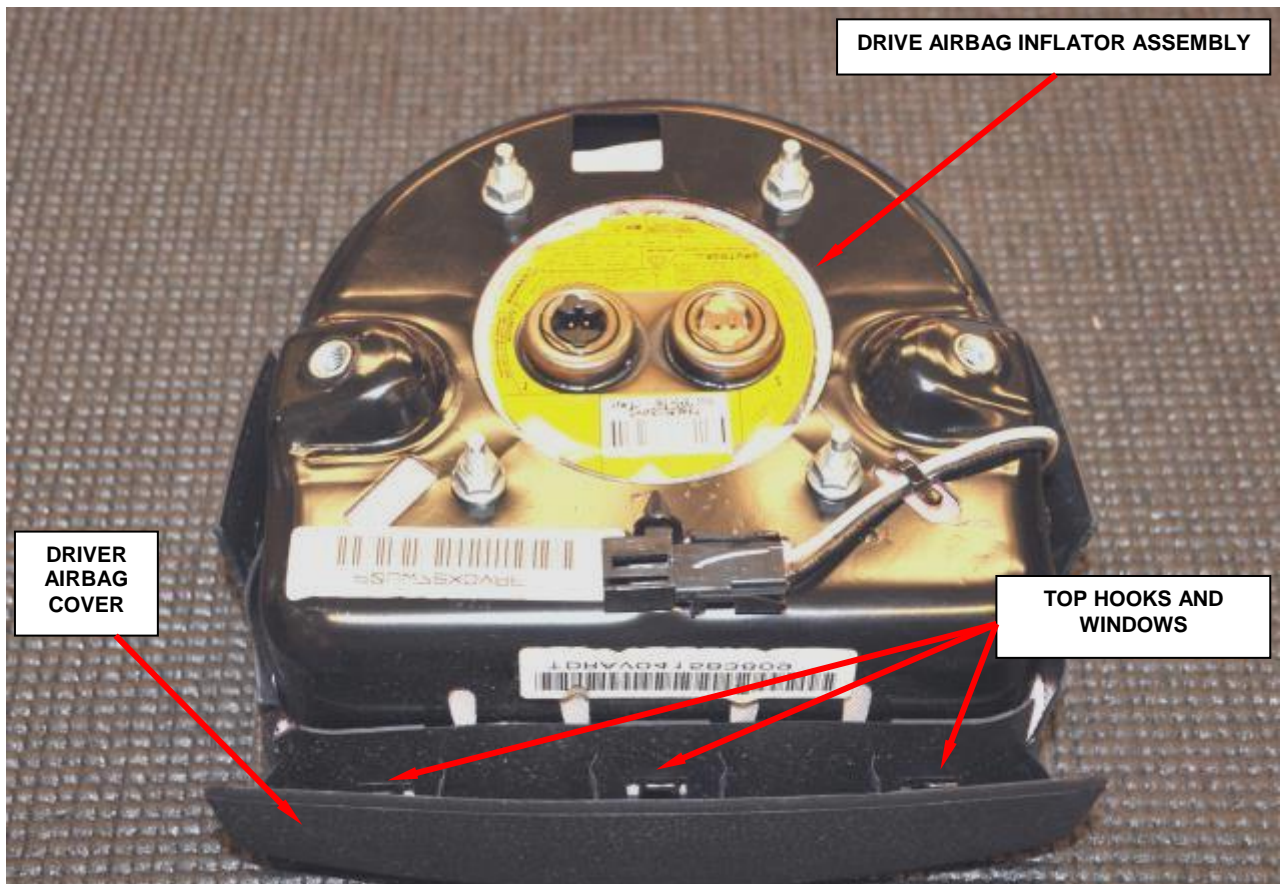
Figure 21 – Driver Airbag Inflator Assembly to Cover

13. Unsnap the bottom hooks by pressing down on the housing until the hooks unsnap from the cover.
14. Unsnap the right side hooks by pressing down on the housing until the hooks unsnap from the cover.
15. Gently pull the housing up slowly making sure that the hooks are clear from the windows on all sides.
16. Disengage the old inflator assembly from the driver airbag cover and set aside for shipping.
17. Install the new inflator assembly to the original driver airbag cover by first inserting the top hooks into the windows (Figure 21).

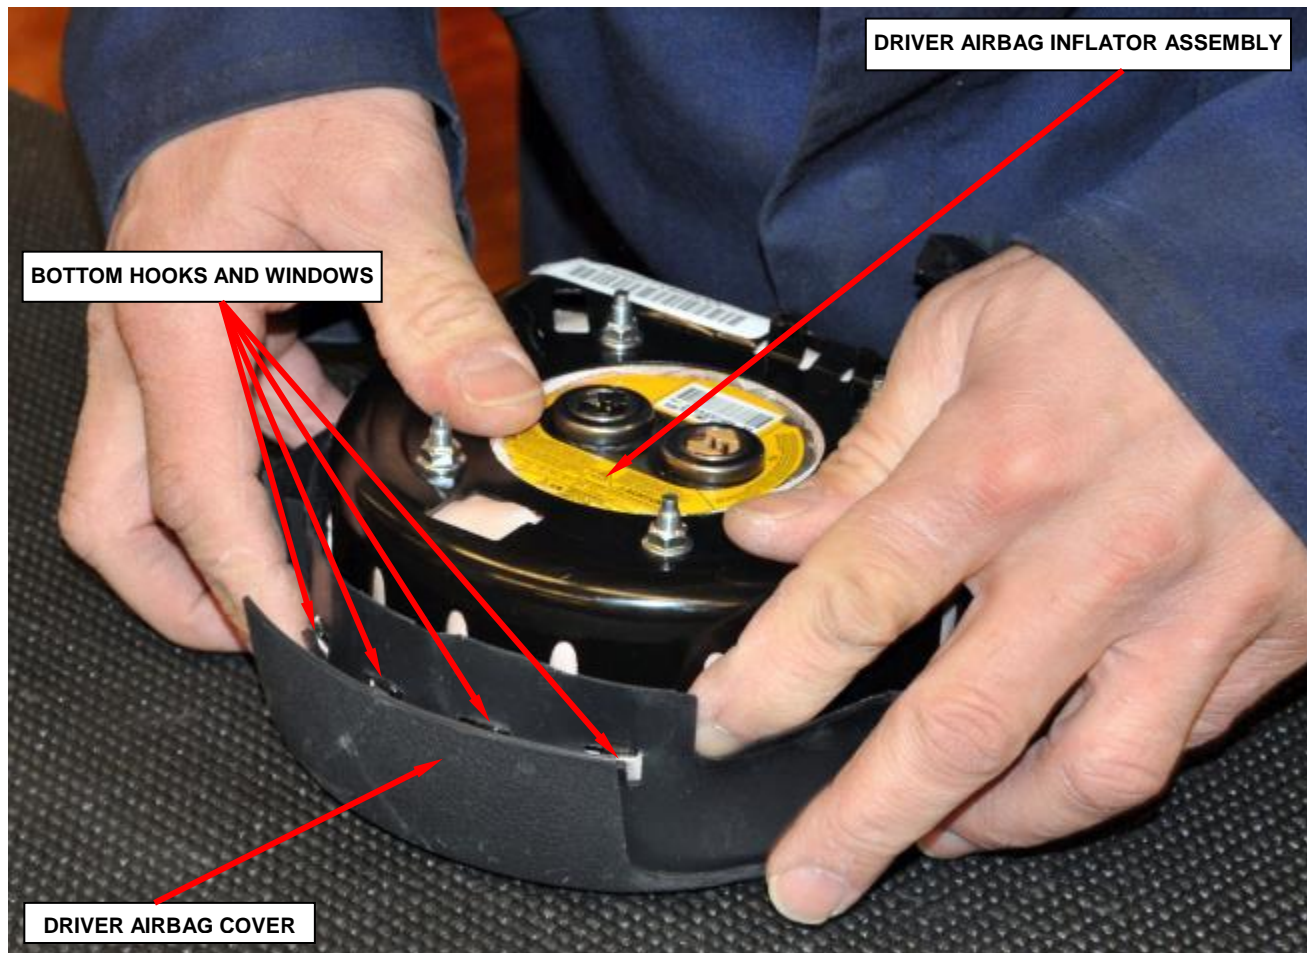
Figure 22 - Verify Hook and Window Engagement

18. Snap the remaining hooks in the windows on all sides into place.
19. Pull on the driver airbag inflator assembly to fully engage the hooks and windows on all sides of the driver airbag cover (Figure 22).

NOTE: Visually inspect and verify that all the hooks are fully engaged with the windows on all sides.

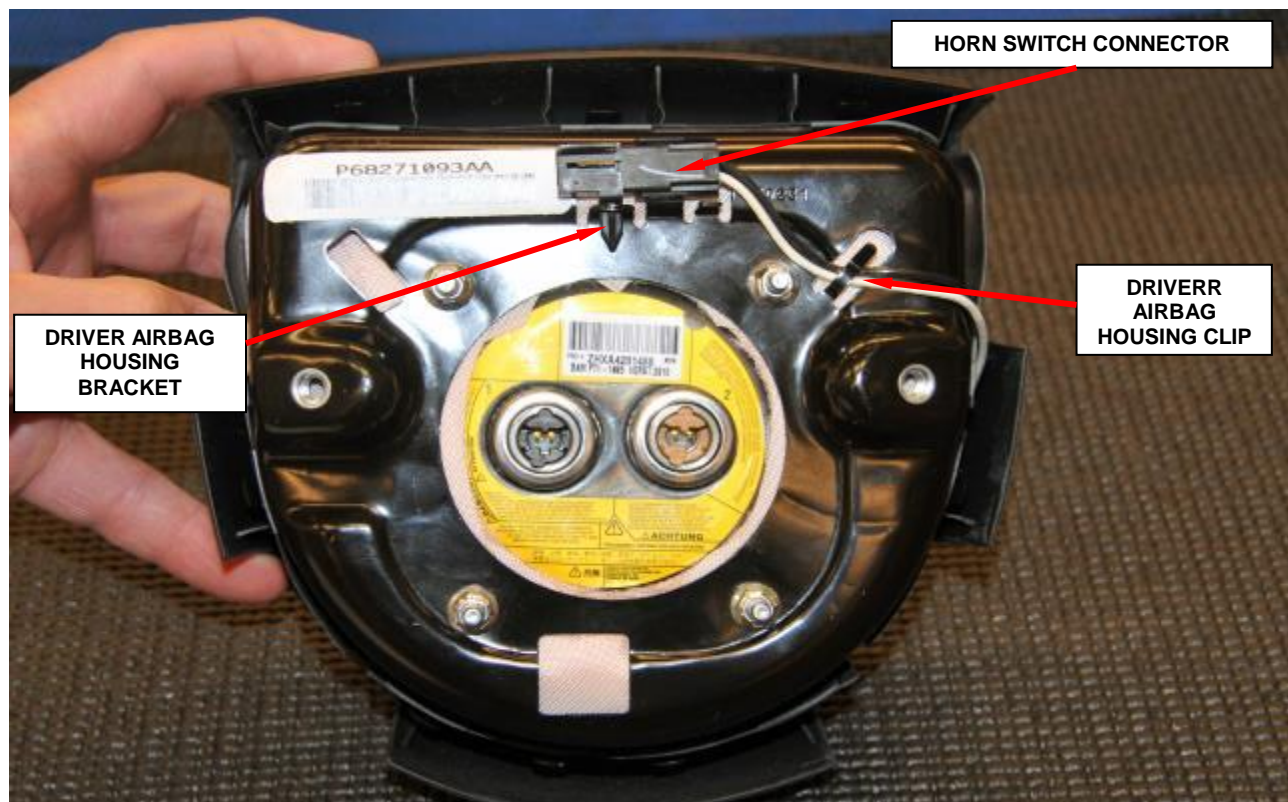
Figure 23 – Horn Switch Connector

20. Clip the horn switch connector to the driver airbag housing bracket (Figure 23).
21. Engage the horn switch wire harness pigtail to the driver airbag housing clip (Figure 23).
22. Driver airbag retrofit is complete (Figure 23).

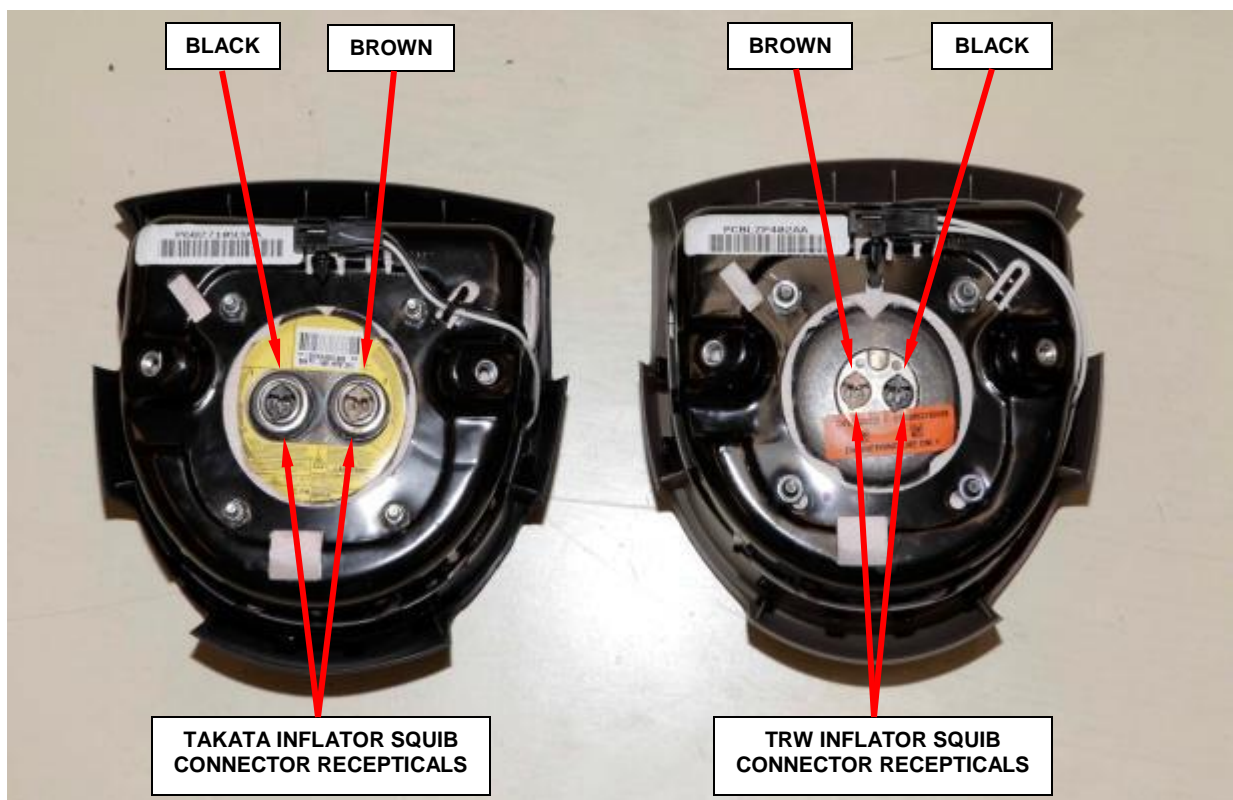
Figure 24 - Squib Connector Receptacles

NOTE: The squib connector receptacle locations on the driver airbag inflators are switched between the original Takata inflator and the TRW replacement inflator kits. Squib connectors are keyed and color coded for error proofing (Figure 24).
