December 19, 2015

02025 Version 4

Safety Recall: Driver's Airbag Inflator Can Be Over-Pressurized

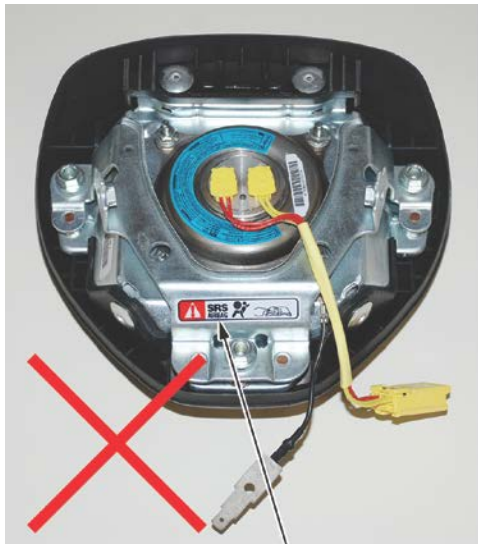
- If there is nothing unusual about the airbag or the inflator, go to step 6.
- If there are any unusual markings, like an incorrect label or a model year written in marker, the airbag and inflator may not be the correct airbag and/or inflator for the vehicle or it may be a counterfeit part. For more information about counterfeit airbags, you can refer to safercar.gov, enter keywords **MANAGING COUNTERFEIT**, and select **Recommended Dealer Guidance for Managing Counterfeit Air Bags** from the list. **If you suspect that the airbag or inflator is counterfeit, do not continue this procedure.** Contact your DPSM for assistance.

NON-STANDARD
SAFETY LABEL

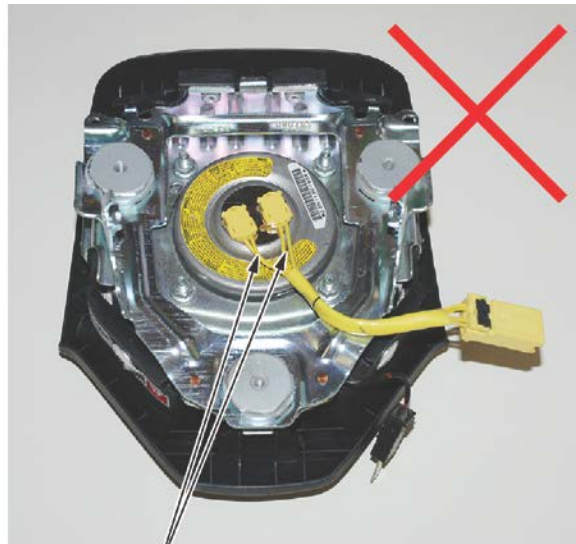
NON-STANDARD
WIRES

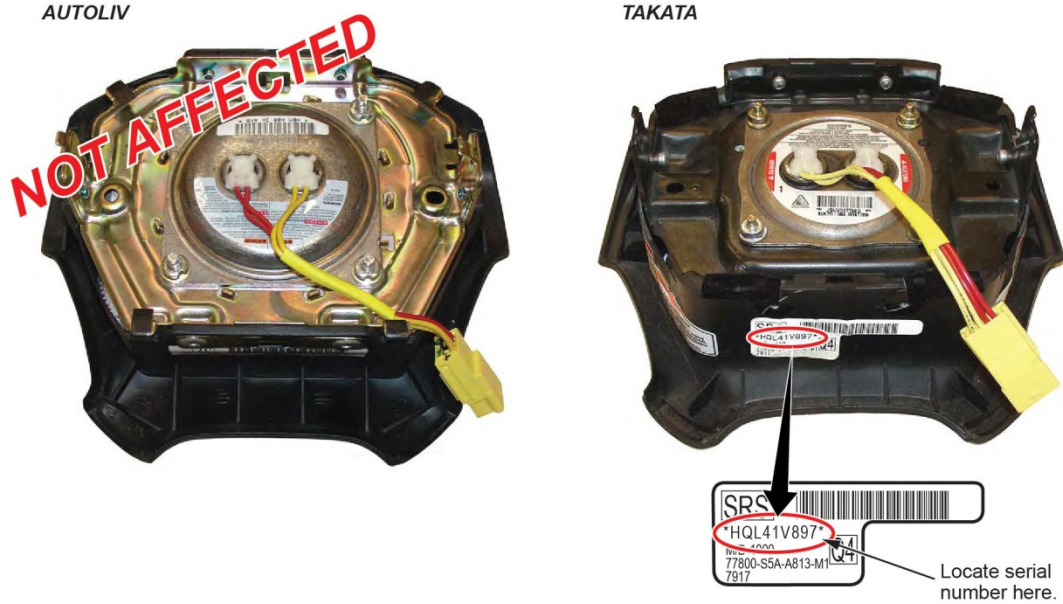
6. **Civic only** - Determine if the airbag is made by Autoliv or Takata by comparing the inflators to those in the images below.

NOTE: The Autoliv serial number label is different from the Takata label; the Autoliv has 11 characters, the Takata has 9.

- If the airbag is made by Autoliv, the airbag is OK. Reinstall the airbag using new Torx bolts. Torque the bolts to **9.8 N-m (7.2 lb-ft)**. If you already received a replacement inflator, return the unopened kit to American Honda.
- If the airbag is made by Takata, go to step 7.

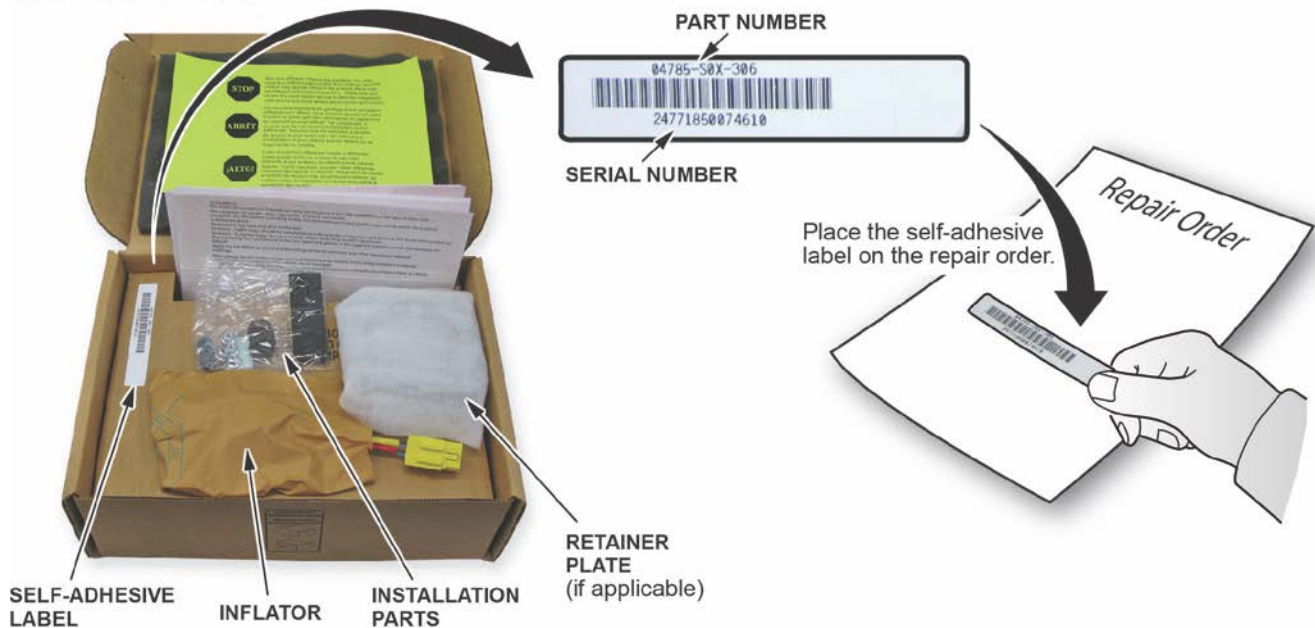
INFLATOR PARTS BOX

7. Peel the label located inside the inflator box from its backing and attach it to the RO. For the warranty claim to be paid, the **replacement inflator part number that you received** must be included in the warranty claim.

- The replacement part number is printed on the top part of the label and the serial number is printed on the bottom. **Make sure you attach the label to the RO and give it to the warranty clerk.**
- There may also be a colored sticker located in the kit, ignore it because it is not used.
- Not all inflator kits have a label included. In those cases, write the serial number and part number from the side of the inflator box on the RO. The part number always starts with 047.

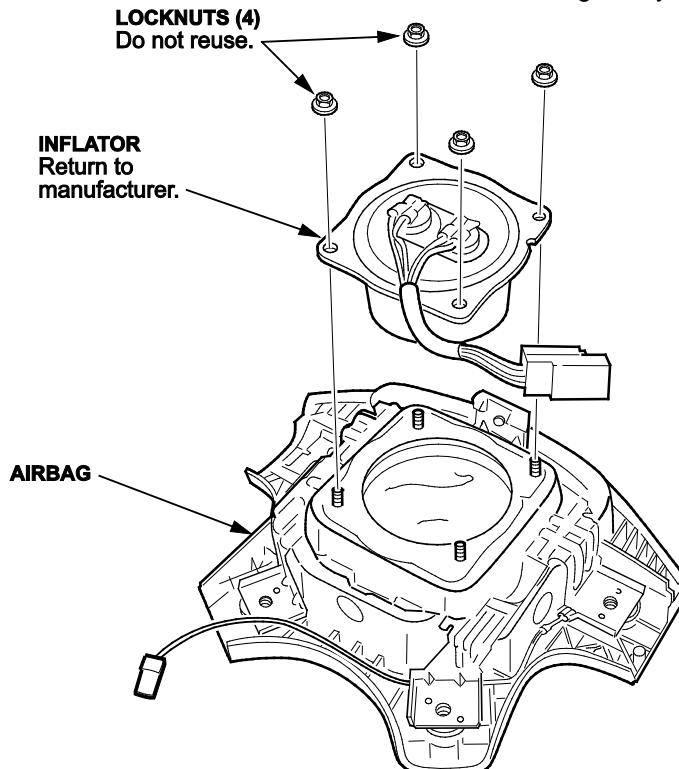
9. Using needle-nose vise grips or a 3/8 in. 6-point socket, remove the four locknuts from the inflator. The locknuts will not be reused.

NOTE: Do not remove the inflator from the airbag until you complete step 10.

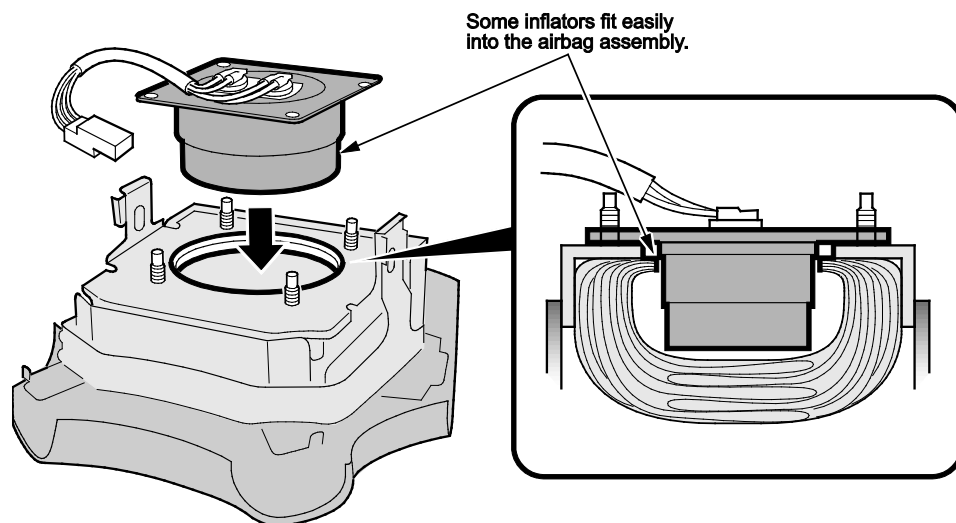
- Insert the inflator into the opening.

NOTE: Make sure the inflator wires are positioned toward the bottom of the airbag. If you install the inflator incorrectly, you may not be able to reconnect the SRS airbag harness.

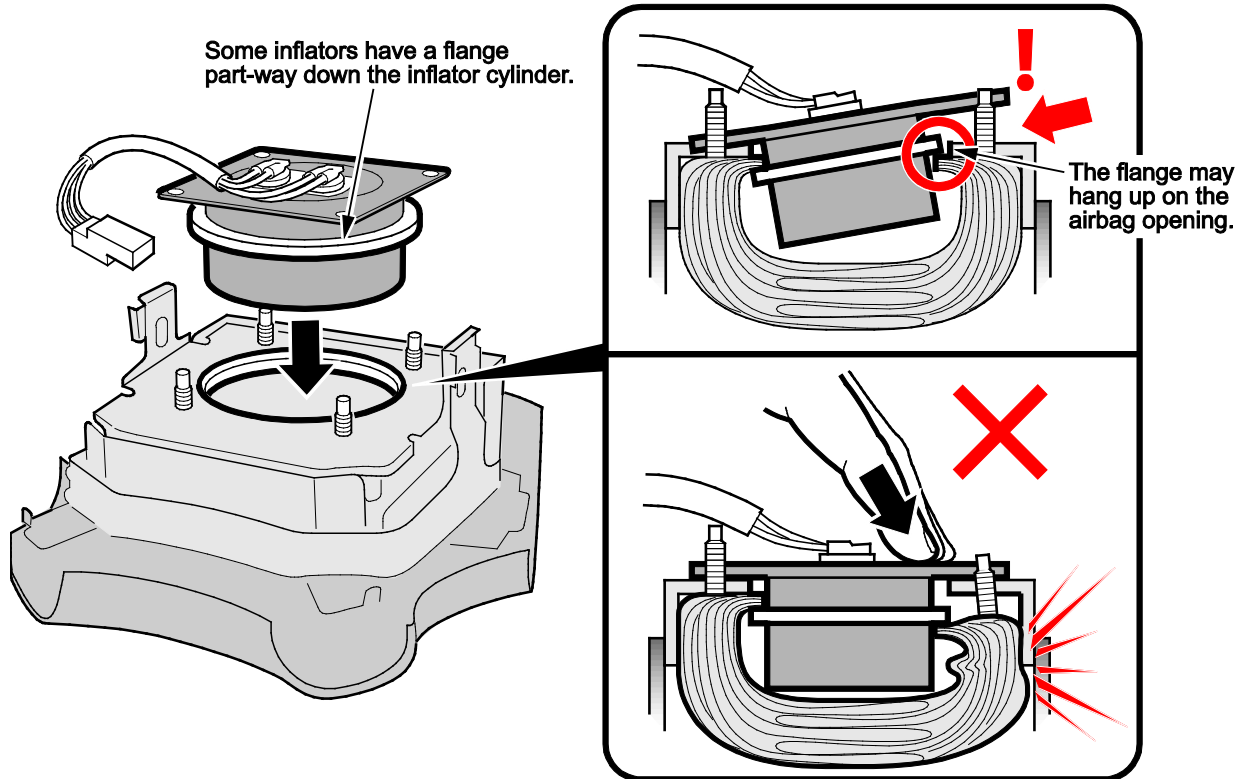
- Insert the airbag inflator into the opening. Do not force it into the airbag module.

NOTE: Make sure the inflator wires are positioned toward the bottom of the airbag. If you install the inflator incorrectly, you may not be able to reconnect the SRS airbag harness.

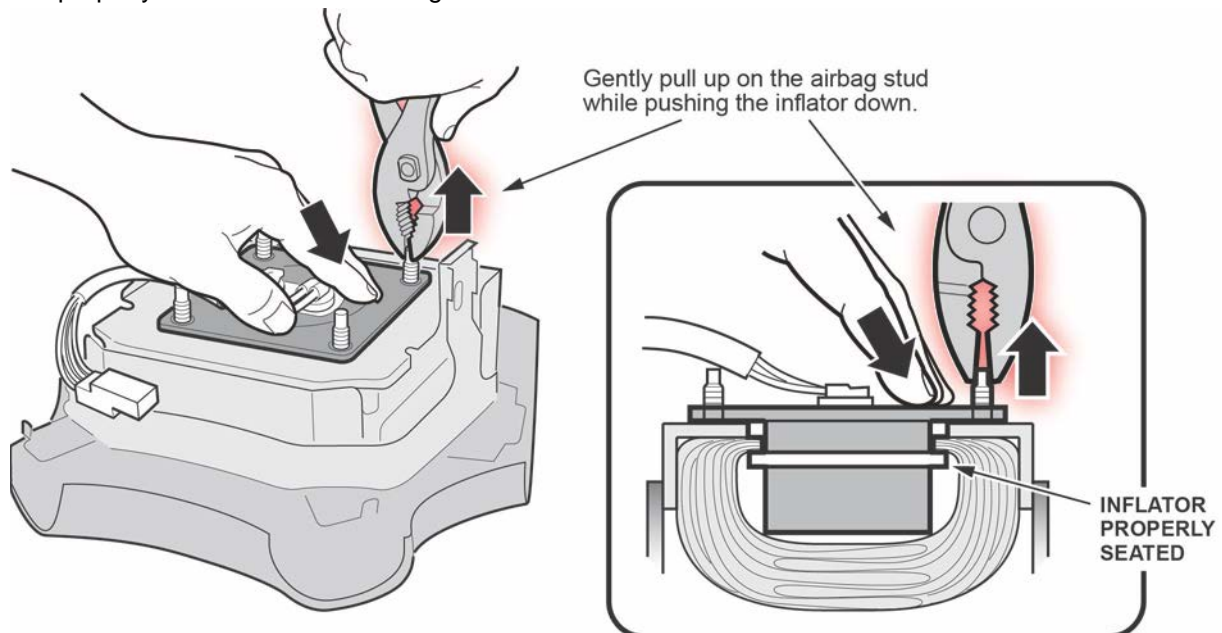
- Using a pair of pliers, gently pull up on each stud up while pushing the inflator module down until the airbag is properly seated within the airbag module.

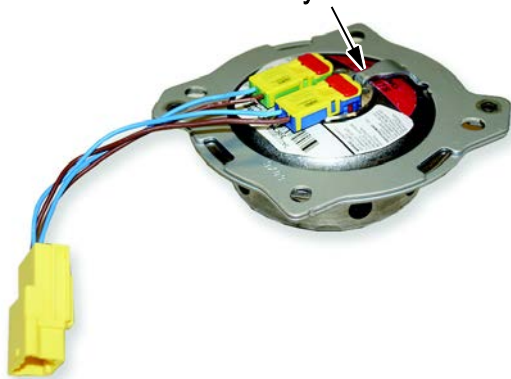
The inflator is held down by a directional retainer that is keyed to the inflator.

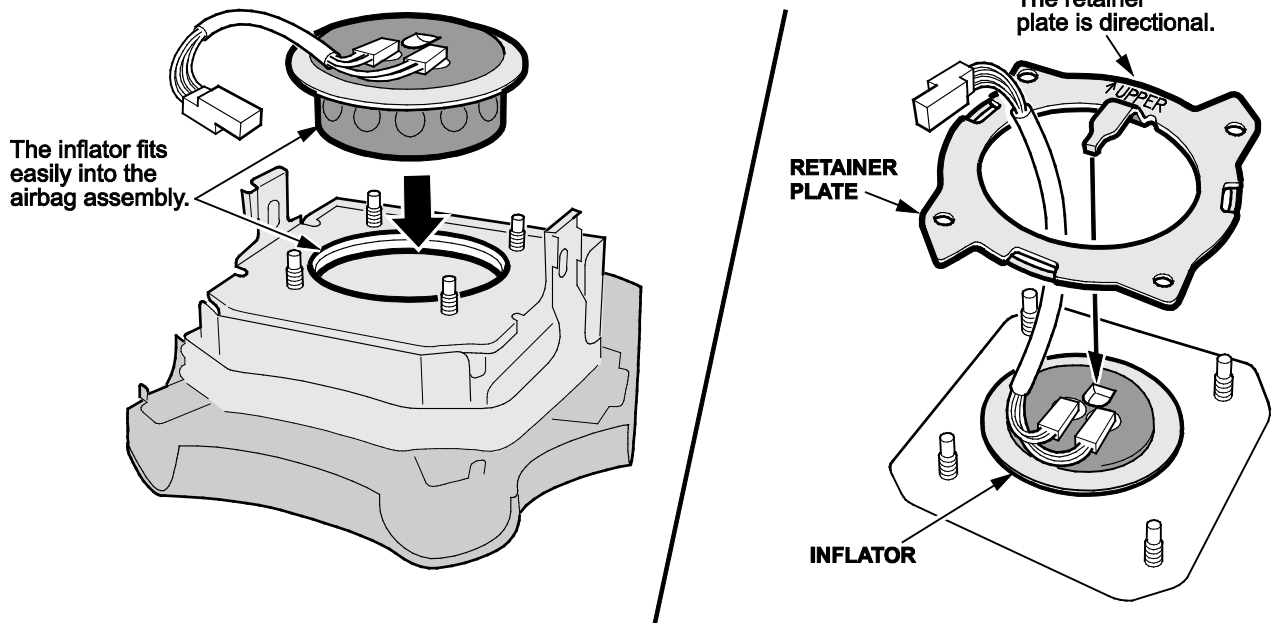
- Place the inflator into the opening with the inflator harness toward the bottom of the airbag.

- Install the bracket onto the studs. Make sure the locator tab fits into the locator hole as shown.
NOTE: Make sure the harness comes out through the center opening. Do not install the bracket over the harness wires.

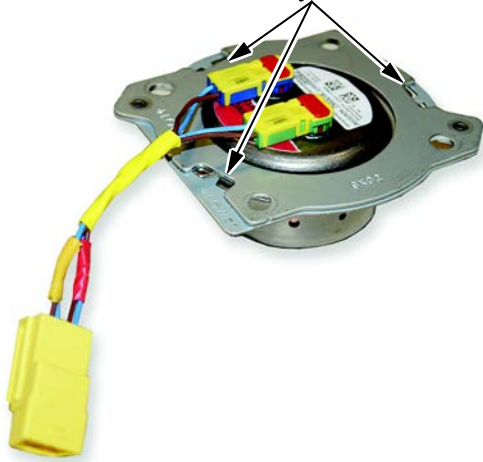
The inflator is held down by a directional retainer that is keyed to the inflator.

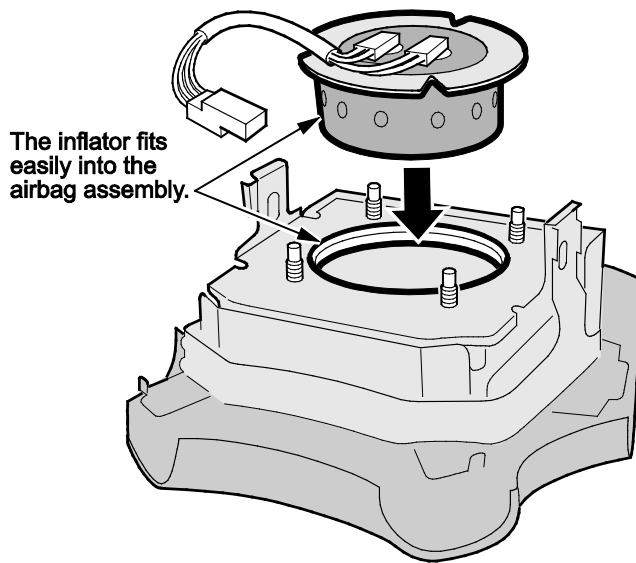
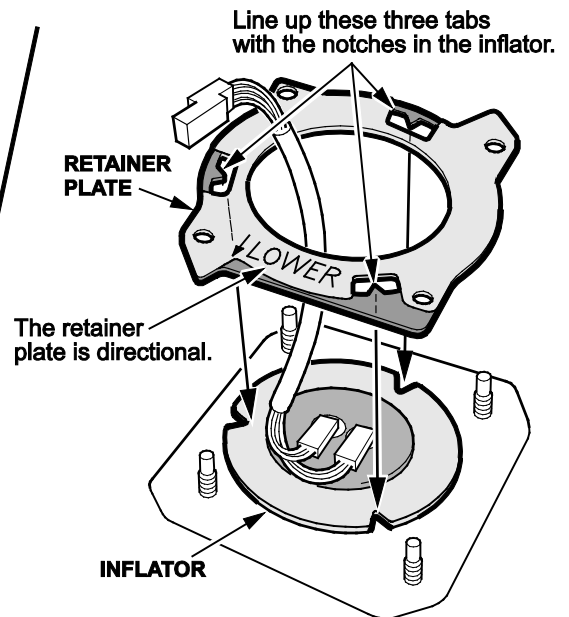
- Place the inflator into the opening with the inflator harness toward the bottom of the airbag.

- Install the bracket onto the studs with the stamp **LOWER** at the bottom of the airbag.
- Make sure the three tabs and notches are properly aligned.

- The tabs and notches are designed to align in one direction only. If the tabs and notches are not aligned, the inflator and bracket are not installed correctly.
- Make sure the harness comes out through the center opening. Do not install the bracket over the harness wires.
