Service Bulletin

15-040

Safety Recall: Driver's Airbag Inflator Can Be Over-Pressurized

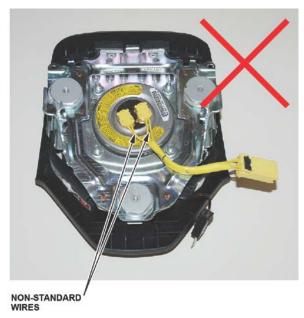
- 4. Place the airbag, face down, on a clean shop towel.
- 5. Visually inspect the airbag and the inflator for any unusual writing or markings.
 - If there is nothing unusual about the airbag or the inflator, go to step 6.

- If there are any unusual markings, like an incorrect label or a model year written in marker, the airbag and inflator may not be the correct airbag and/or inflator for the vehicle or it may be a counterfeit part. For more information about counterfeit airbags, you can refer to safercar.gov, enter keywords MANAGING COUNTERFEIT, and select Recommended Dealer Guidance for Managing Counterfeit Air Bags from the list. If you suspect that the airbag or inflator is counterfeit, do not continue this procedure. Contact your DPSM for assistance.

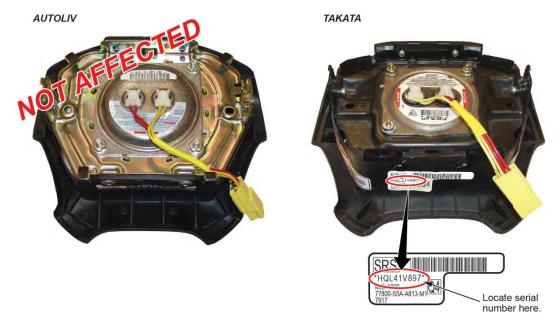
6. **Civic only** - Determine if the airbag is made by Autoliv or Takata by comparing the inflators to those in the images below.

NOTE: The Autoliv serial number label is different from the Takata label; the Autoliv has 11 characters, the Takata has 9.

- If the airbag is made by Autoliv, the airbag is OK. Reinstall the airbag using new Torx bolts. Torque the bolts to 9.8 N-m (7.2 lb-ft). If you already received a replacement inflator, return the unopened kit to American Honda.
- If the airbag is made by Takata, go to step 8.

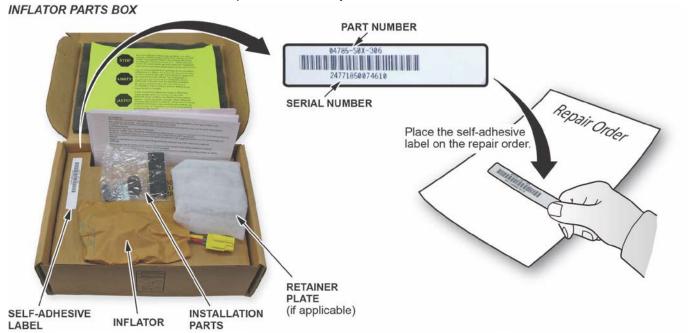
7. Peel the label located inside the inflator box from its backing and attach it to the R.O. For the warranty claim to be paid, the **replacement inflator part number that you received** must be on the warranty claim and your warranty clerk must enter the serial number in the Diagnostic Trouble Codes field.

- The replacement part number is printed on the top part of the label and the serial number is printed on the bottom. Make sure you attach the label to the R.O. and give it to the warranty clerk.
- There may also be a colored sticker located in the kit, ignore it because it is not used.
- Not all inflator kits have a label included. In those cases, write the serial number and part number from the side of the inflator box on the R.O. The part number always starts with 047.

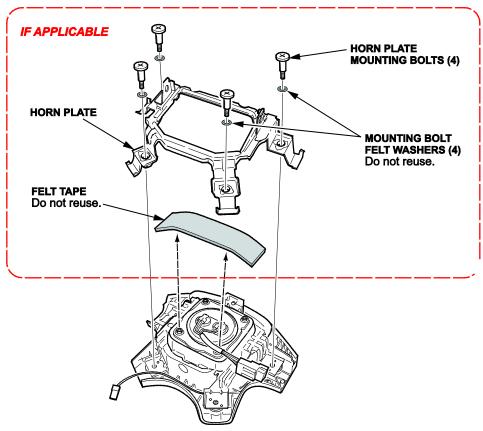
8. If there is no horn plate installed, go to step 9. If there is a horn plate installed, remove the four horn plate mounting bolts, the mounting bolt felt washers, the horn plate, and remove the felt tape covering the lower two inflator locknuts. The felt washers and felt tape will not be reused.

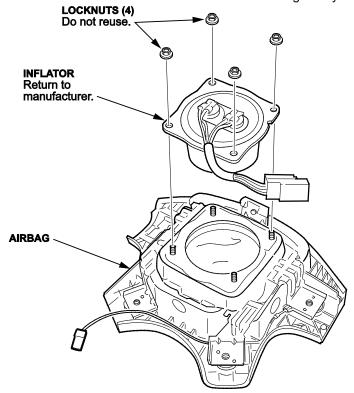
9. Using needle-nose vise grips or a 3/8 in. 6-point socket, remove the four locknuts from the inflator. The locknuts will not be reused.

NOTE: Do not remove the inflator from the airbag until you complete step 10.

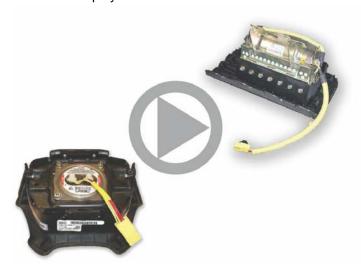
NOTE: There may be some minor surface rust or corrosion on the new inflator; this is OK. Click on the image below for a short video about the different variations of the driver's and front passenger's replacement inflators involved with the recalls related to Takata inflators. While both the driver's and front passengers inflators are shown in the video, this is informational only. Replace inflators only as directed by the iN VIN status inquiry.

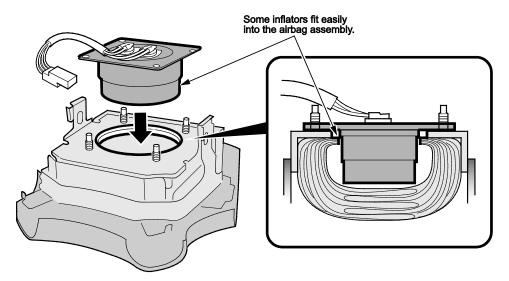
04770-S5A-305 04770-SDA-305

04770-S9A-306 Refer to **Driver's Inflator Type 1** in the video.

04770-SCV-306 04770-SJC-306

• Insert the inflator into the opening.

NOTE: Make sure the inflator wires are positioned toward the bottom of the airbag. If you install the inflator incorrectly, you may not be able to reconnect the SRS airbag harness.

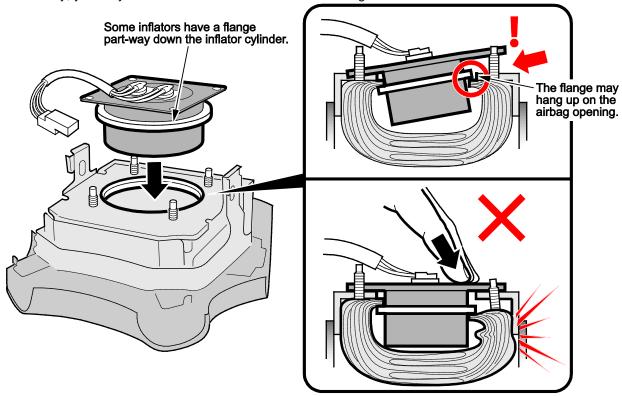
04770-SJC-406

04770-S5A-405 04770-SDA-406 04770-S9A-405 Refer to **Driver's Inflator Type 2** in the video. 04770-SCV-405

• Insert the airbag inflator into the opening. Do not force it into the airbag module.

NOTE: Make sure the inflator wires are positioned toward the bottom of the airbag. If you install the inflator incorrectly, you may not be able to reconnect the SRS airbag harness.

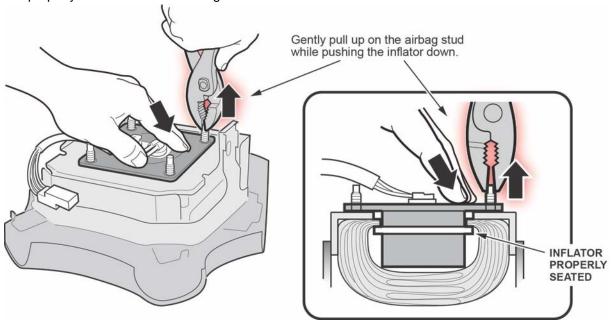
• Using a pair of pliers, gently pull up on each stud up while pushing the inflator module down until the airbag is properly seated within the airbag module.

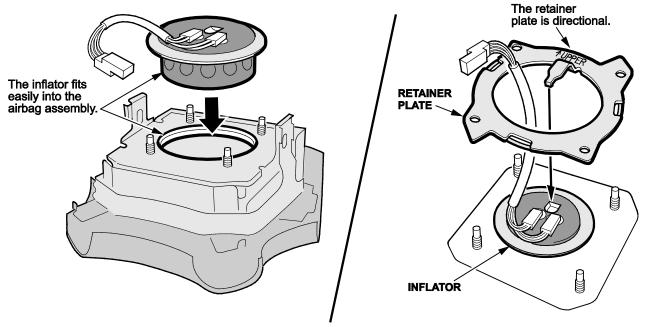
Place the inflator into the opening with the inflator harness toward the bottom of the airbag.

Install the bracket onto the studs. Make sure the locator tab fits into the locator hole as shown.
 NOTE: Make sure the harness comes out through the center opening. Do not install the bracket over the harness wires.

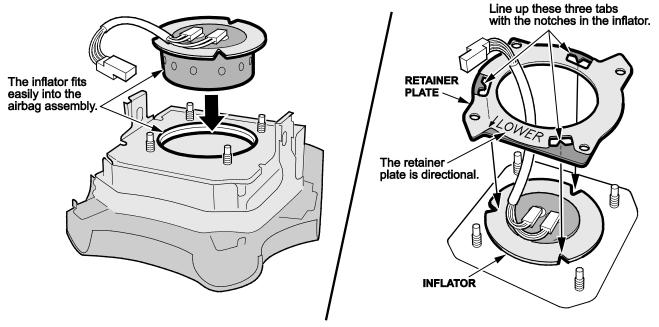
Place the inflator into the opening with the inflator harness toward the bottom of the airbag.

- Install the bracket onto the studs with the stamp LOWER at the bottom of the airbag.
- Make sure the three tabs and notches are properly aligned.

- The tabs and notches are designed to align in one direction only. If the tabs and notches are not aligned, the inflator and bracket are not installed correctly.
- Make sure the harness comes out through the center opening. Do not install the bracket over the harness wires.
